ADDENDUM #4

43-47 Bronson Court Abatement Addendum #4

Limited Pre-Renovation Regulated Building Materials Inspection

Bronson Court Townhomes
43 & 47 Bronson Court
Rochester, New York 14608

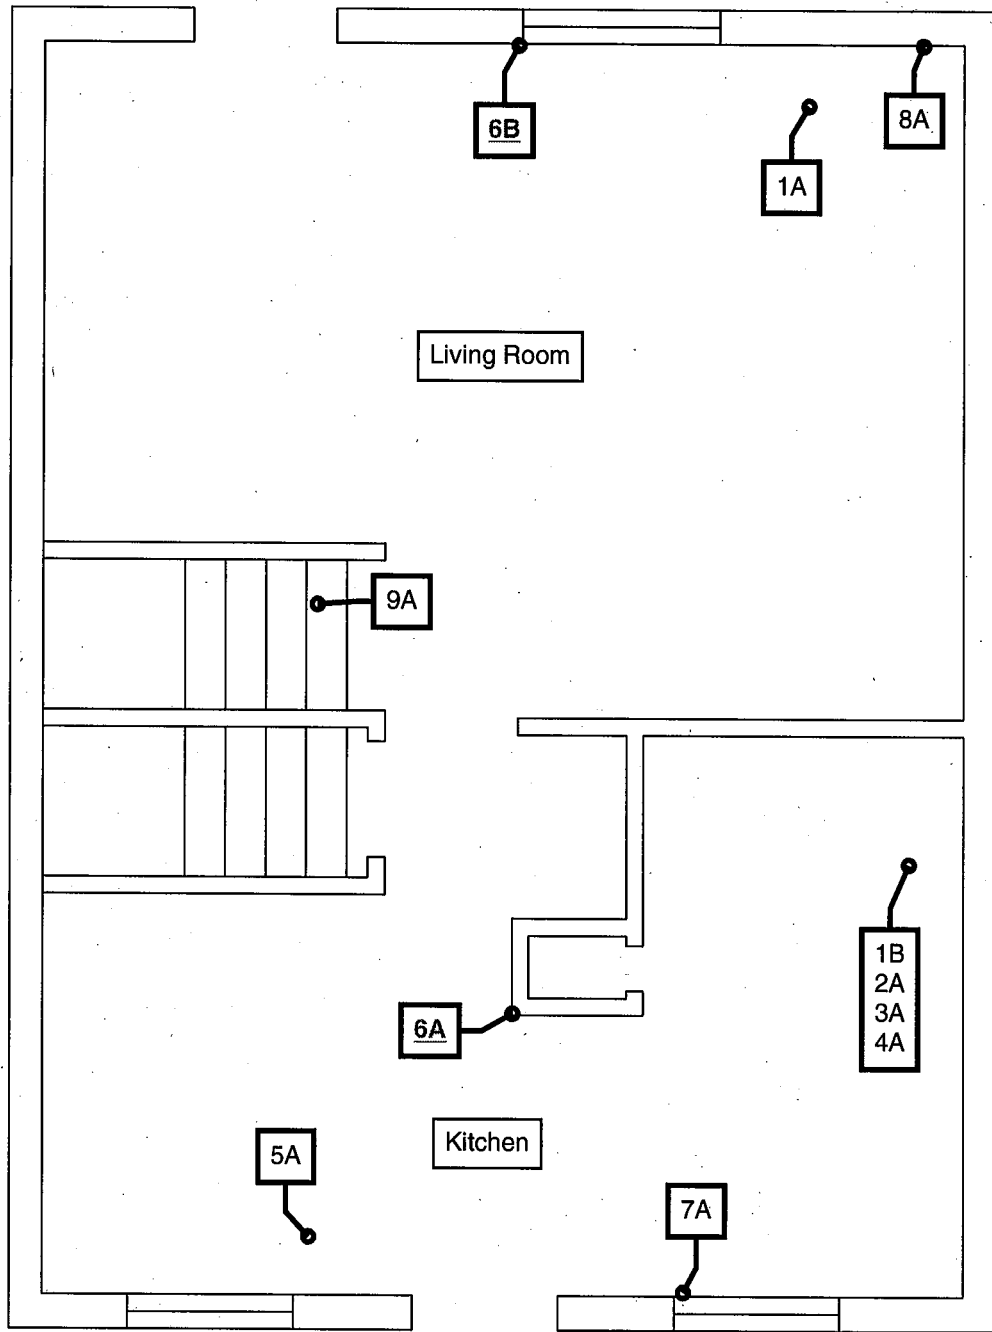
FIRST FLOOR

Confirmed ACM **6B** and **9A**

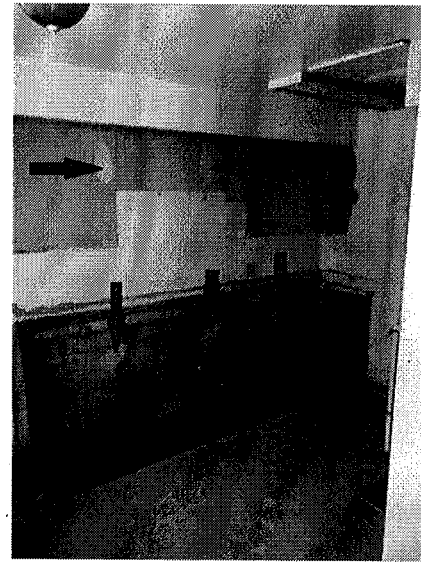
White asbestos-containing joint compound located on walls throughout Apartment 43

White asbestos-containing joint compound is located on walls and ceilings throughout Apartment 43. The joint compound is generally in good condition and covers an area of approximately 3,700 square feet within this unit. This material is considered to be non-friable in its current, intact condition. However, this material has the potential to become friable during any renovation/demolition activities that will disturb the material.
