ATTACHMENT A:
LIMITED PRE-RENOVATION
REGULATED BUILDING MATERIALS
INSPECTION REPORT -
AUGUST 24, 2023

Limited Pre-Renovation Regulated Building Materials Inspection

26 Weld Street
Rochester, New York 14605

2232834

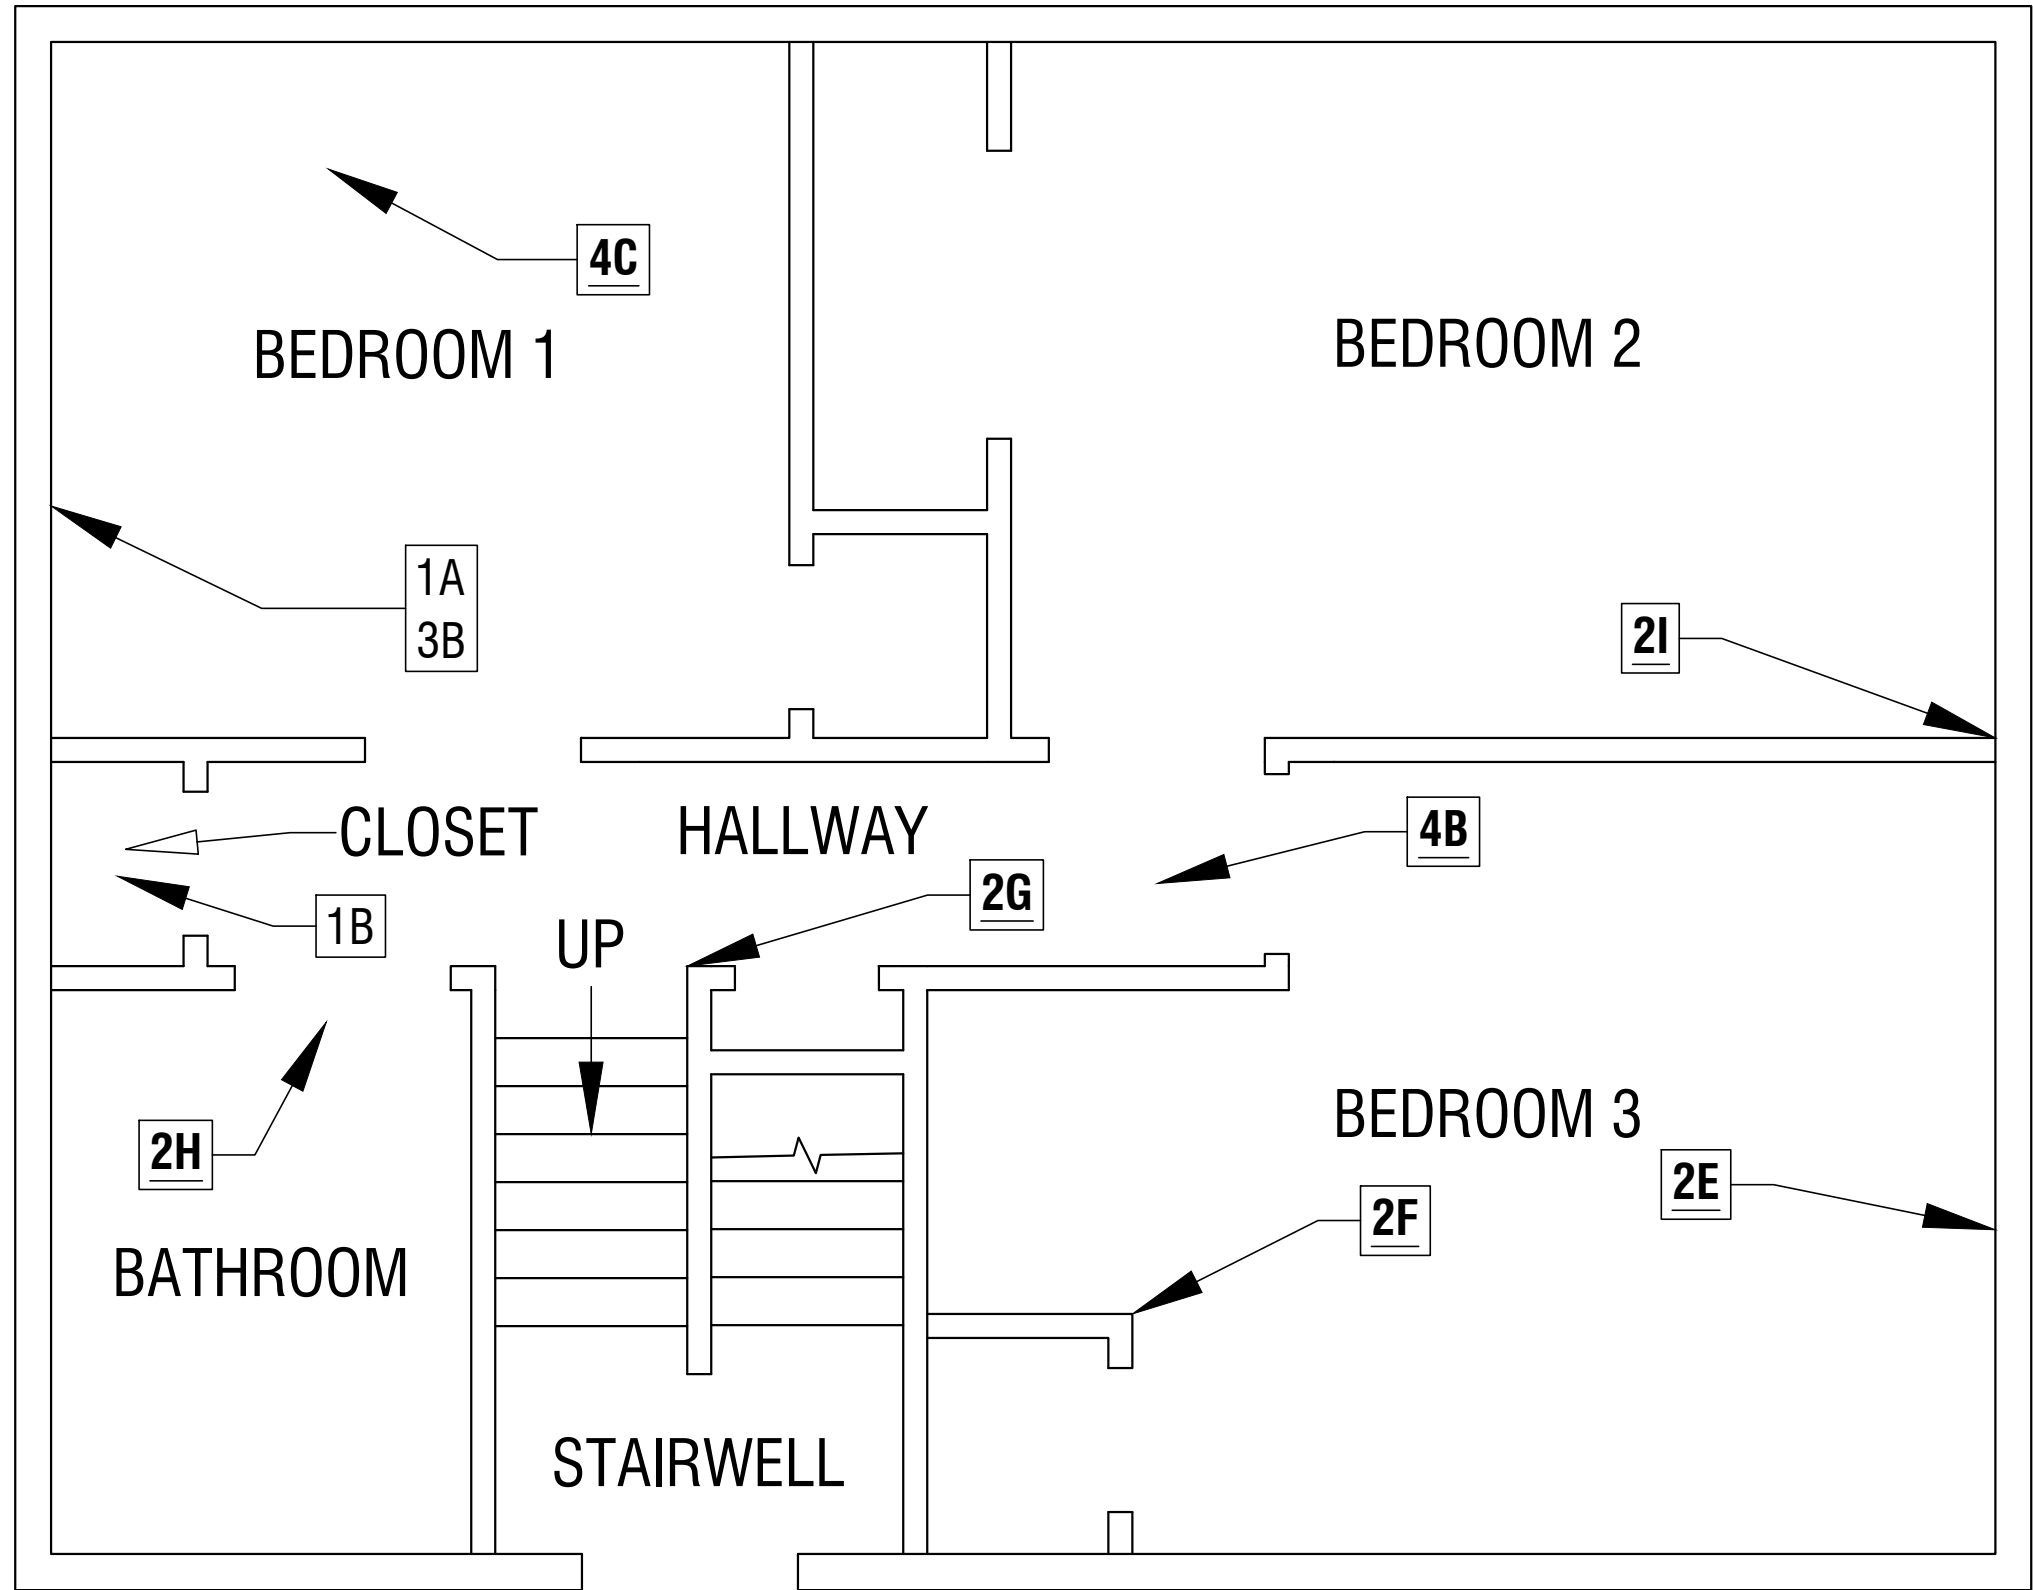
H101

ITEMS IN BOLD ARE **CONFIRMED ACM**

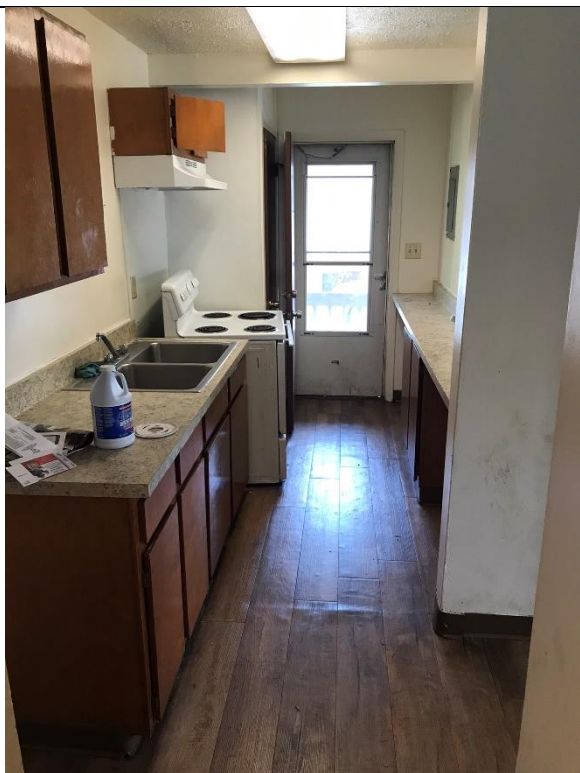
Photo 1

White asbestos-containing joint compound is located on the walls and ceilings in the following locations:

View of White Asbestos-Containing Joint Compound on Walls & Ceiling in the Kitchen

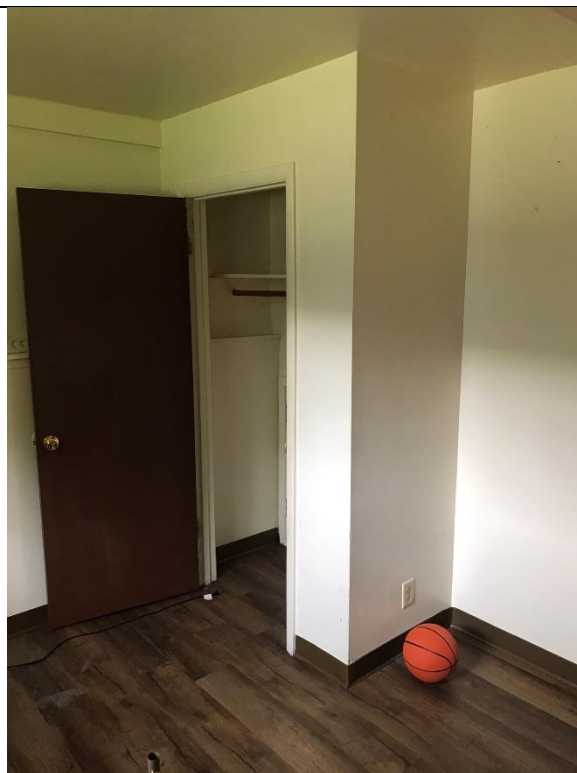
Photo 2

View of White Asbestos-Containing Joint Compound on Walls & Ceiling in the Bedroom 3

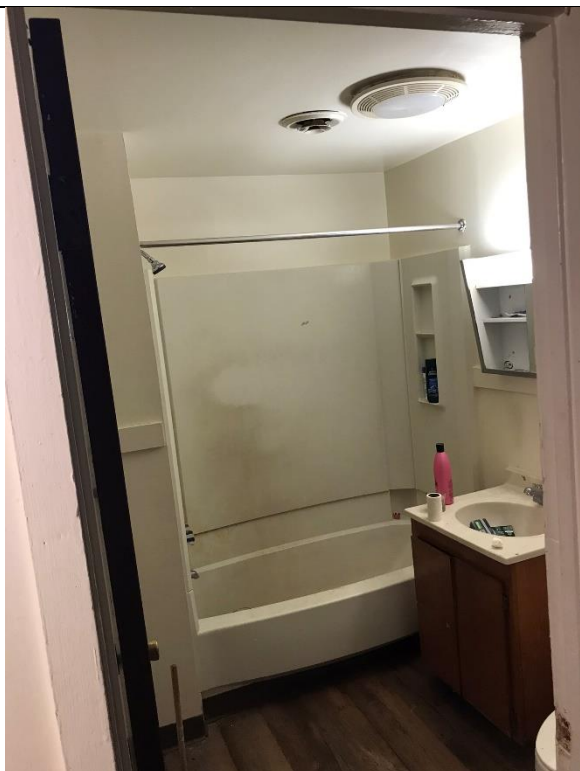
Photo 3

View of White Asbestos-Containing Joint Compound on Walls & Ceiling in the Bathroom

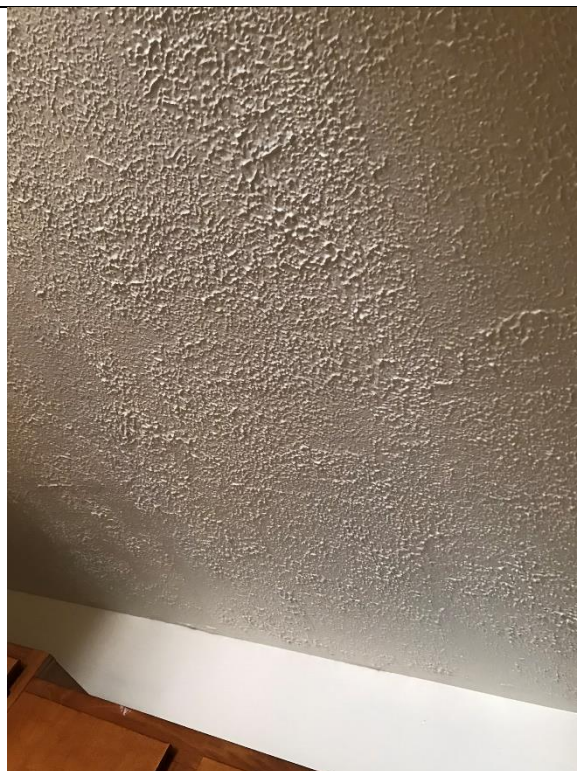
Photo 4

White asbestos-containing stucco is located on the ceiling in the following locations:

View of White Asbestos-Containing Stucco on the Ceiling in the Kitchen

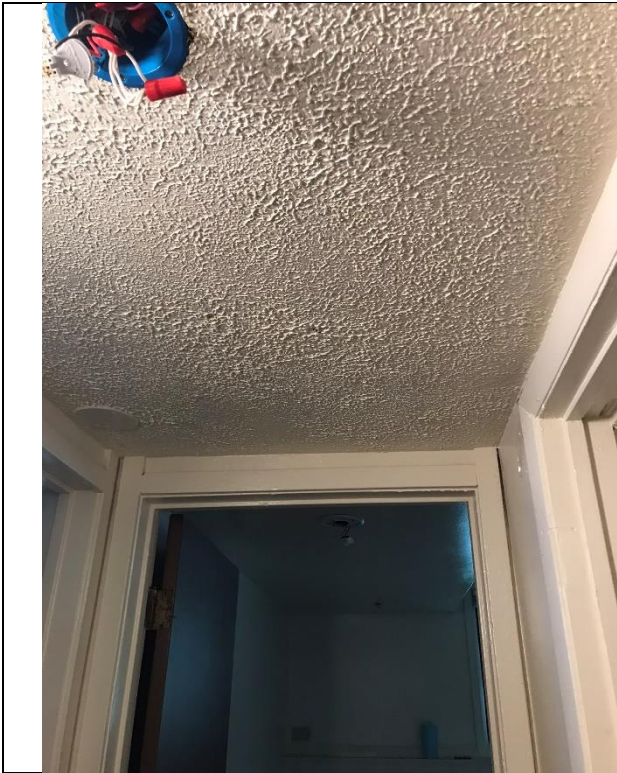
Photo 5

View of White Asbestos-Containing Stucco on the Ceiling in the Hallway

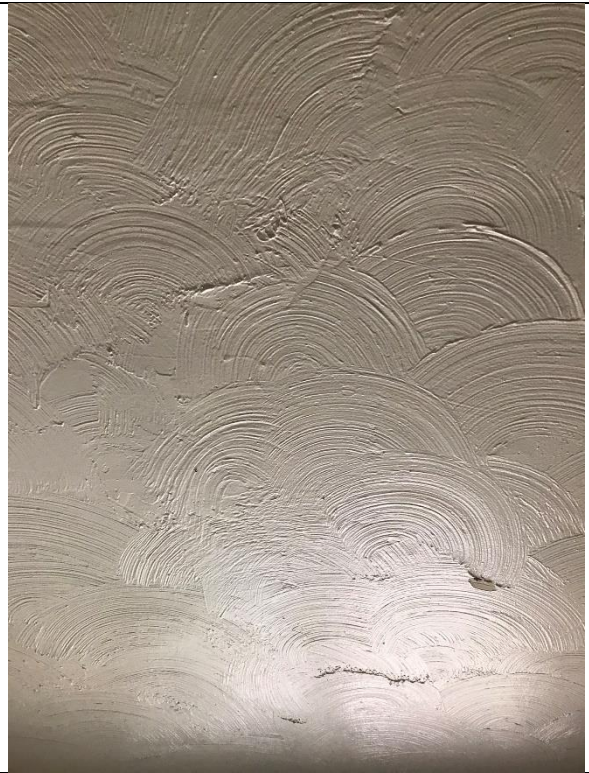
Photo 6

View of White Asbestos-Containing Stucco on the Ceiling in Bedroom 1
