# Comprehensive Pre-Renovation Regulated Building Materials Inspection

24 Weld Street  
Rochester, New York 14605

2254106

August 20, 2025

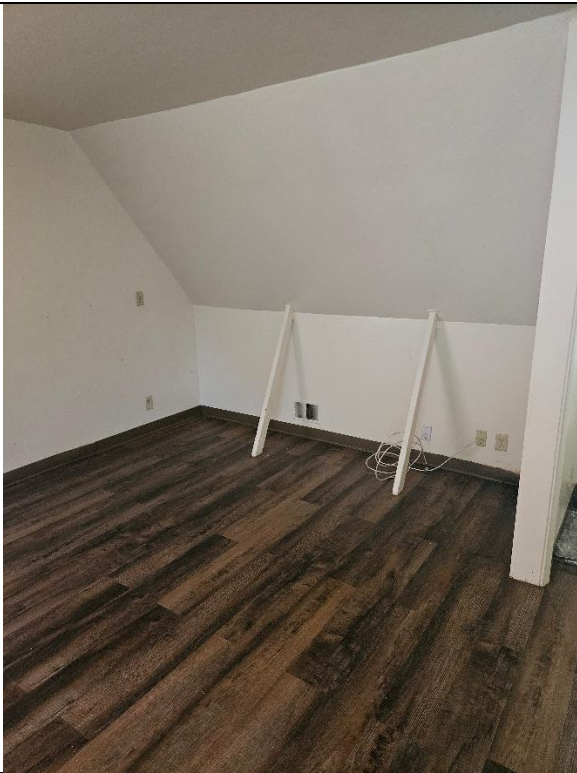
**Photo 1**

| <i>Sample #</i> | <i>Type of Material</i> | <i>Sample Location</i> | <i>Results % Asbestos</i> |
|---|---|---|---|
| 9F | <b>White Joint Compound</b> | <b>Living Room Wall</b> | <b>2.1% Chrysotile</b> |

View of White Asbestos-Containing Joint Compound on Walls & Ceiling in Living Room

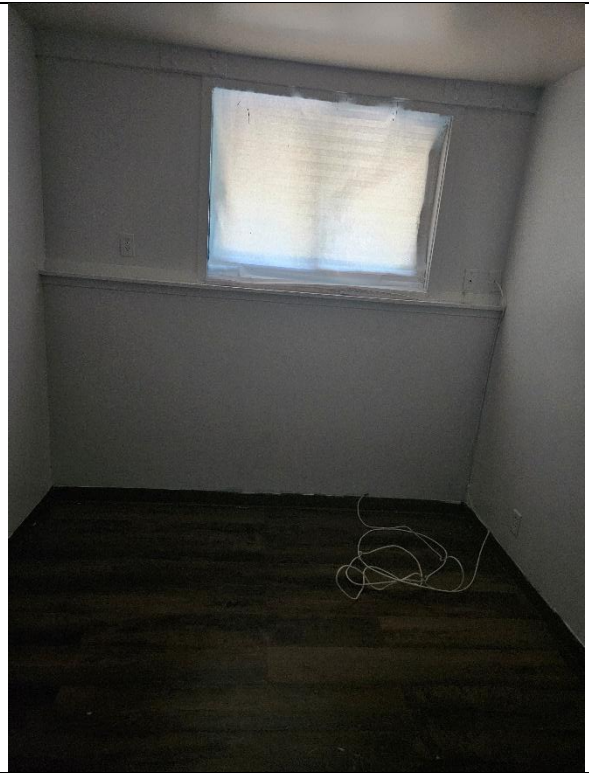
**Photo 2**

| <i>Sample #</i> | <i>Type of Material</i> | <i>Sample Location</i> | <i>Results % Asbestos</i> |
|---|---|---|---|
| 9E | <b>White Joint Compound</b> | <b>Bedroom 3 Wall</b> | <b>1.9% Chrysotile</b> |

View of White Asbestos-Containing Joint Compound on Walls & Ceiling in the Bedroom 3

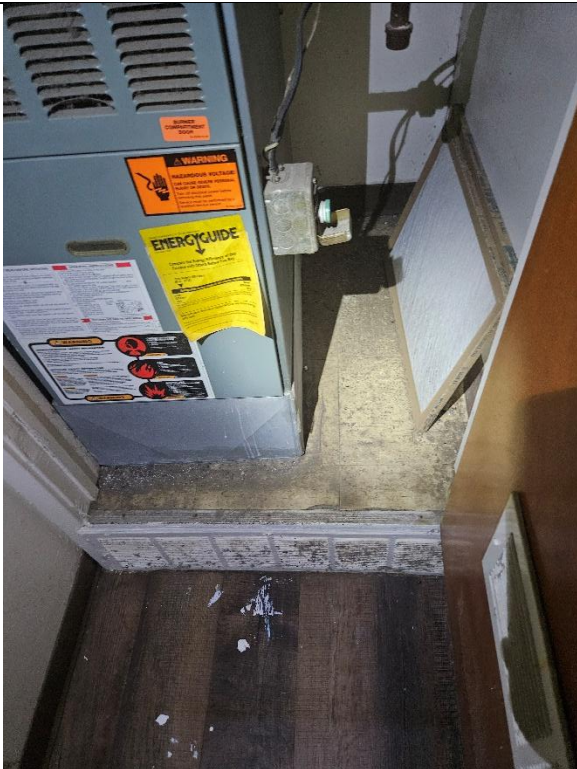
**Photo 3**

View of Furnace Closet and Non-Asbestos-Containing Tan 12" Floor Tile

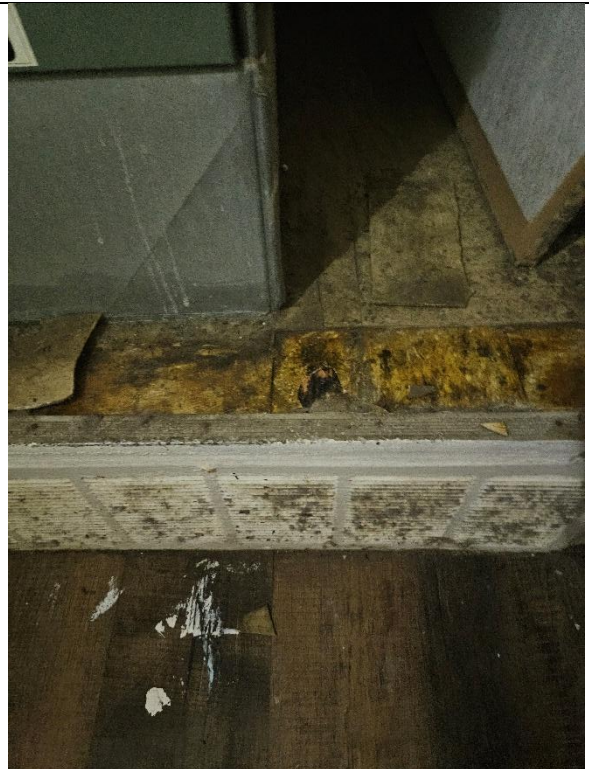
**Photo 4**

| <i>Sample #</i> | <i>Type of Material</i> | <i>Sample Location</i> | <i>Results % Asbestos</i> |
|---|---|---|---|
| <b>12A</b> | <b>White 9" Floor Tile</b> | <b>Furnace Closet Floor – 2<sup>nd</sup> Layer</b> | <b>20% Chrysotile</b> |

View of White Asbestos-Containing 9" Floor Tile under Non-AC Tan 12" Floor Tile

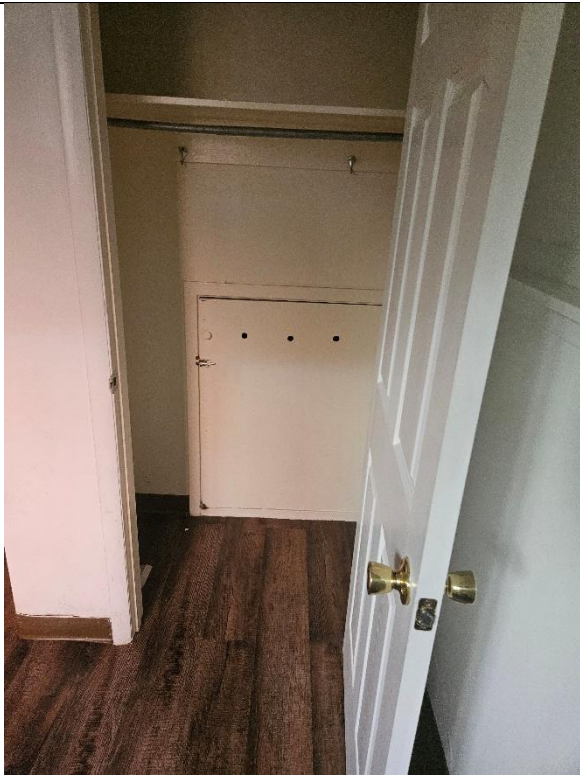
Photo 5

View of White Asbestos-Containing Joint Compound on Walls in Bedroom 1 Closet

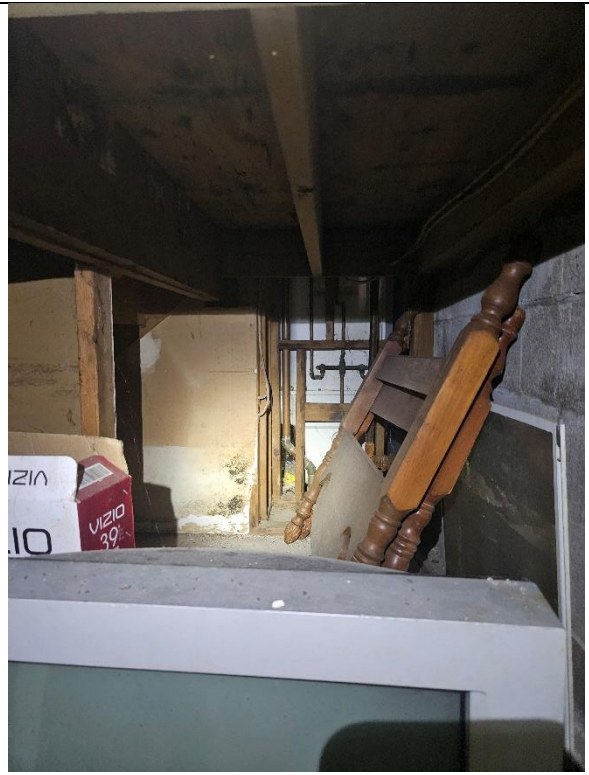
Photo 6

At the time of the inspection, areas of suspect mold growth and/or water damage were noted in the storage area underneath the stairwell. See Appendix C for photographs of this suspect mold growth.

View of White Asbestos-Containing Joint Compound & Mold on Drywall in Stairwell Storage

In accordance with current regulations, areas requiring remediation that exceed 10 square feet shall require a remedial work plan prepared in accordance with New York State Department of Labor’s (NYSDOL) Licensing of Mold Inspection, Assessment and Remediation Specialists and Minimum Work Standards: Article 32 New York State Labor Law. Prior to any mold remediation, the remedial work plan shall be provided to a licensed mold remediation contractor and must include the following:

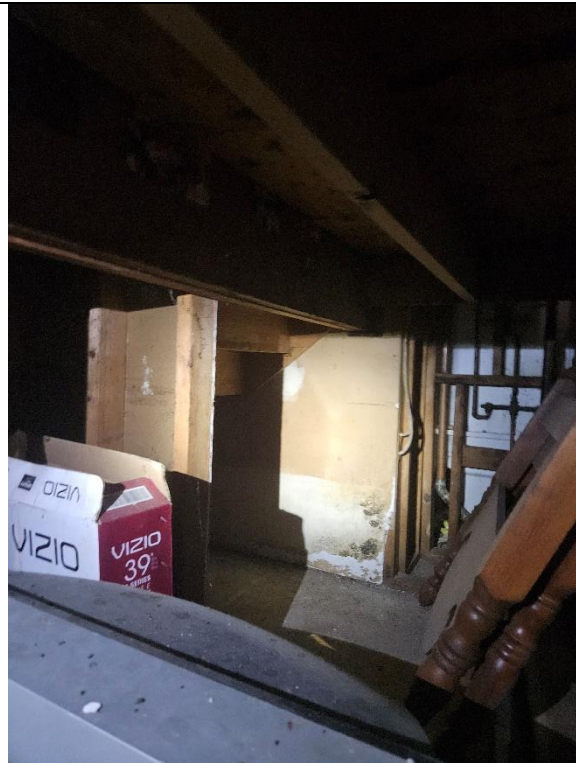
Photo 7

View of White Asbestos-Containing Joint Compound & Mold on Drywall in Stairwell Storage

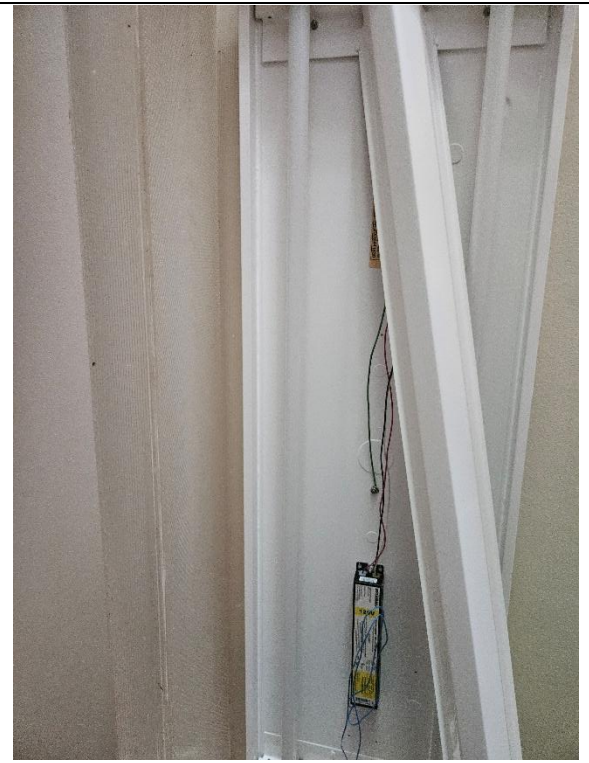
Photo 8

Ceiling mounted fluorescent light fixtures were observed throughout the various sections of the building. Older vintage fluorescent light fixtures manufactured prior to 1980 typically contained a capacitor filled with PCB fluid. A representative number of light fixtures were dismantled in each area of investigation, and all had ballasts labeled “No PCBs”. Based on these observations made at the time of the site visit, to the extent feasible, the ballasts within the inspection area can be considered to be non-PCB-containing.

View of Fluorescent Lights with Non-PCB Ballast in Kitchen

During the inspection, approximately 13 fluorescent light bulbs were observed in ceiling mounted fluorescent light fixtures throughout the unit. These light bulbs contain varying amounts of mercury vapor. To prevent breakage and the release of mercury, bulbs should be removed and sent to a mercury recycling facility prior to renovations.
