ASBESTOS, LEAD PAINT, AND PCB CAULK SURVEY REPORT

Danforth Tower East – Boiler Room
140 West Avenue
Rochester, New York

February 2024

Project No. 40609-56

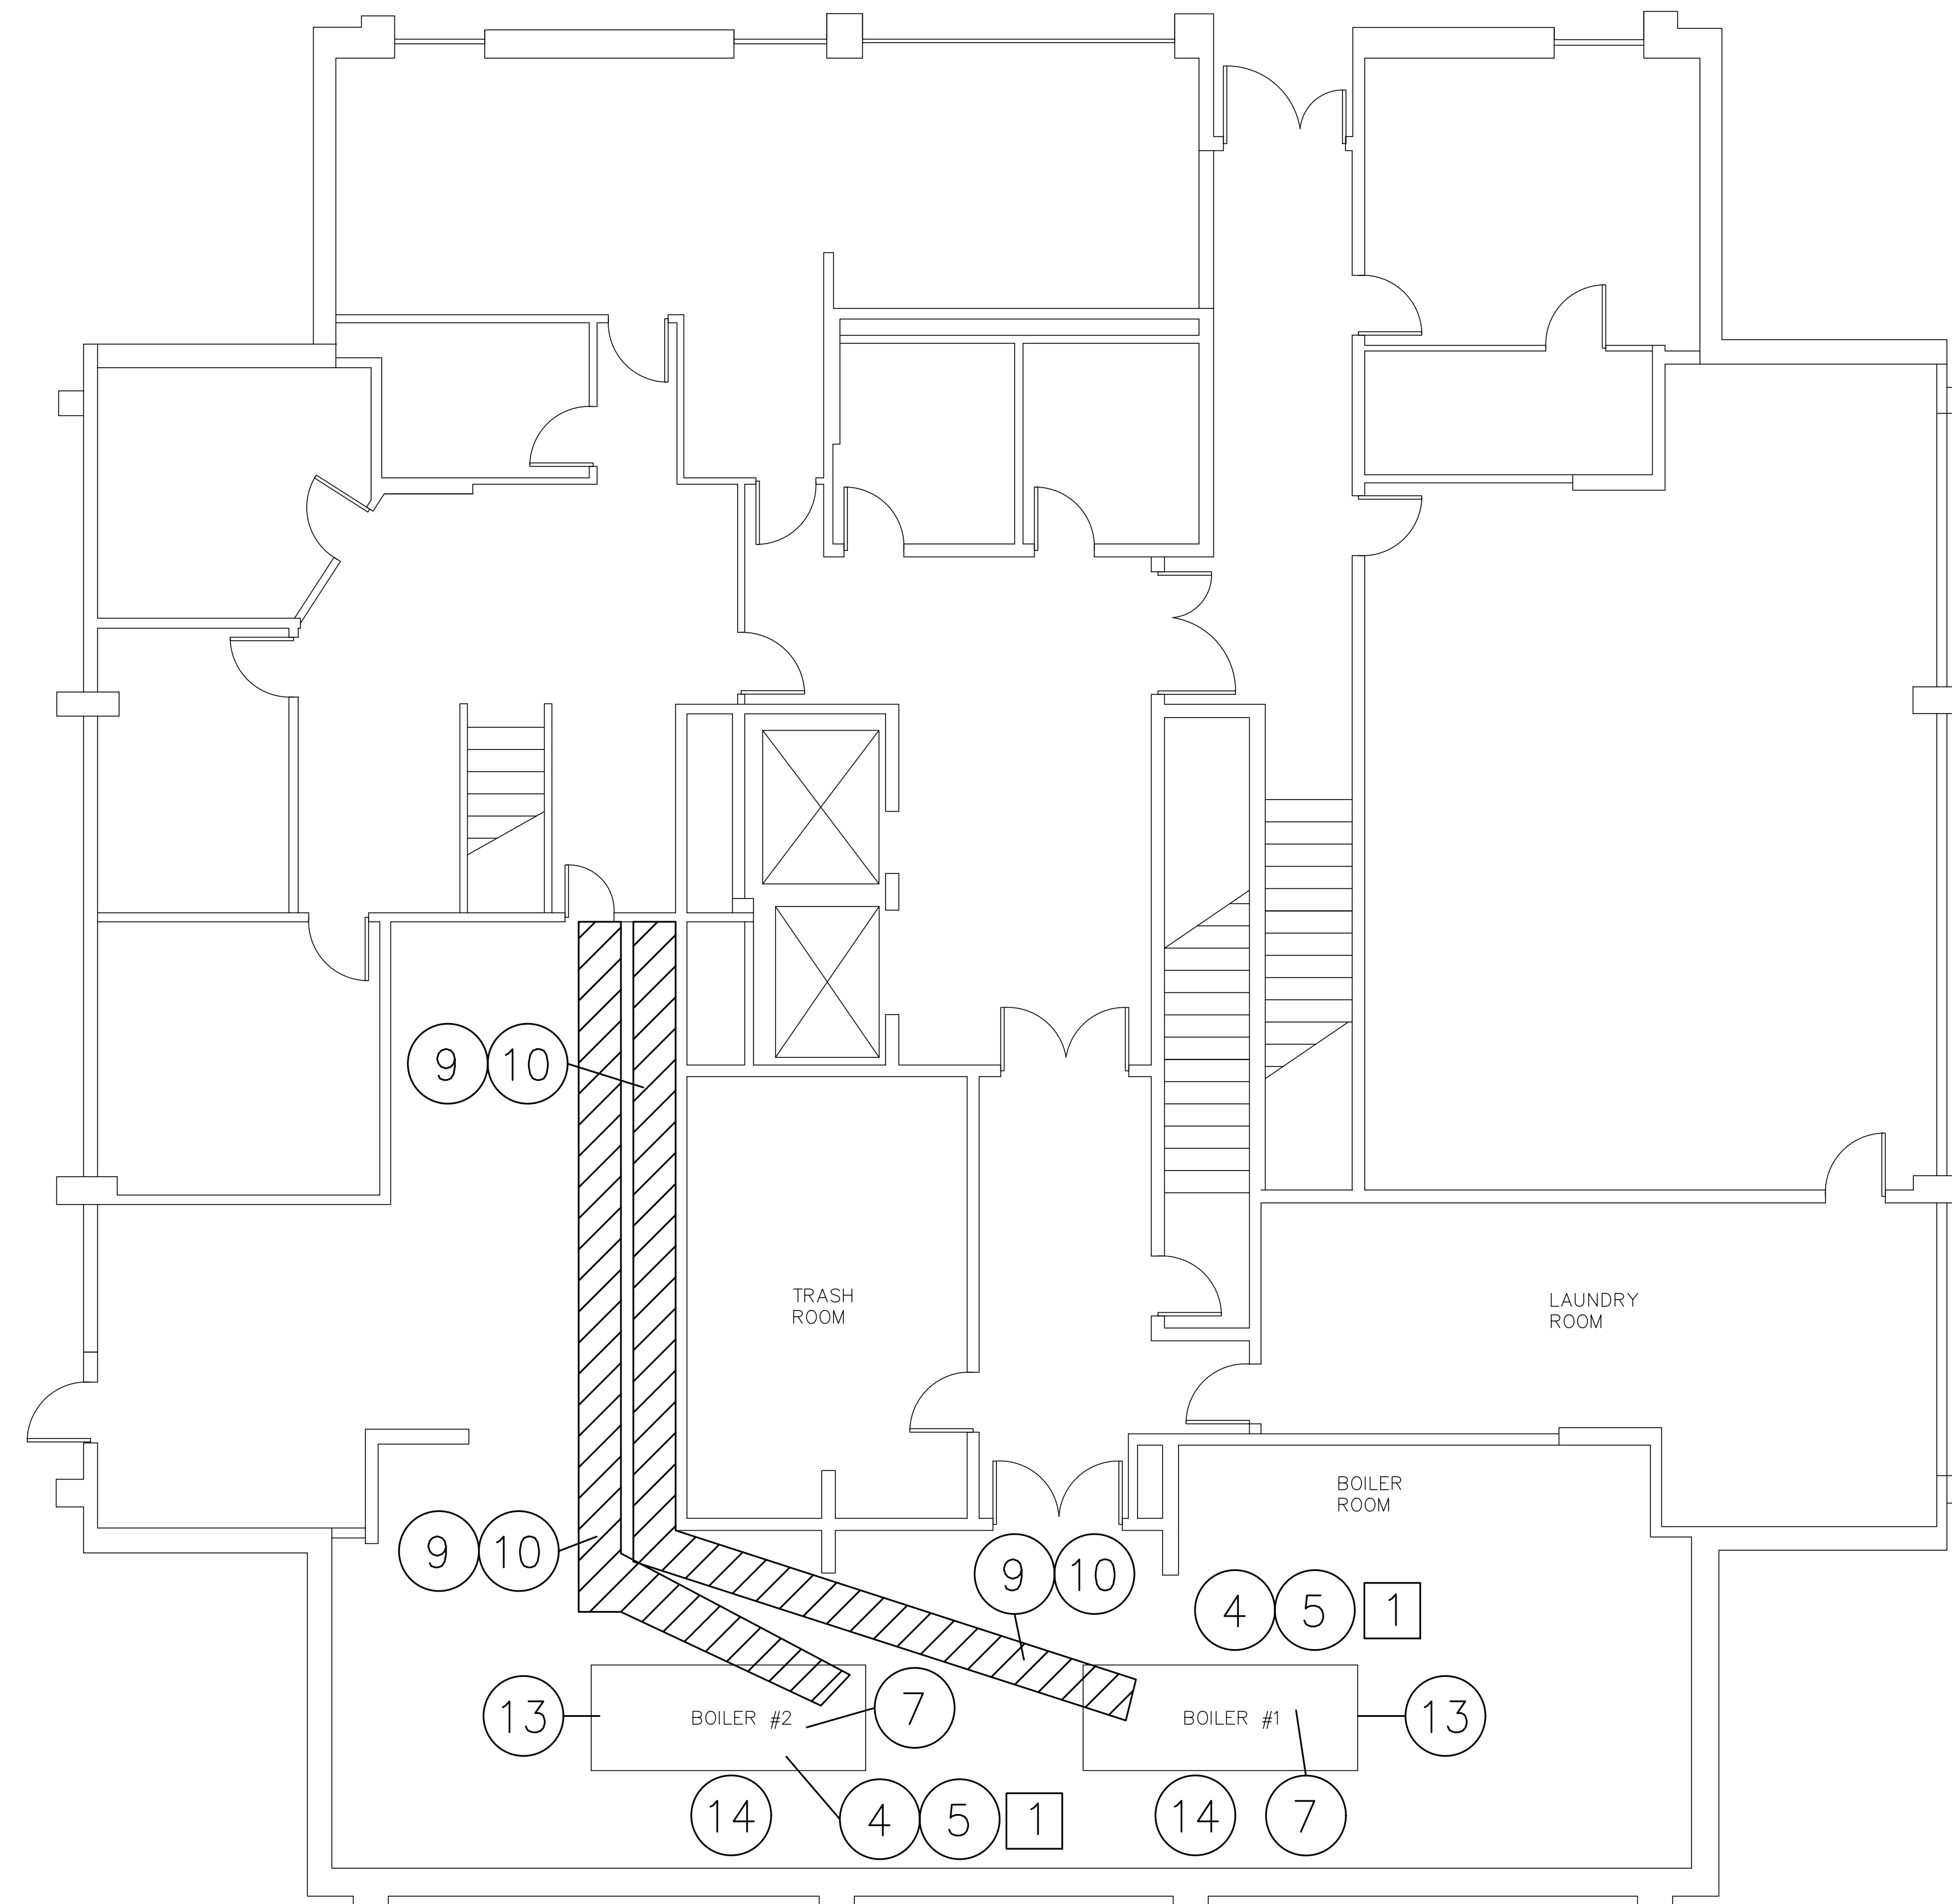
- 1 ASBESTOS CONTAINING PIPE
COVERING AND MUDDIED
FITTINGS EXIST ABOVE AND
BESIDE THE BOILERS

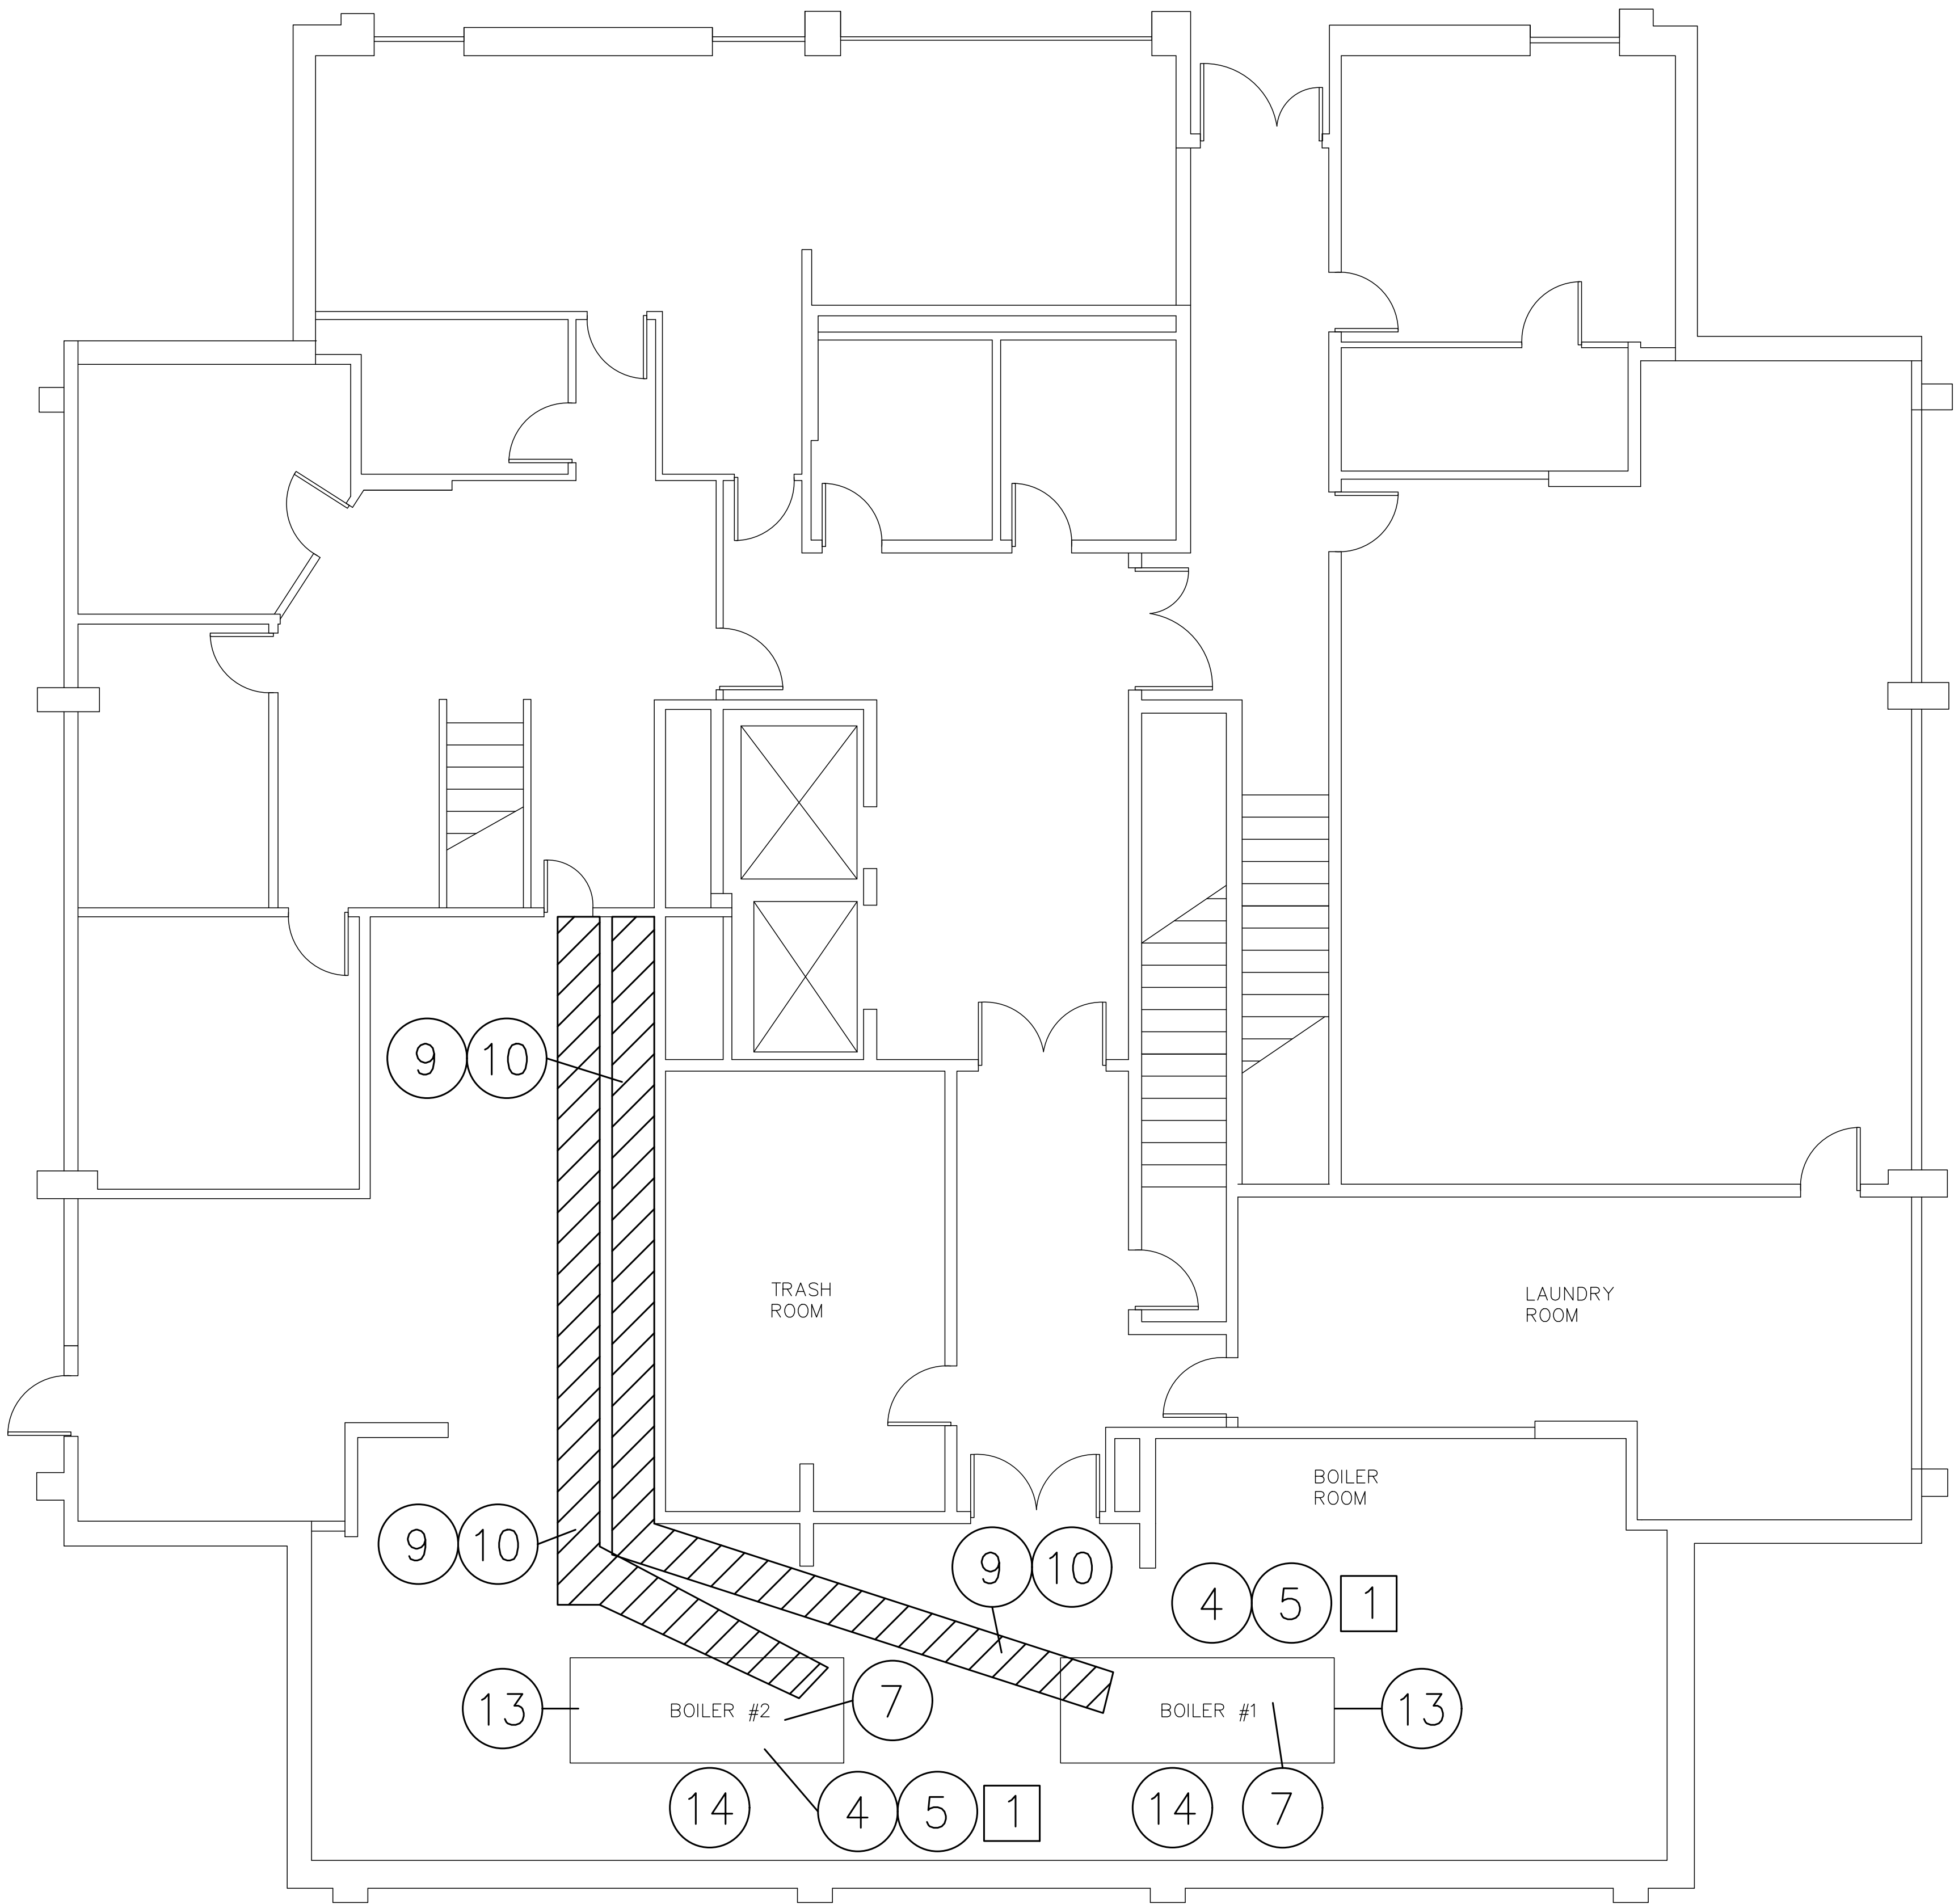
- 1

ASBESTOS CONTAINING PIPE
COVERING AND MUDDED
FITTINGS EXIST ABOVE AND
BESIDE THE BOILERS

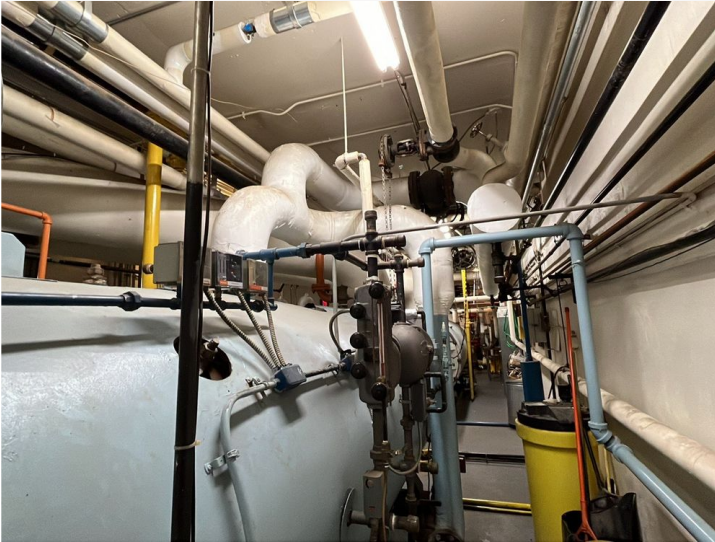
1

View looking at Boilers #1 and #2 along rear wall.

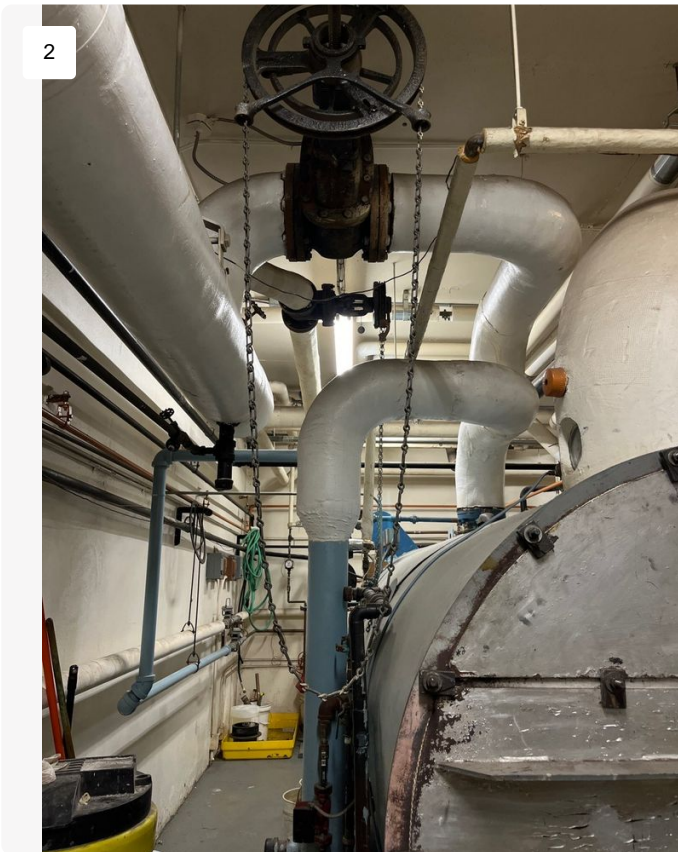
2

View looking along rear wall adjacent to Boiler #2.

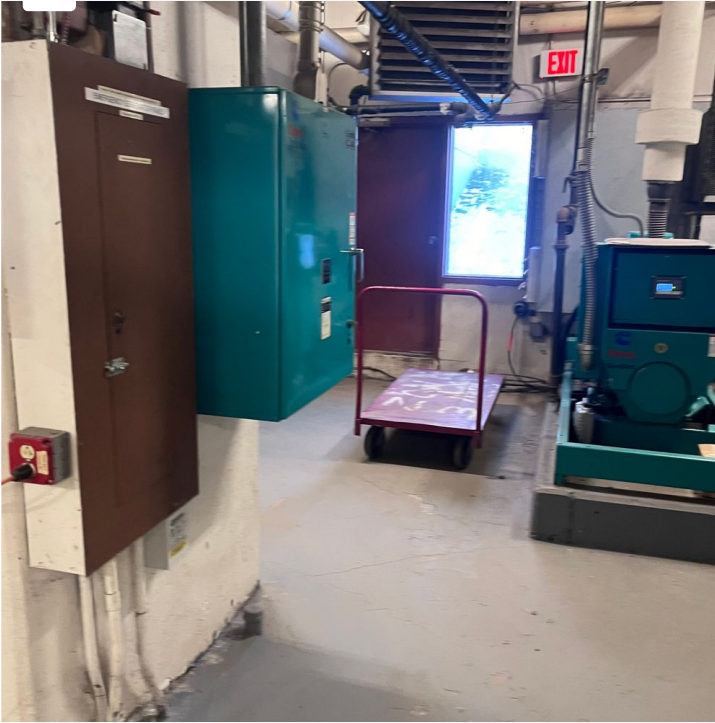
Equipment adjacent to Boiler #2

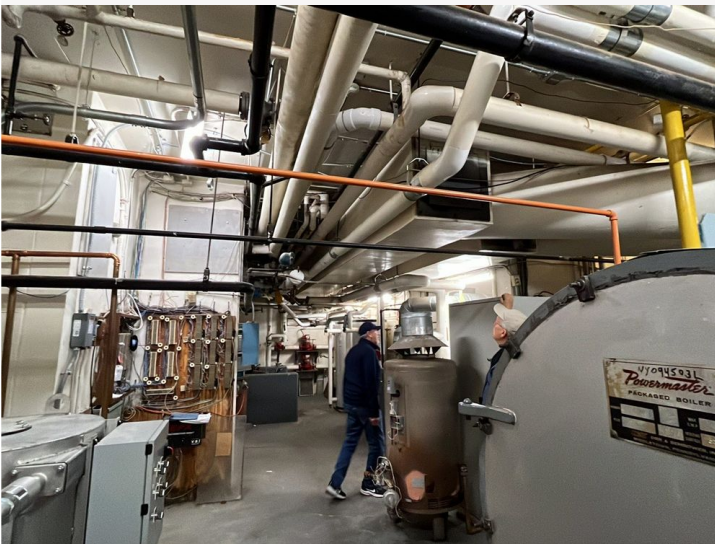
4

View looking along area adjacent to Boilers #1 and #2.
