SECTION 020800 – ASBESTOS REMOVAL

- D. An inspection report titled “Limited Pre-Renovation Regulated Building Materials Inspection”, dated January 23, 2025, drafted by LaBella Associates D.P.C., documenting the presence of known regulated building materials, including ACM, is attached to Section 003126 - Existing Hazardous Material Information. The report incorporates and includes all testing data obtained for the site, based on project scope and materials reported to be disturbed by planned renovations. See the report for detailed descriptions of the types of ACM identified and the locations.

ROCHESTER HOUSING
AUTHORITY

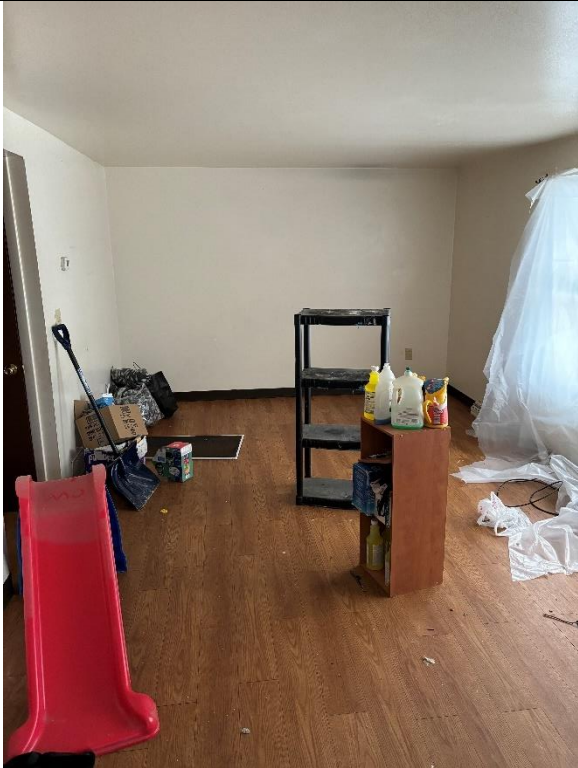
Photo 1

View of White Asbestos-Containing Joint Compound on Walls and Ceilings Throughout

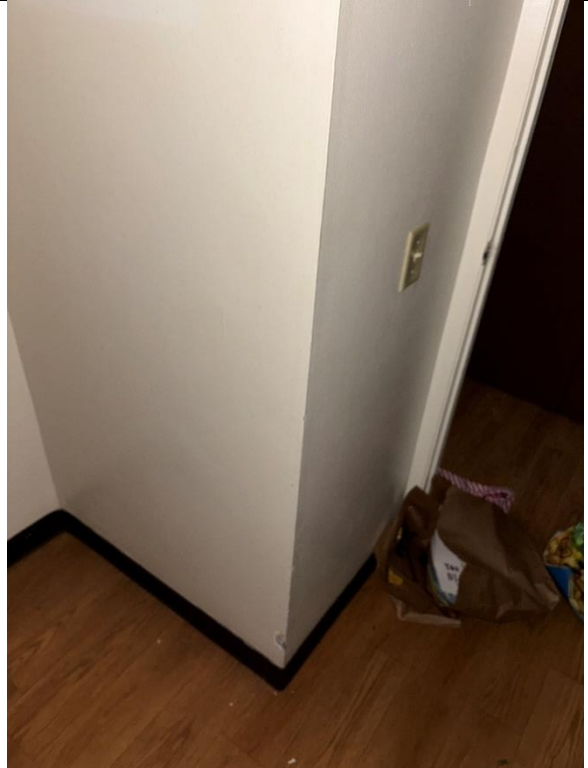
Photo 2

View of White Asbestos-Containing Joint Compound on Walls and Ceilings Throughout

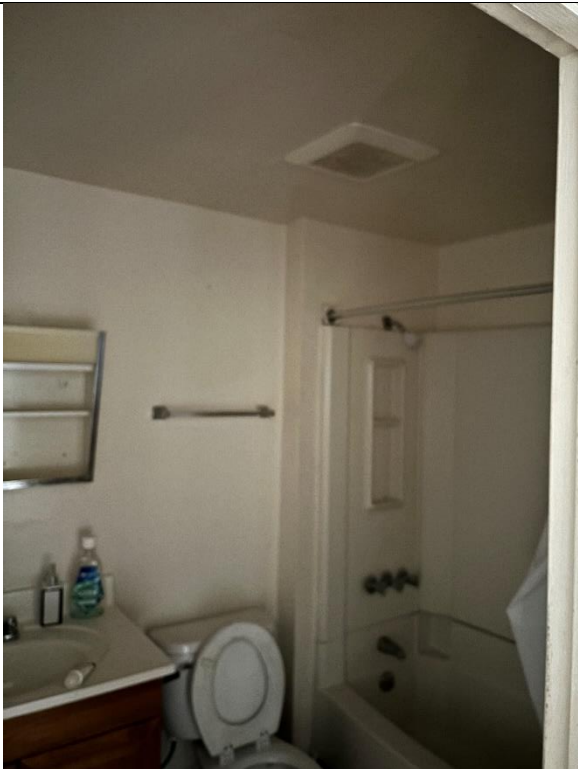
Photo 3

View of White Asbestos-Containing Joint Compound on Walls and Ceilings Throughout

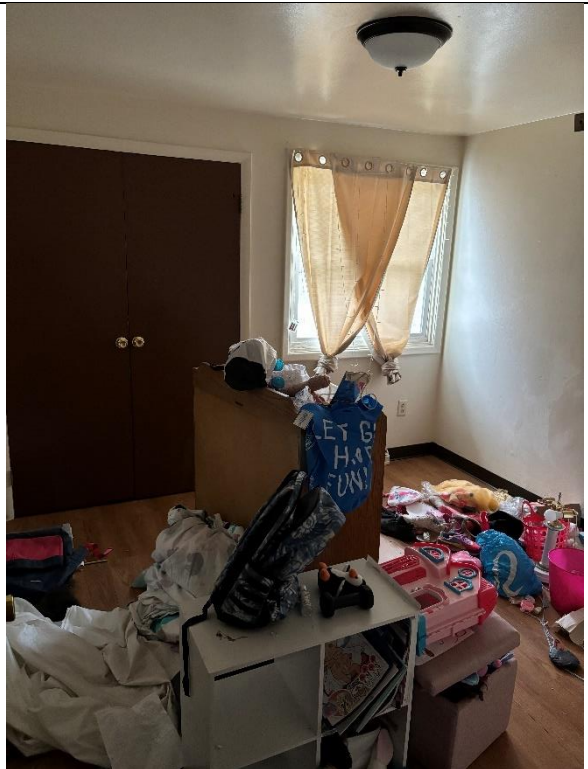
Photo 4

View of White Asbestos-Containing Joint Compound on Walls and Ceilings Throughout

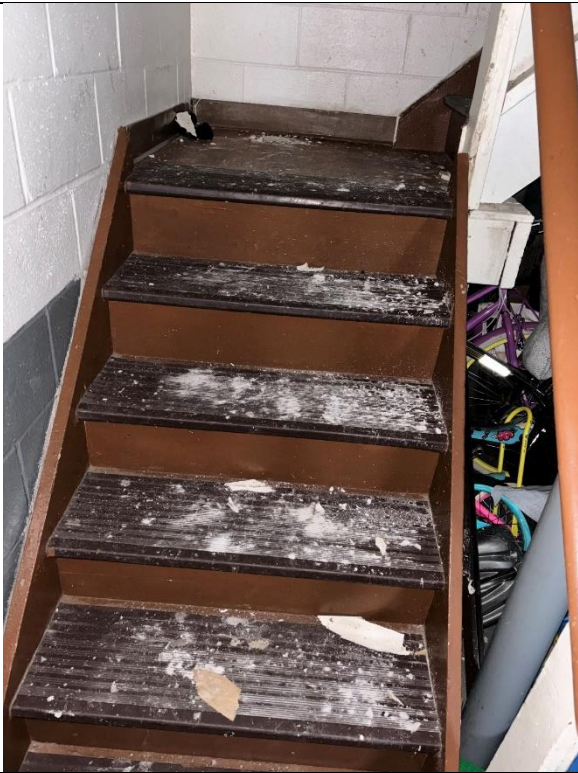
Photo 5

Additionally, the majority of joint compound within the inspected spaces was observed to be in good condition. However, rooms 1, 5, 7, 8, 12 and the basement stairwell had extensive damage to the wall and ceiling systems caused by a recent fire. As such, drywall/joint compound debris was observed throughout the impacted spaces.

View of Damaged Asbestos-Containing Joint Compound in the Basement Stairwell

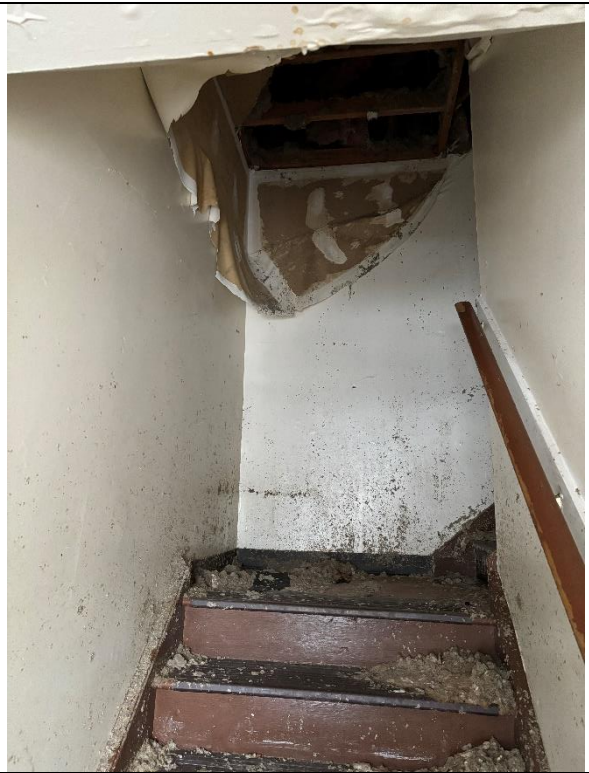
Photo 6

View of Damaged Asbestos-Containing Joint Compound in Room 1

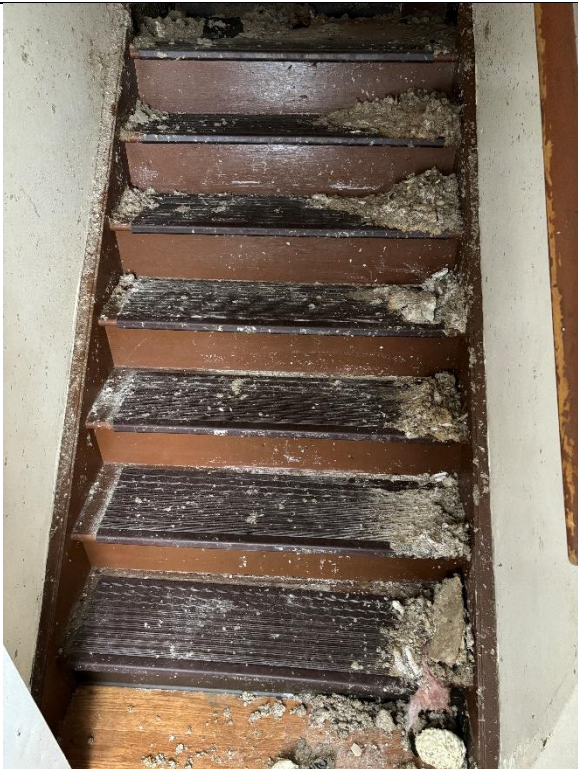
Photo 7

View of Damaged Asbestos-Containing Joint Compound in Room 1

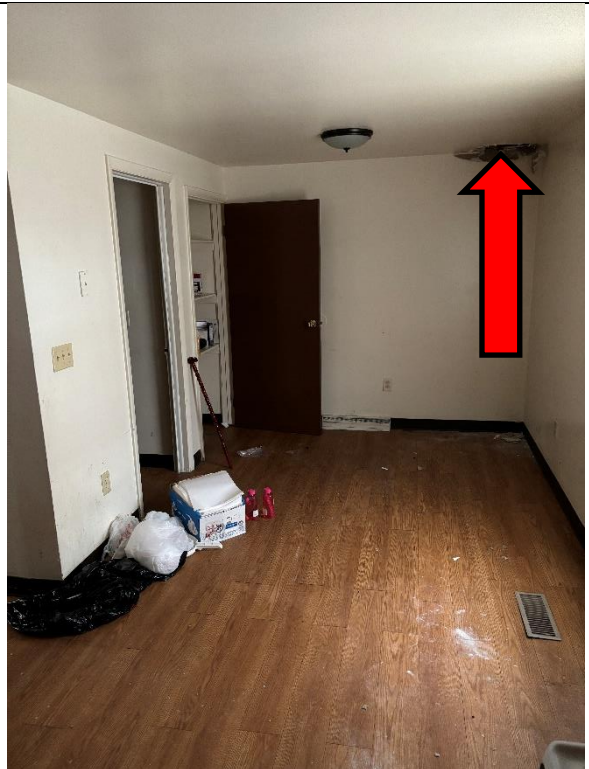
Photo 8

View of Damaged Asbestos-Containing Joint Compound in Room 5

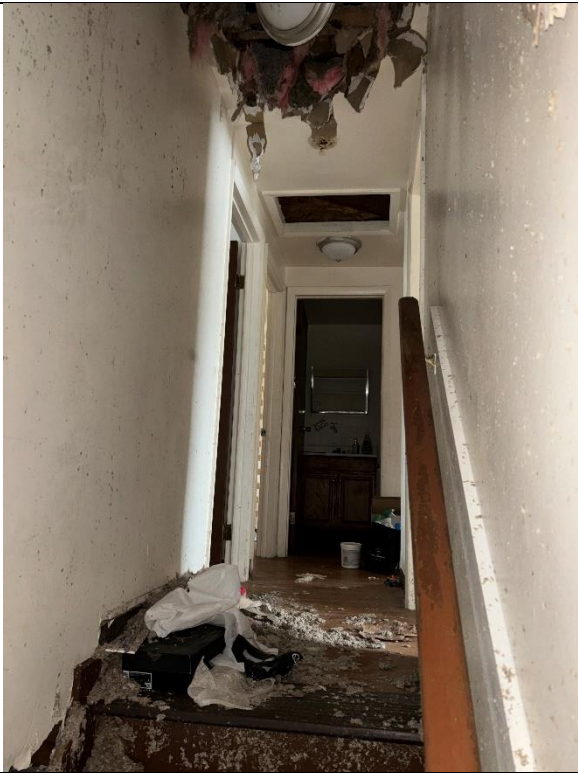
Photo 9

View of Damaged Asbestos-Containing Joint Compound in Room 7

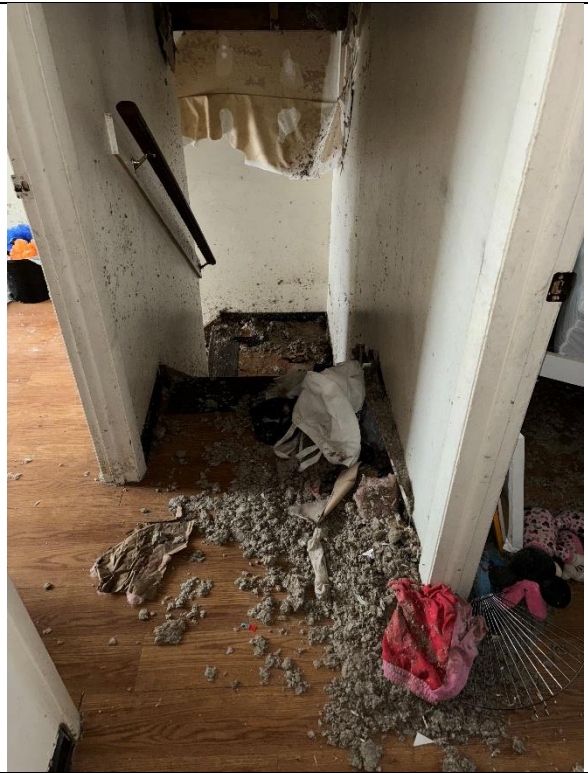
Photo 10

View of Damaged Asbestos-Containing Joint Compound in Room 7

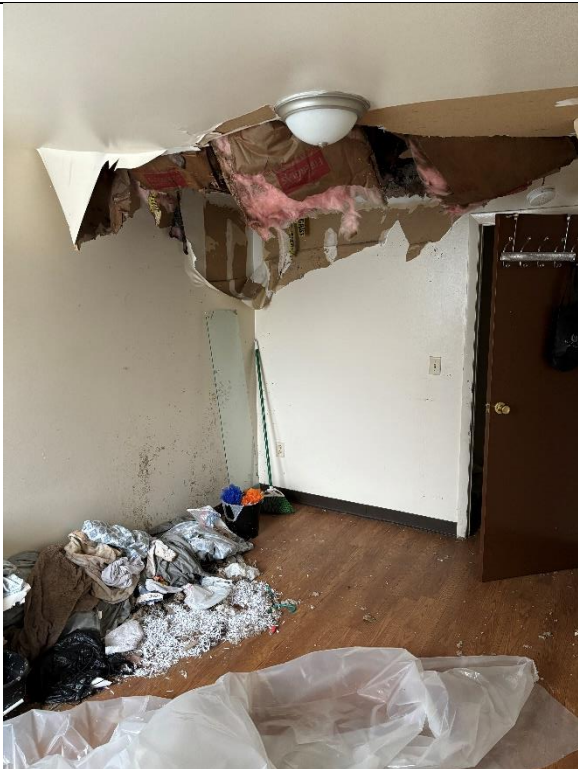
Photo 11

View of Damaged Asbestos-Containing Joint Compound in Room 8

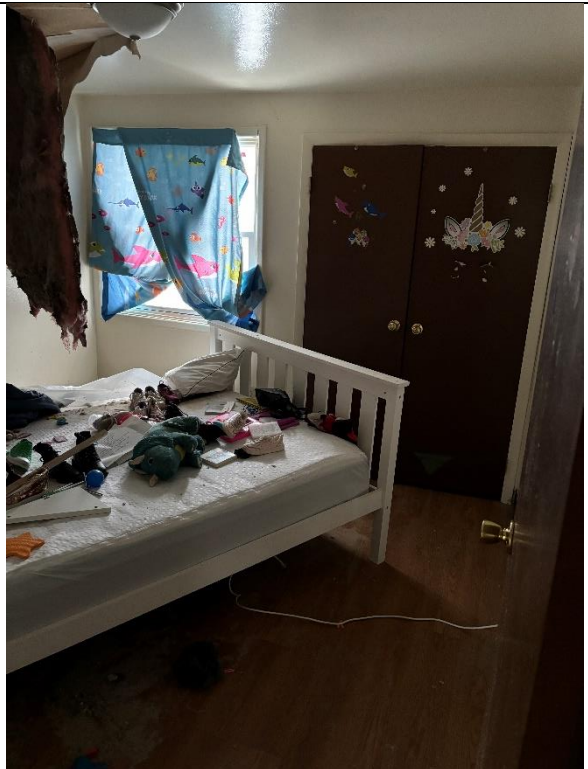
Photo 12

View of Damaged Asbestos-Containing Joint Compound in Room 12

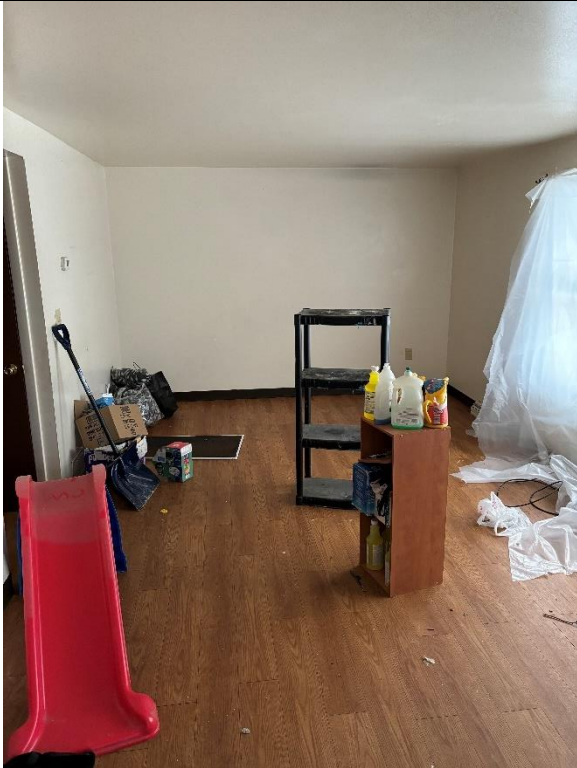
Photo 1

View of White Asbestos-Containing Joint Compound on Walls and Ceilings Throughout

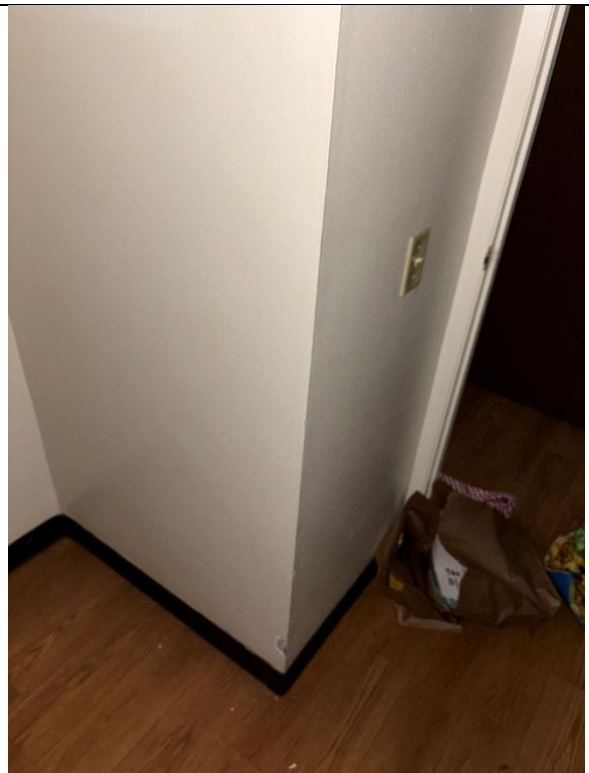
Photo 2

View of White Asbestos-Containing Joint Compound on Walls and Ceilings Throughout

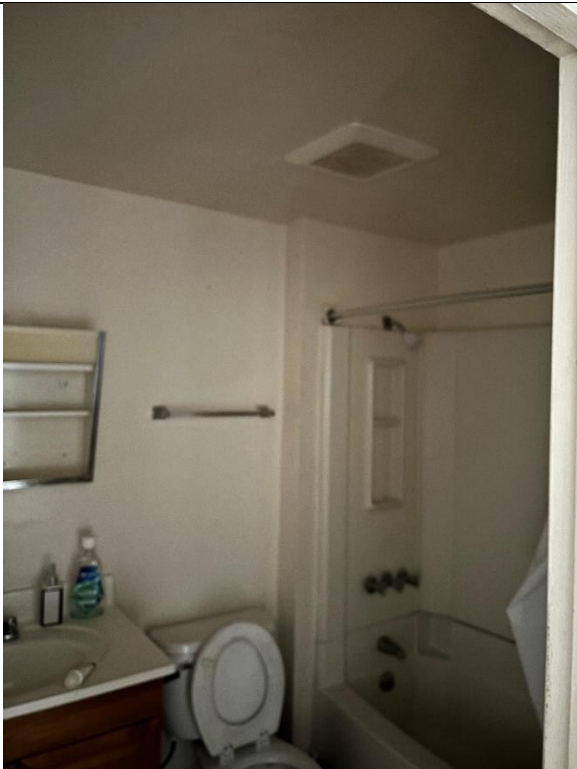
Photo 3

View of White Asbestos-Containing Joint Compound on Walls and Ceilings Throughout

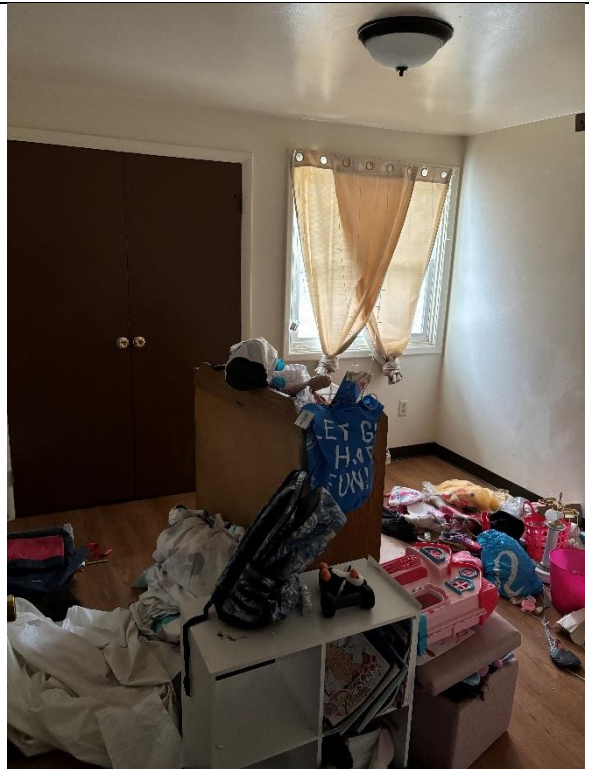
Photo 4

View of White Asbestos-Containing Joint Compound on Walls and Ceilings Throughout

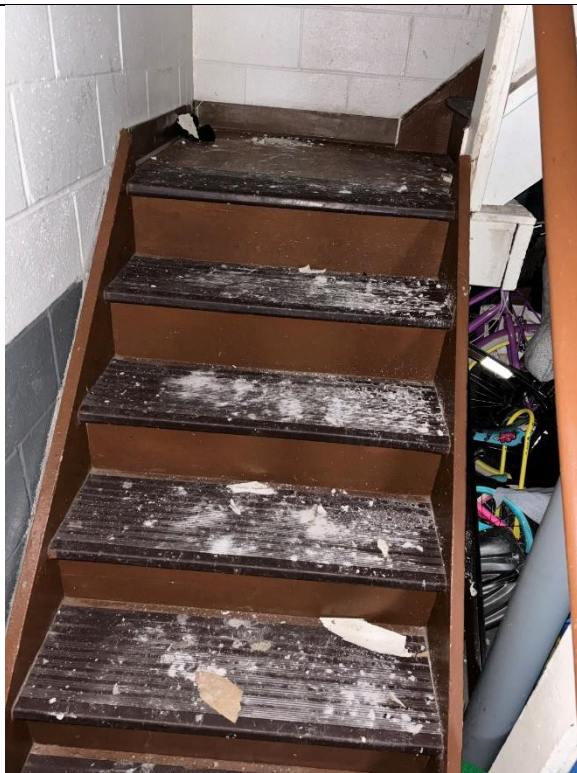
Photo 5

View of Damaged Asbestos-Containing Joint Compound in the Basement Stairwell

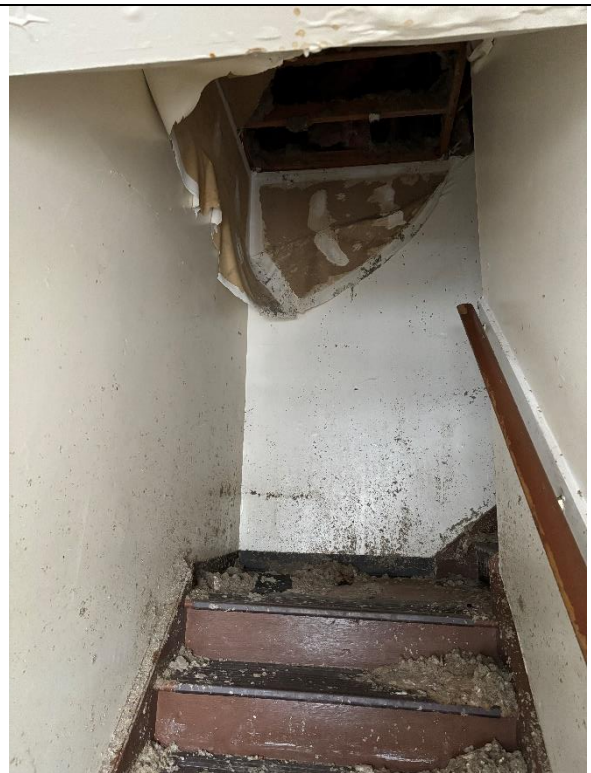
Photo 6

View of Damaged Asbestos-Containing Joint Compound in Room 1

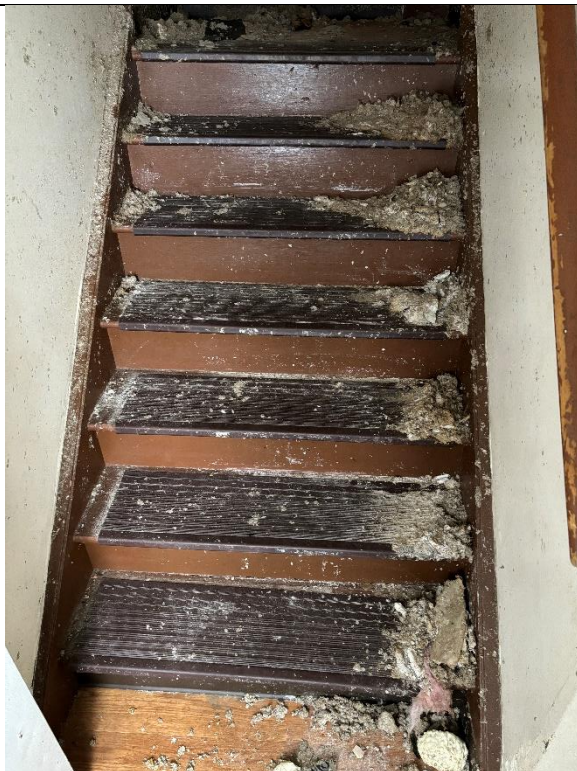
Photo 7

View of Damaged Asbestos-Containing Joint Compound in Room 1

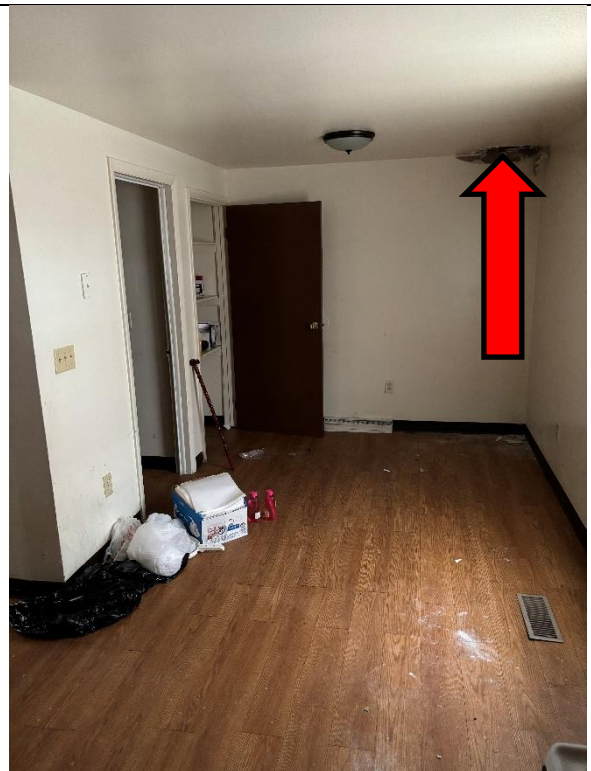
Photo 8

View of Damaged Asbestos-Containing Joint Compound in Room 5

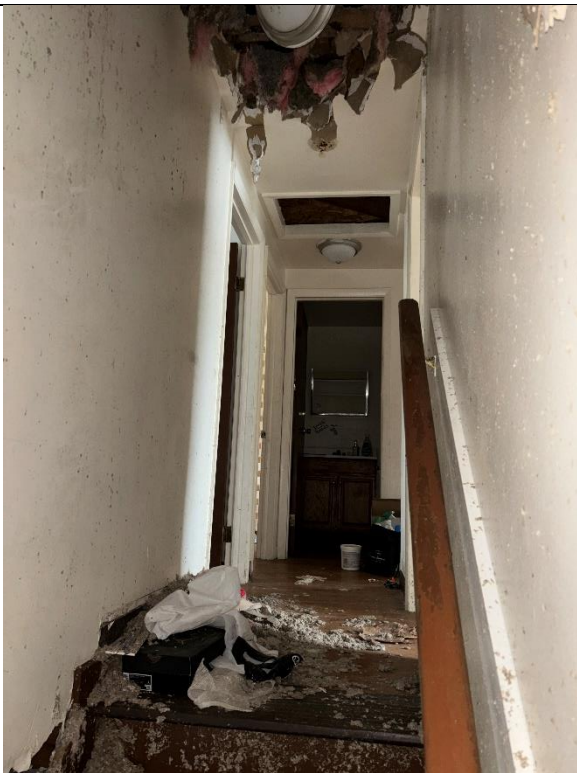
Photo 9

View of Damaged Asbestos-Containing Joint Compound in Room 7

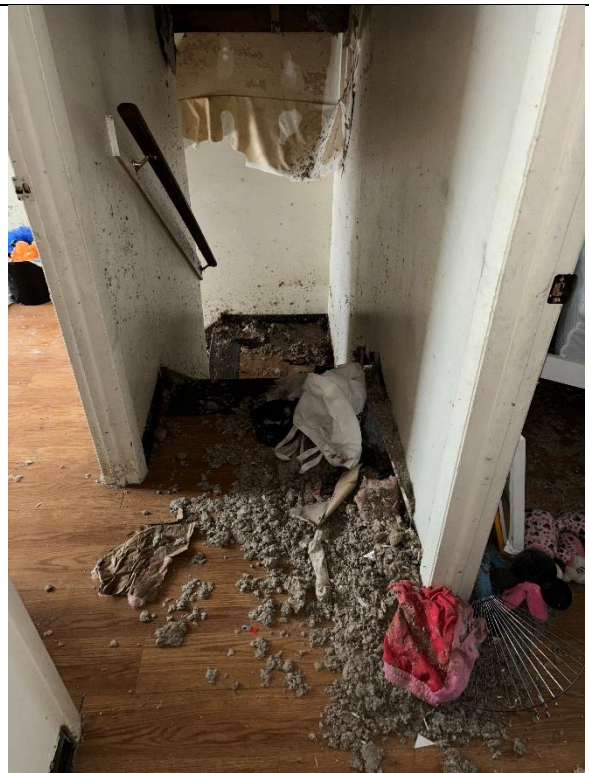
Photo 10

View of Damaged Asbestos-Containing Joint Compound in Room 7

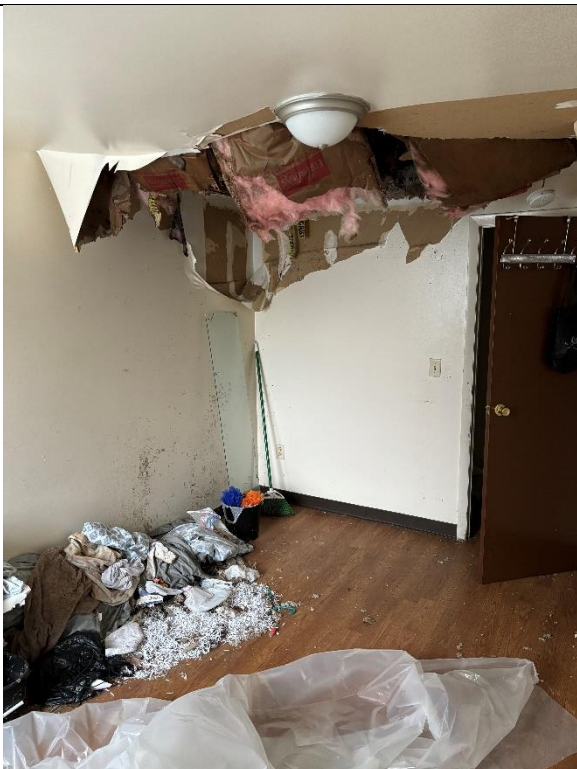
Photo 11

View of Damaged Asbestos-Containing Joint Compound in Room 8

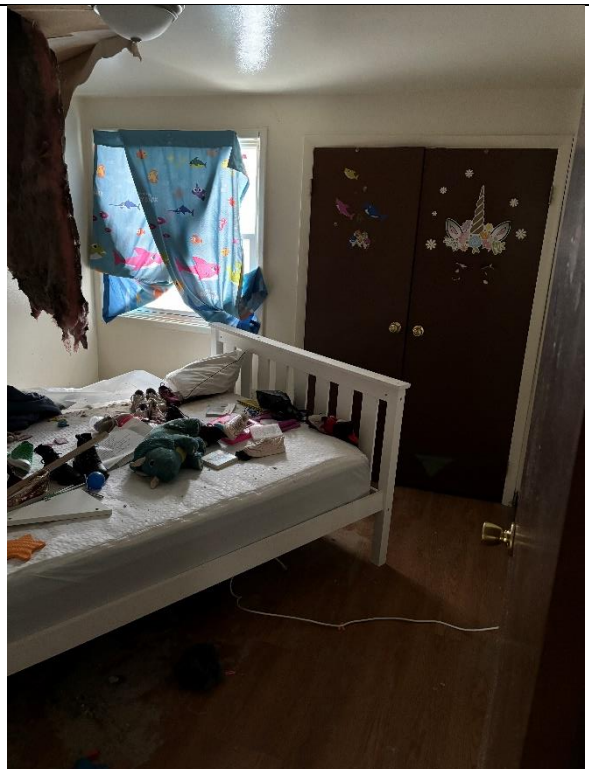
Photo 12

View of Damaged Asbestos-Containing Joint Compound in Room 12

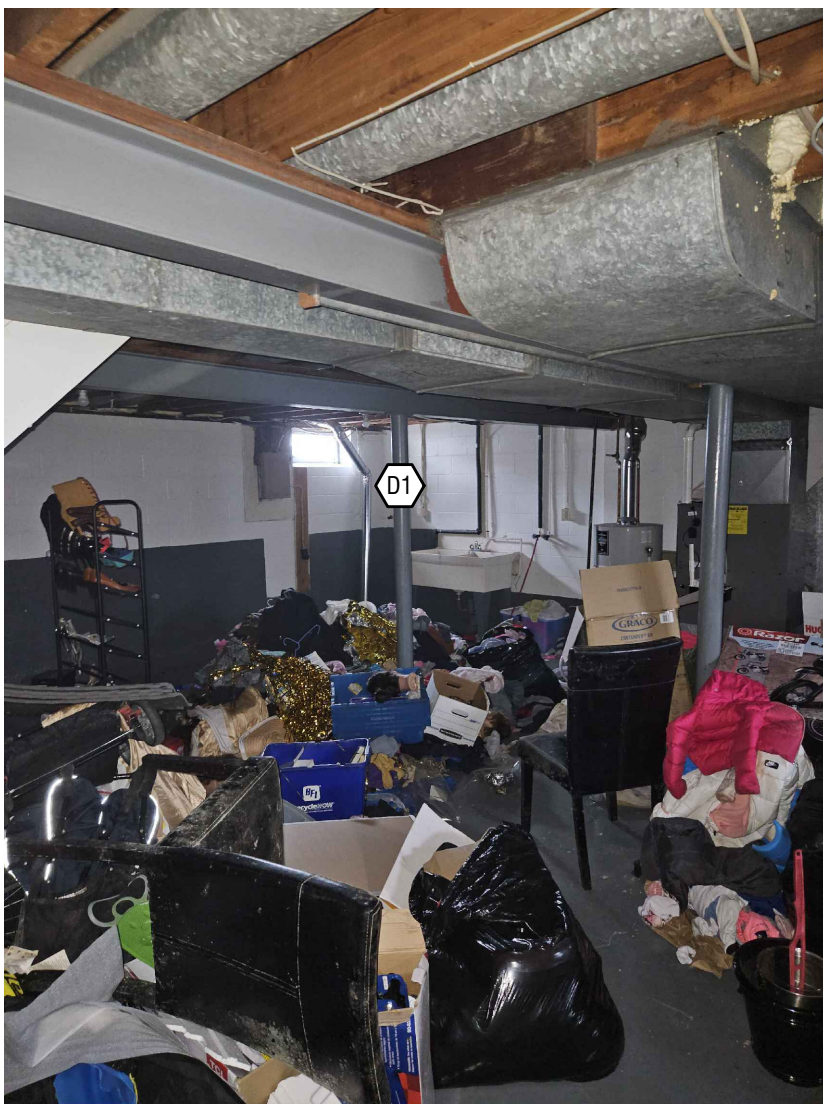
A
H100

VIEW OF BASEMENT DEBRIS & ITEMS
TO BE REMOVED

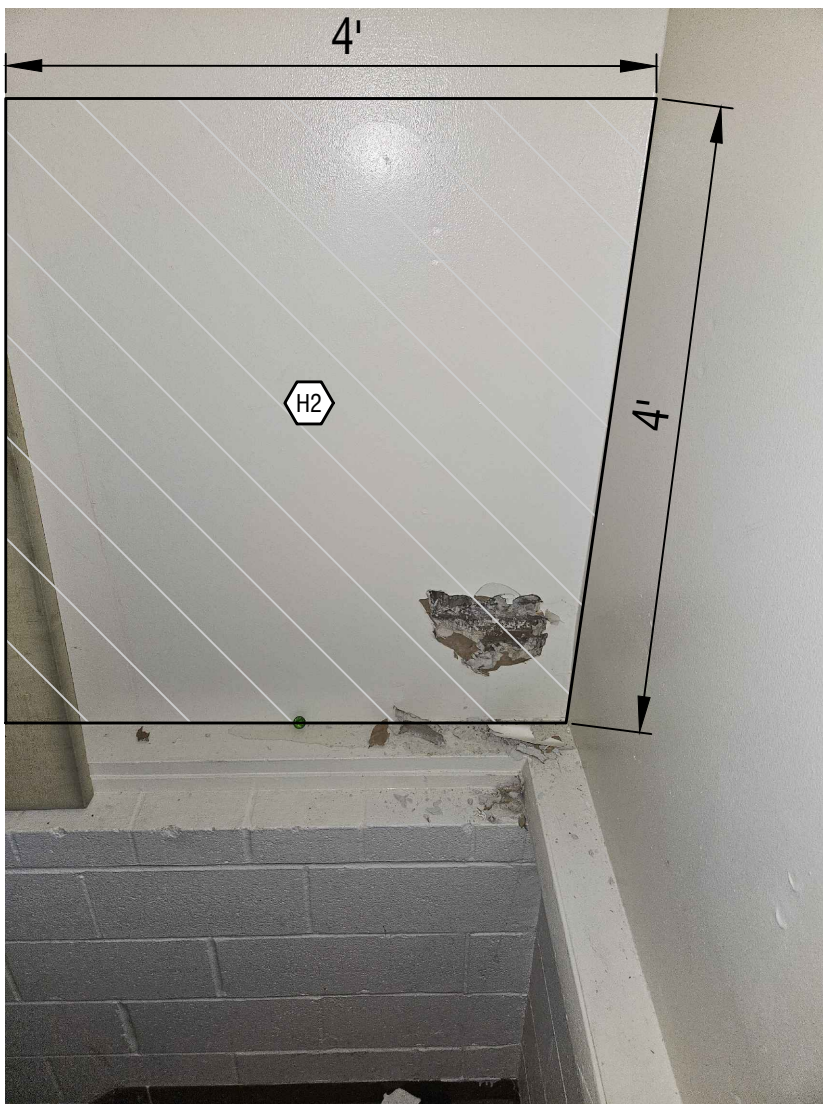
B
H100

VIEW OF BASEMENT DRYWALL &
JOINT COMPOUND TO BE REMOVED

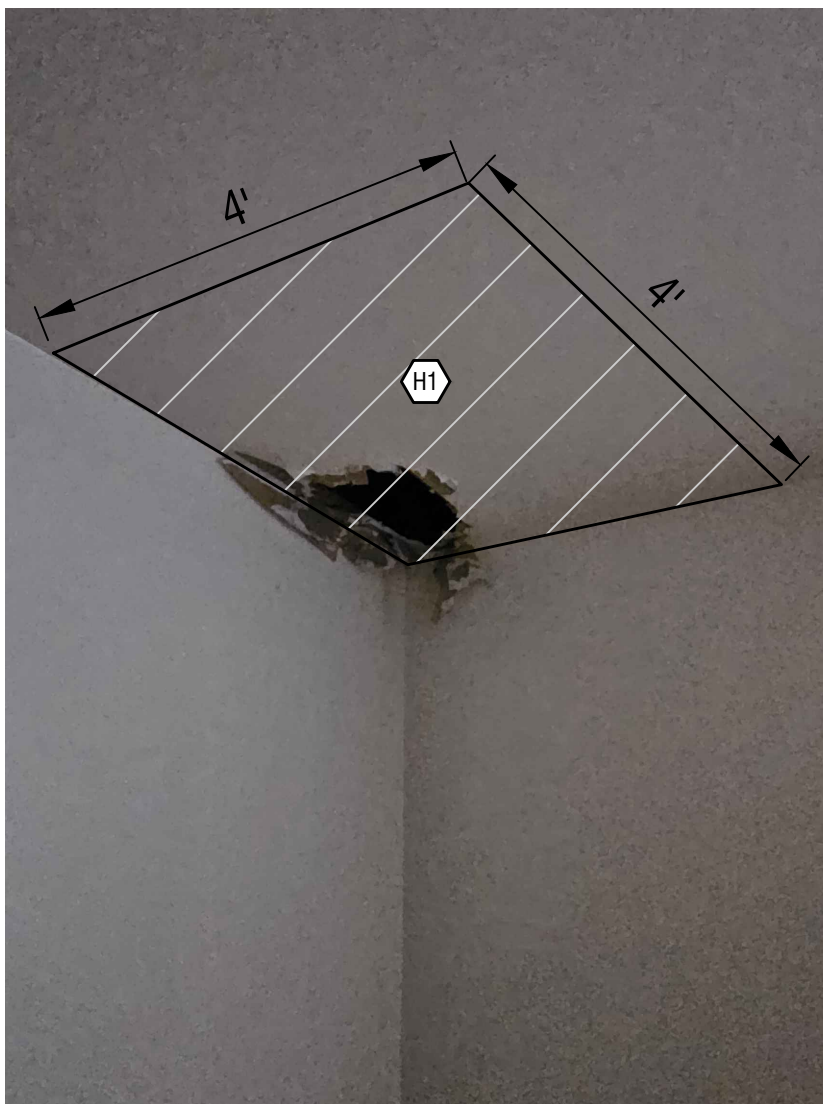
C
H100

VIEW OF DINING ROOM DRYWALL &
JOINT COMPOUND TO BE REMOVED

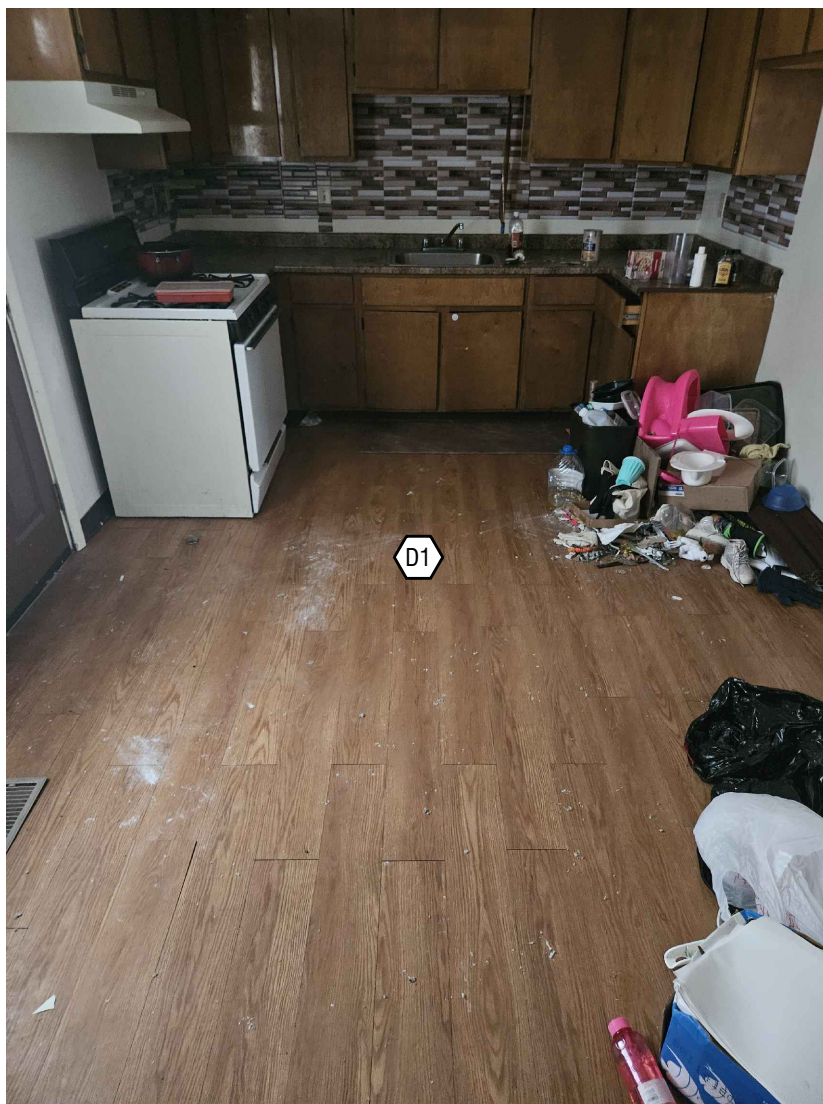
D
H100

VIEW OF KITCHEN DEBRIS & ITEMS
TO BE REMOVED

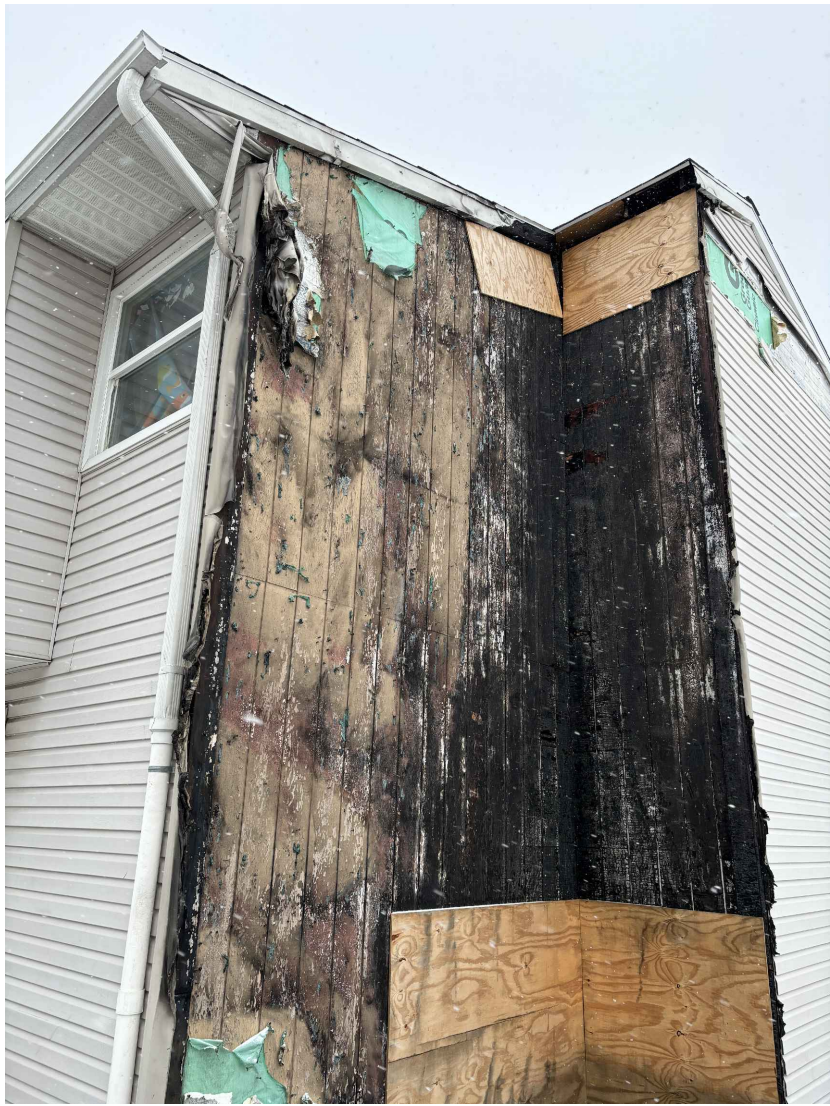
VIEW OF EXTERNAL FIRE DAMAGE

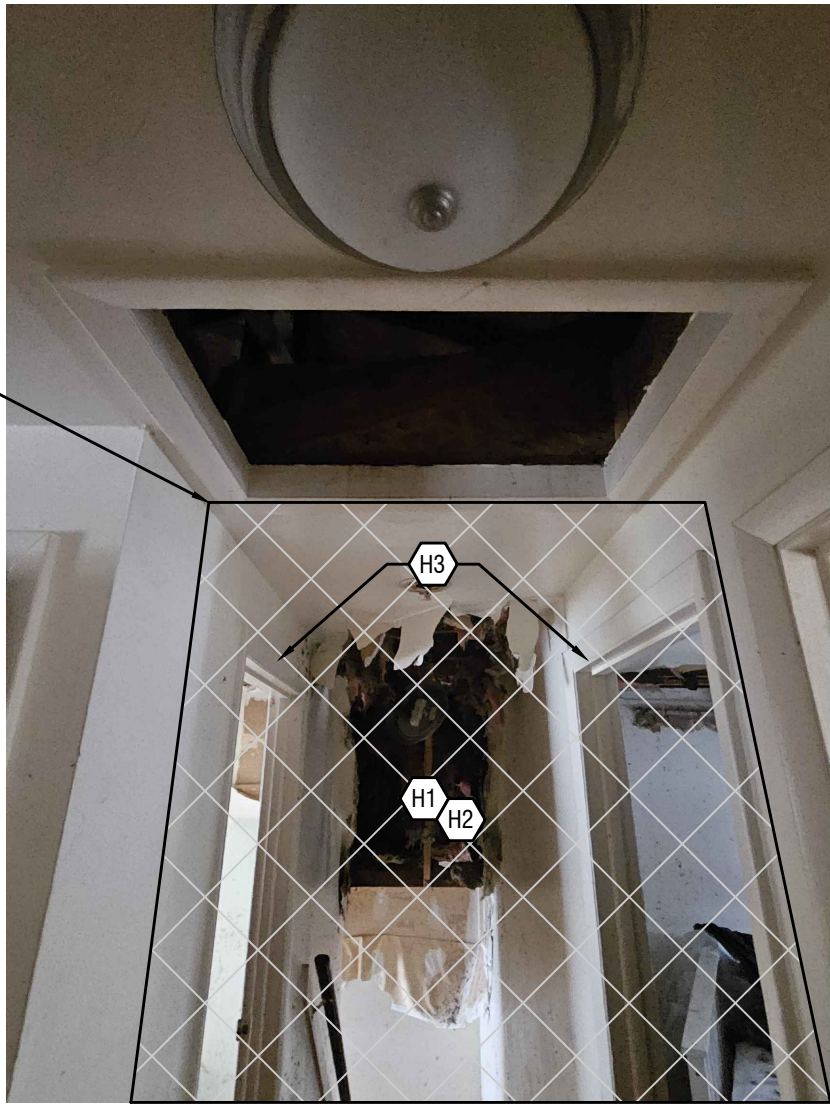
VIEW OF HALLWAY CEILING

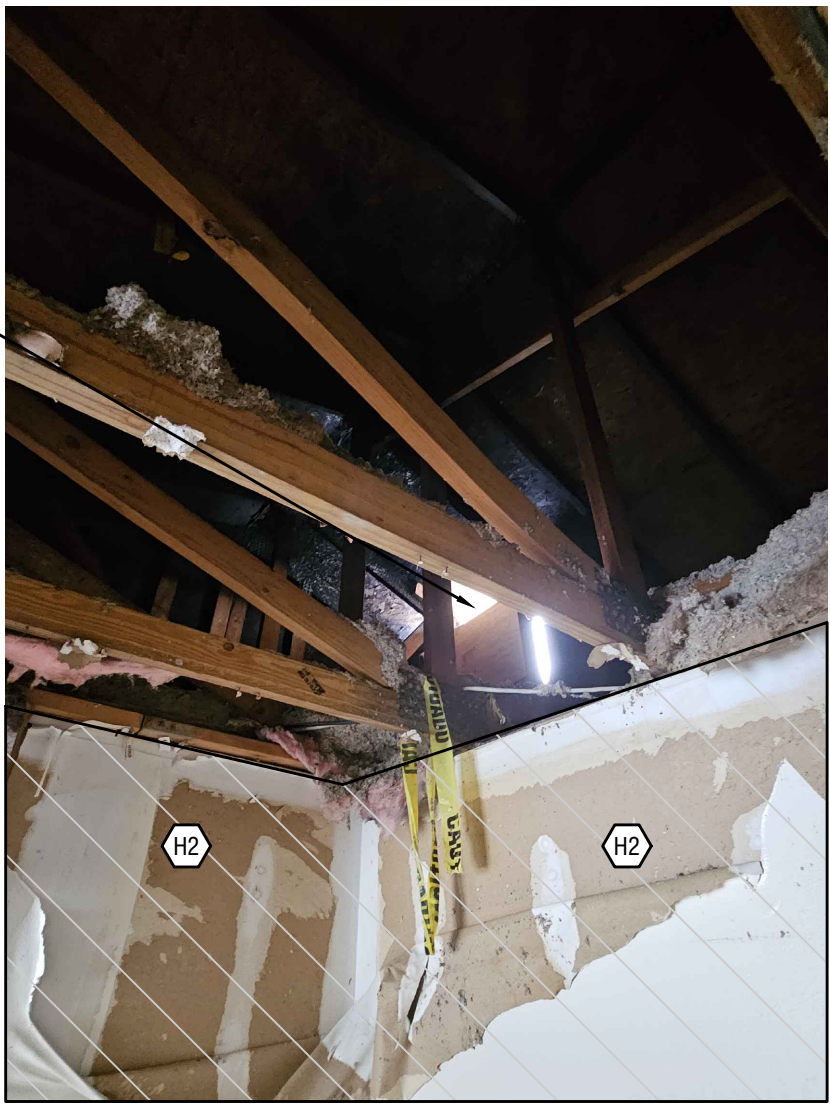
VIEW OF HALLWAY CEILING AND EXPOSED ATTIC SPACE

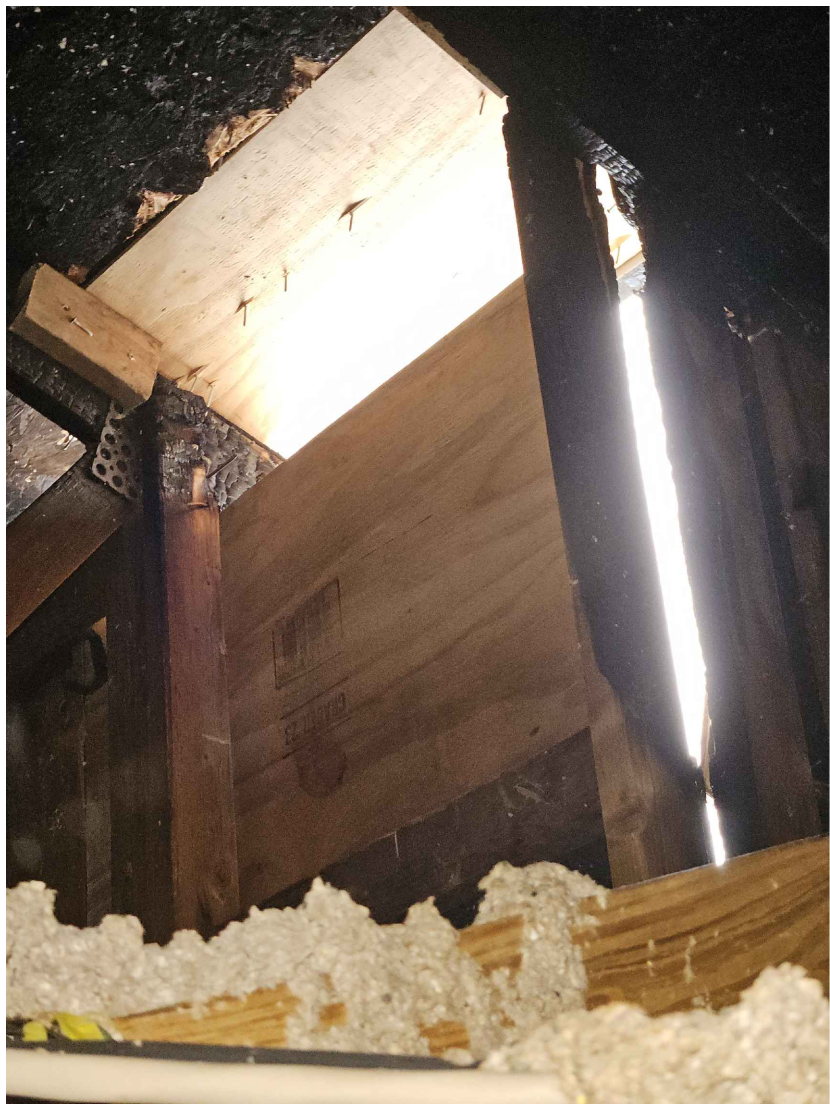
CLOSE UP VIEW OF OPENING ABOVE HALLWAY CEILING

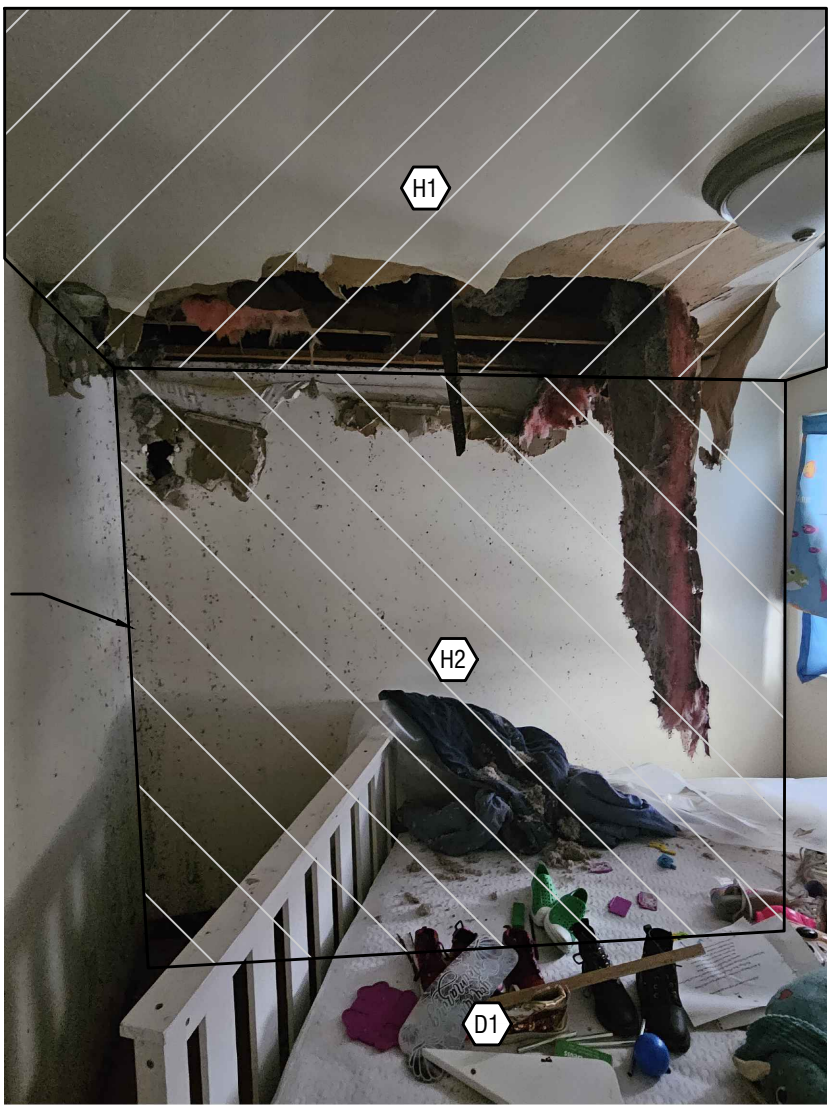
VIEW OF BEDROOM 1 DRYWALL & DEBRIS TO BE REMOVED

DRYWALL WALL SYSTEM REMOVAL IN BEDROOM 1 SHALL BE LIMITED TO WEST WALL

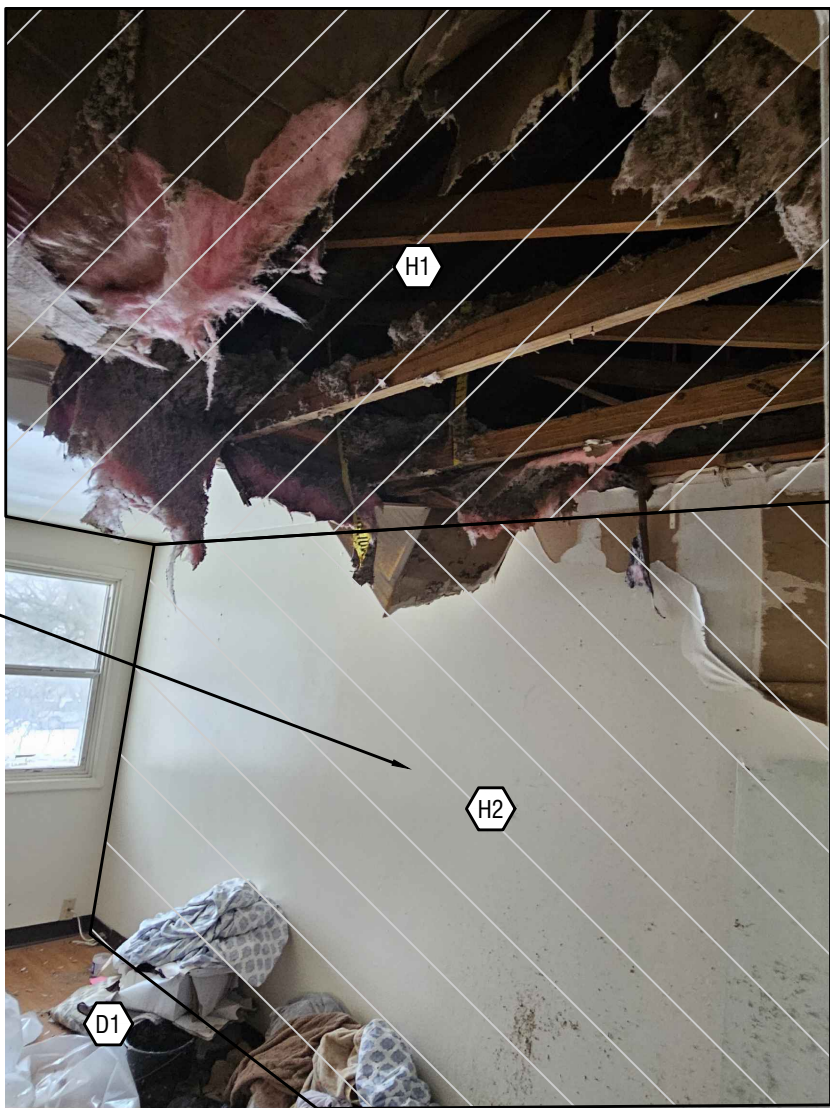
VIEW OF BEDROOM 2 DRYWALL & DEBRIS TO BE REMOVED

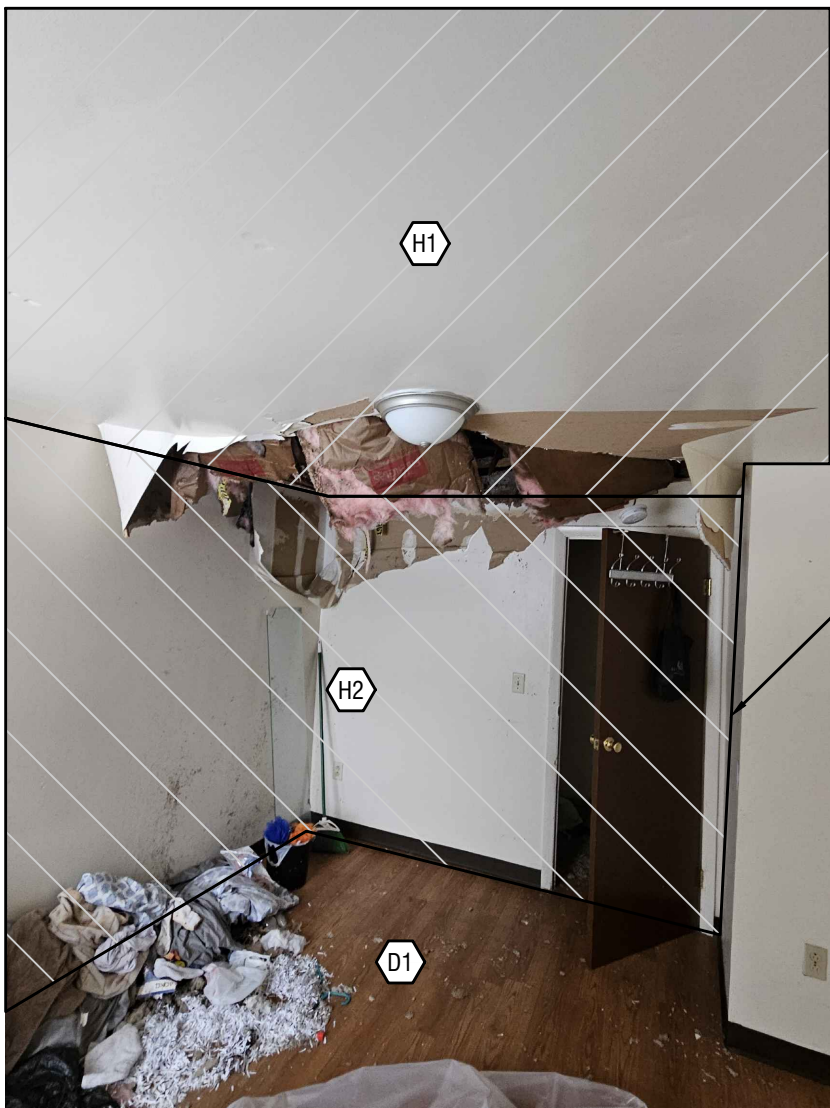
VIEW OF BEDROOM 2 DRYWALL & DEBRIS TO BE REMOVED

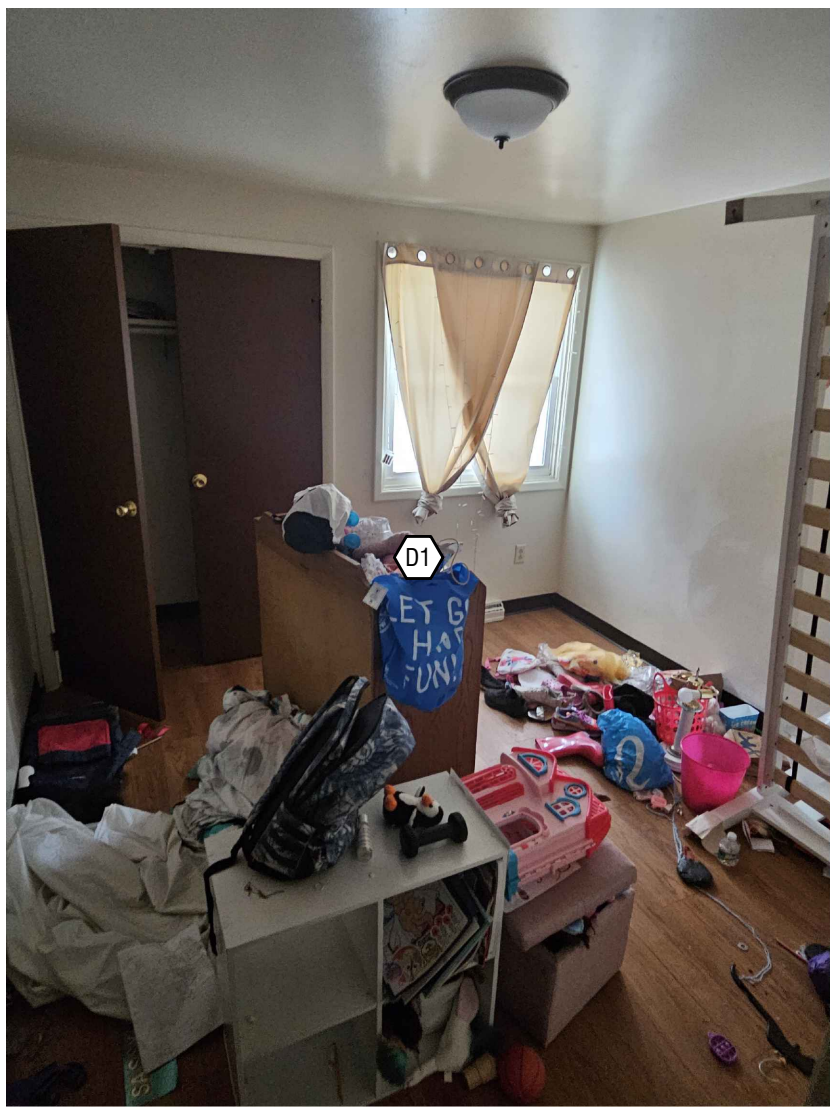
VIEW OF BEDROOM 3 DEBRIS & ITEMS TO BE REMOVED
