### Comprehensive Regulated Building Materials Inspection

Holland Townhouses – Unit 56 56 Holland Street Rochester, New York 14605

Rochester Housing Authority 495 Upper Falls Boulevard Rochester, New York 14605

June 18, 2024

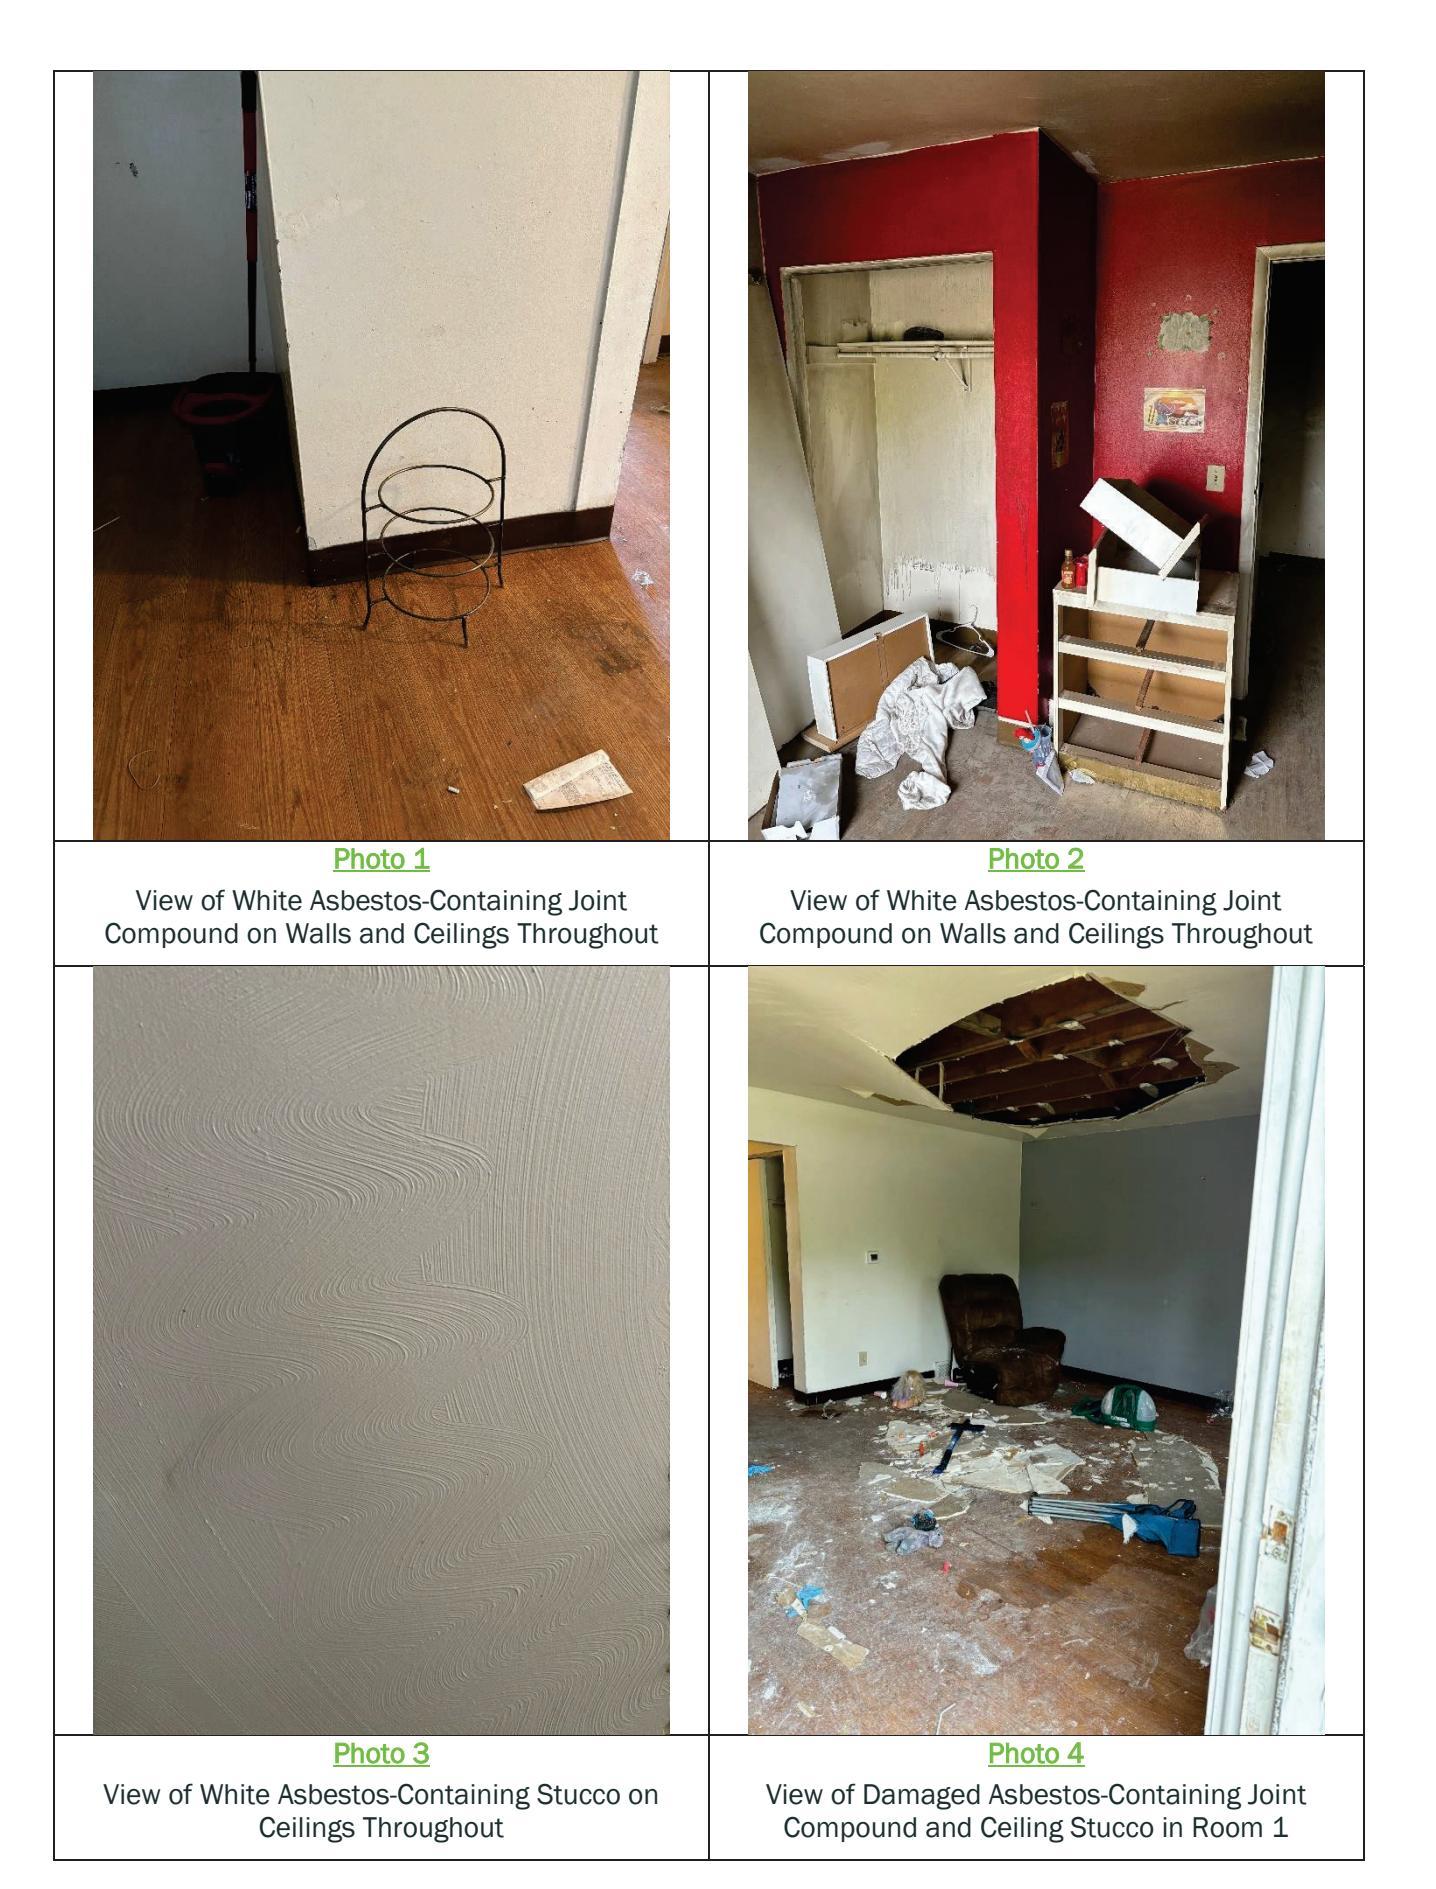
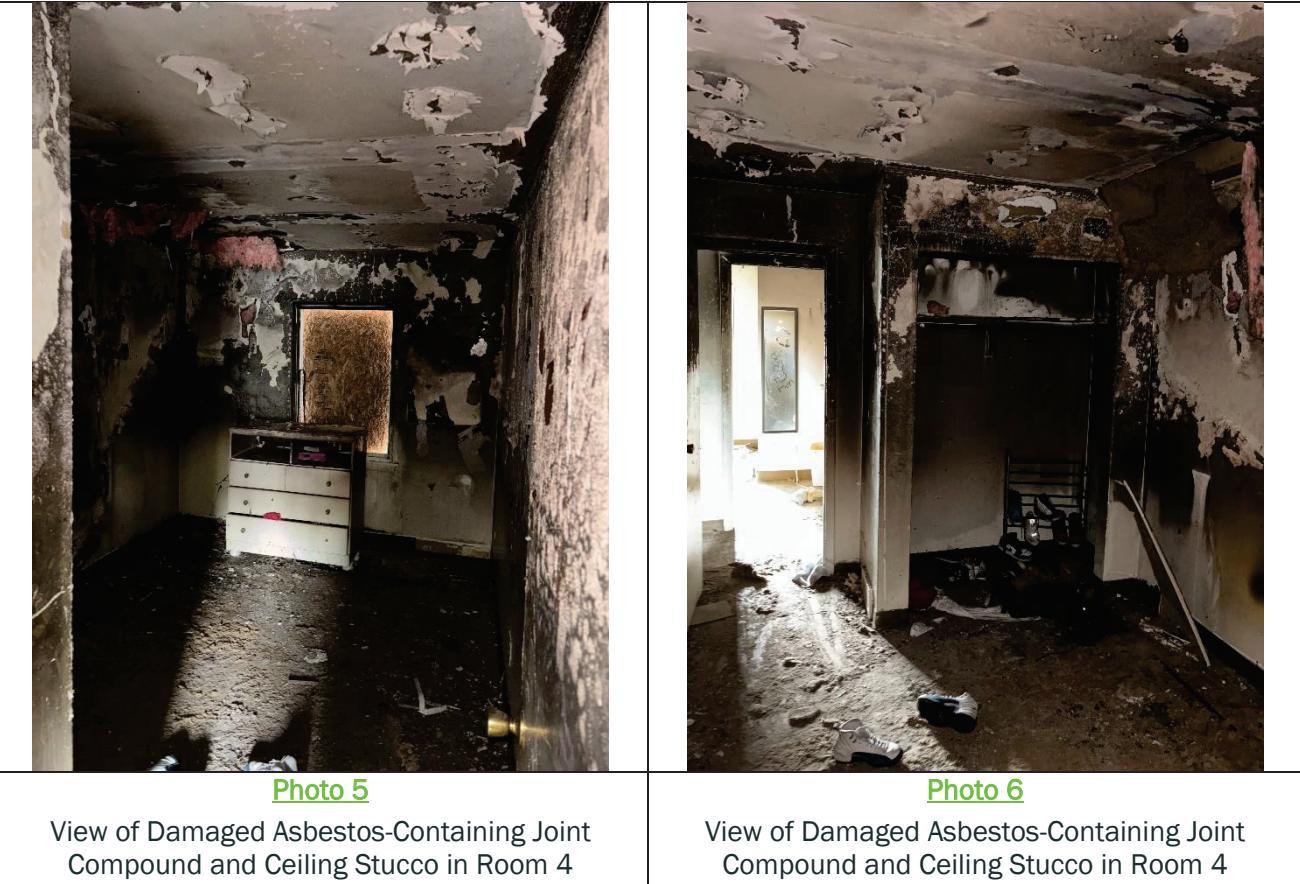
Additionally, the majority of joint compound within the inspected spaces was observed to be in good condition. However, Rooms 1, 4 and 8 had extensive damage to the wall and ceiling systems caused by a recent fire within the unit. As such, drywall/joint compound debris was observed throughout the impacted spaces.

White asbestos-containing stucco is located on the ceilings throughout the inspected unit. The majority of ceiling stucco within the inspected spaces was observed to be in good condition. However, Rooms 1, 4 and 8 had extensive damage to the wall and ceiling systems caused by a recent fire within the unit. As such, ceiling stucco debris was observed throughout the impacted spaces.

View of Damaged Asbestos-Containing Joint Compound and Ceiling Stucco in Room 4

As stated earlier, the presence of damaged asbestos-containing materials were noted in several locations throughout the unit. These conditions represent an "Incidental Asbestos Disturbance" as defined by New York State Asbestos Regulations, (i.e., Industrial Code Rule 56). According to these regulations, personnel access to the areas affected shall be restricted until such time as the materials are cleaned up by a licensed asbestos abatement contractor. The clean-up of these materials shall take place as soon as possible.
