ADDENDUM #4

43-47 Bronson Court Abatement Addendum #4

Limited Pre-Renovation Regulated Building Materials Inspection

Bronson Court Townhomes
43 & 47 Bronson Court
Rochester, New York 14608

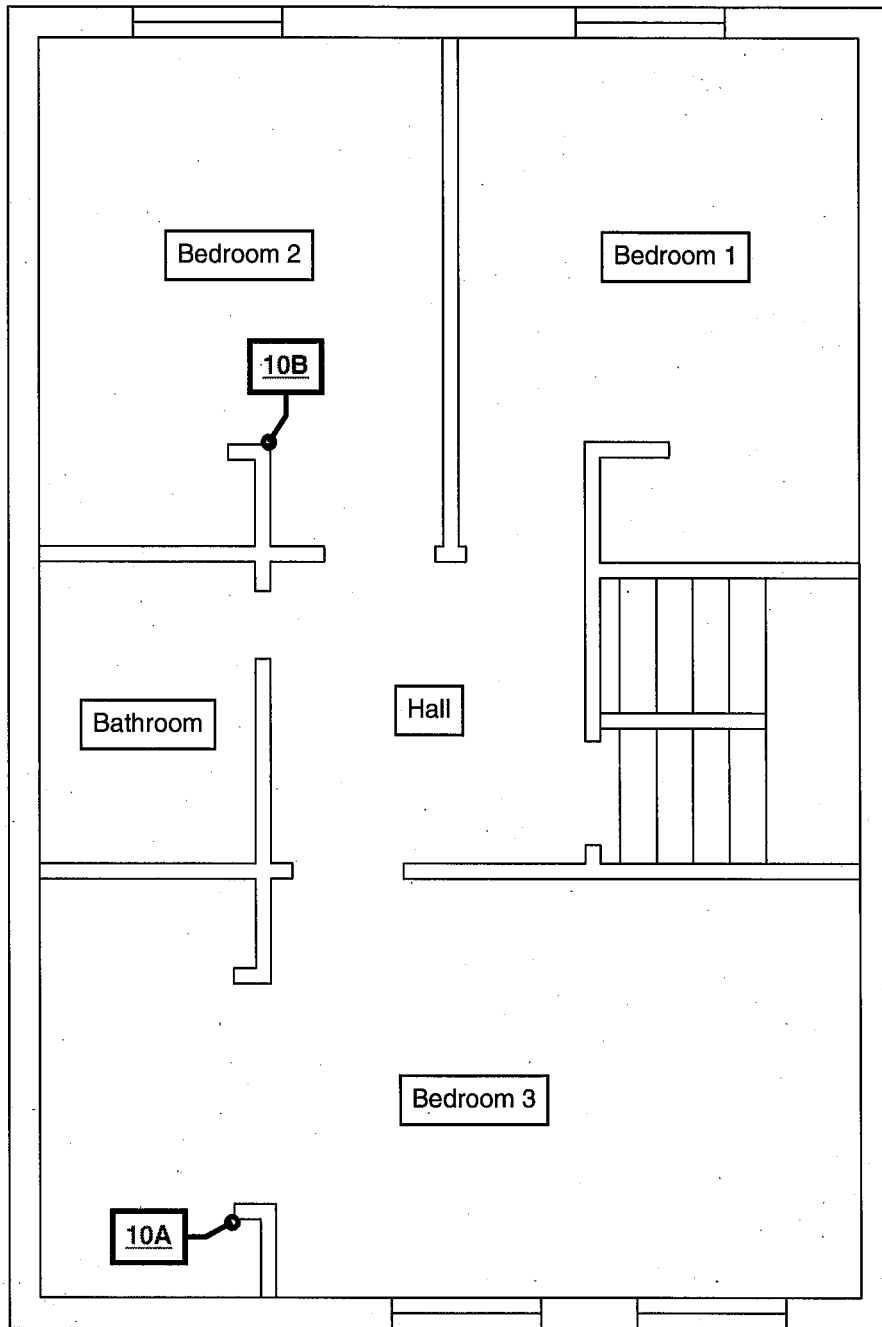
SECOND FLOOR

White asbestos-containing joint compound is located on walls and ceilings throughout Apartment 43. The joint compound is generally in good condition and covers an area of approximately 3,700 square feet within this unit. This material is considered to be non-friable in its current, intact condition. However, this material has the potential to become friable during any renovation/demolition activities that will disturb the material.

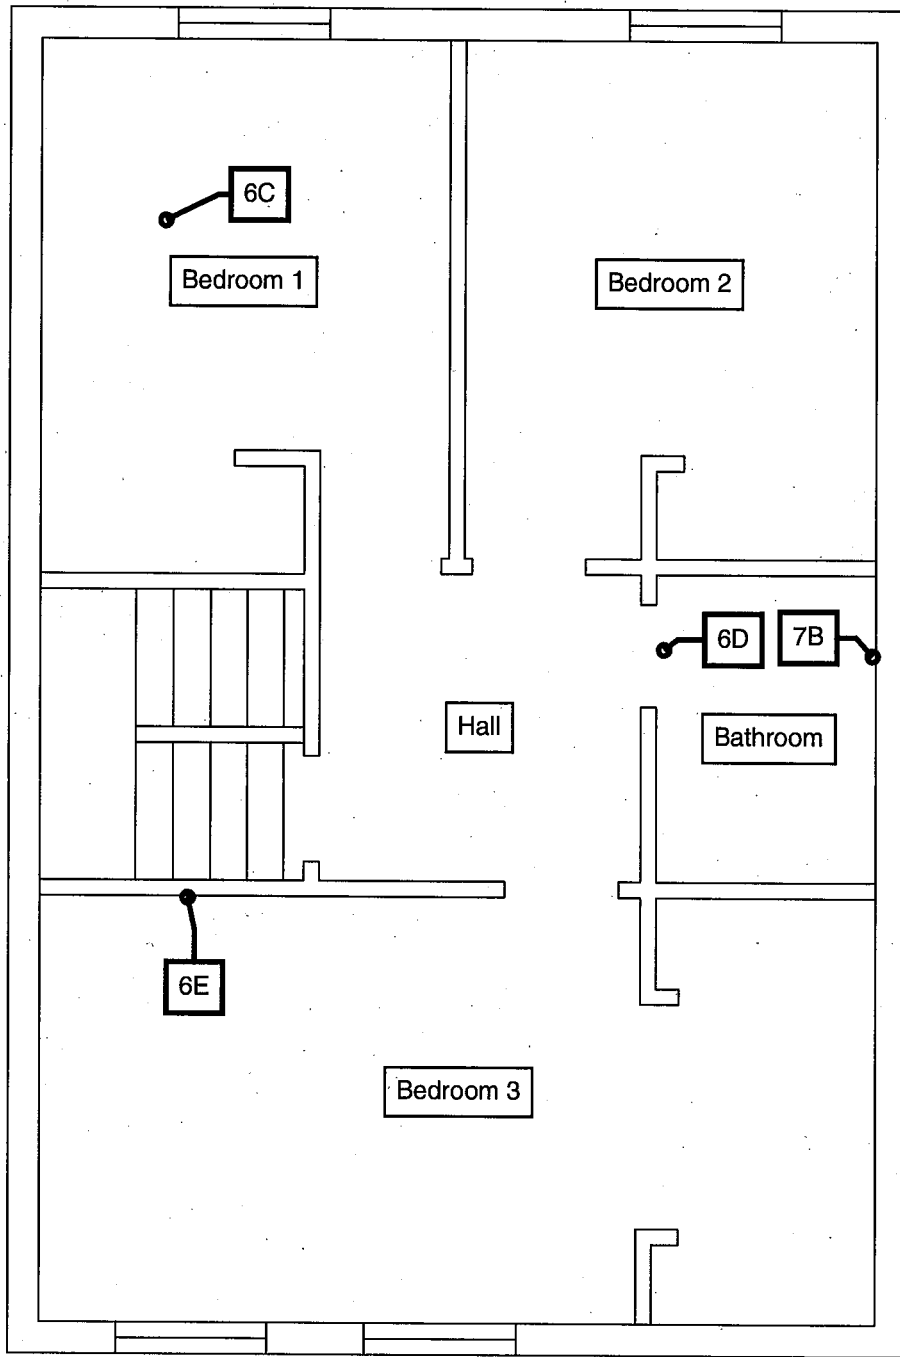
SECOND FLOOR

White asbestos-containing joint compound is located on walls and ceilings throughout Apartment 47. The joint compound is generally in good condition and covers an area of approximately 3,700 square feet within this unit. There were areas observed within the unit where partial walls and ceilings were missing due to a fire. However, there was no visible debris found throughout the unit. This material is considered to be non-friable in its current, intact condition. However, this material has the potential to become friable during any renovation/demolition activities that will disturb the material.
