## ADDENDUM #1

RE: Rochester Housing Authority

## Jonathan Child Apartments Façade Repairs

## TRAUTMAN ASSOCIATES ROCHESTER HOUSING AUTHORITY JONATHAN CHILD APARTMENTS MASONRY RECONSTRUCTION TA PROJECT No. 24042

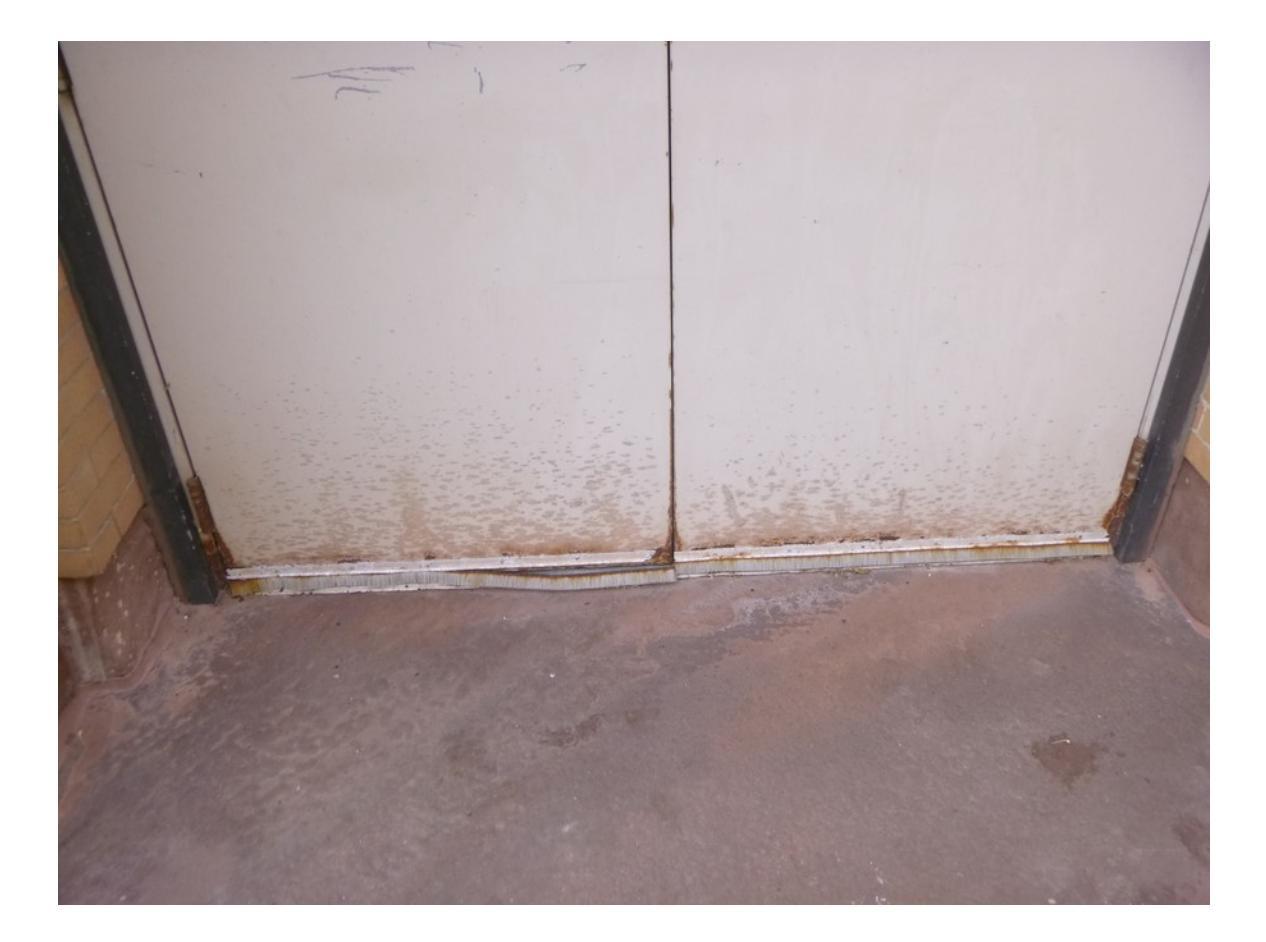
Photo: 223-14 ArchMetal\_Corrosion Surface 2023-1.jpg Material: Architectural Metal Category: Corrosion Surface Condition: Surface TPAS Code: Srf Autocad Layer: ArchMetal\_Corrosion Severity Units: Not applicable Amount Units: Area affected in square feet

Rust on the surface of a metal element, which has not yet resulted in delamination or expansion of the element.

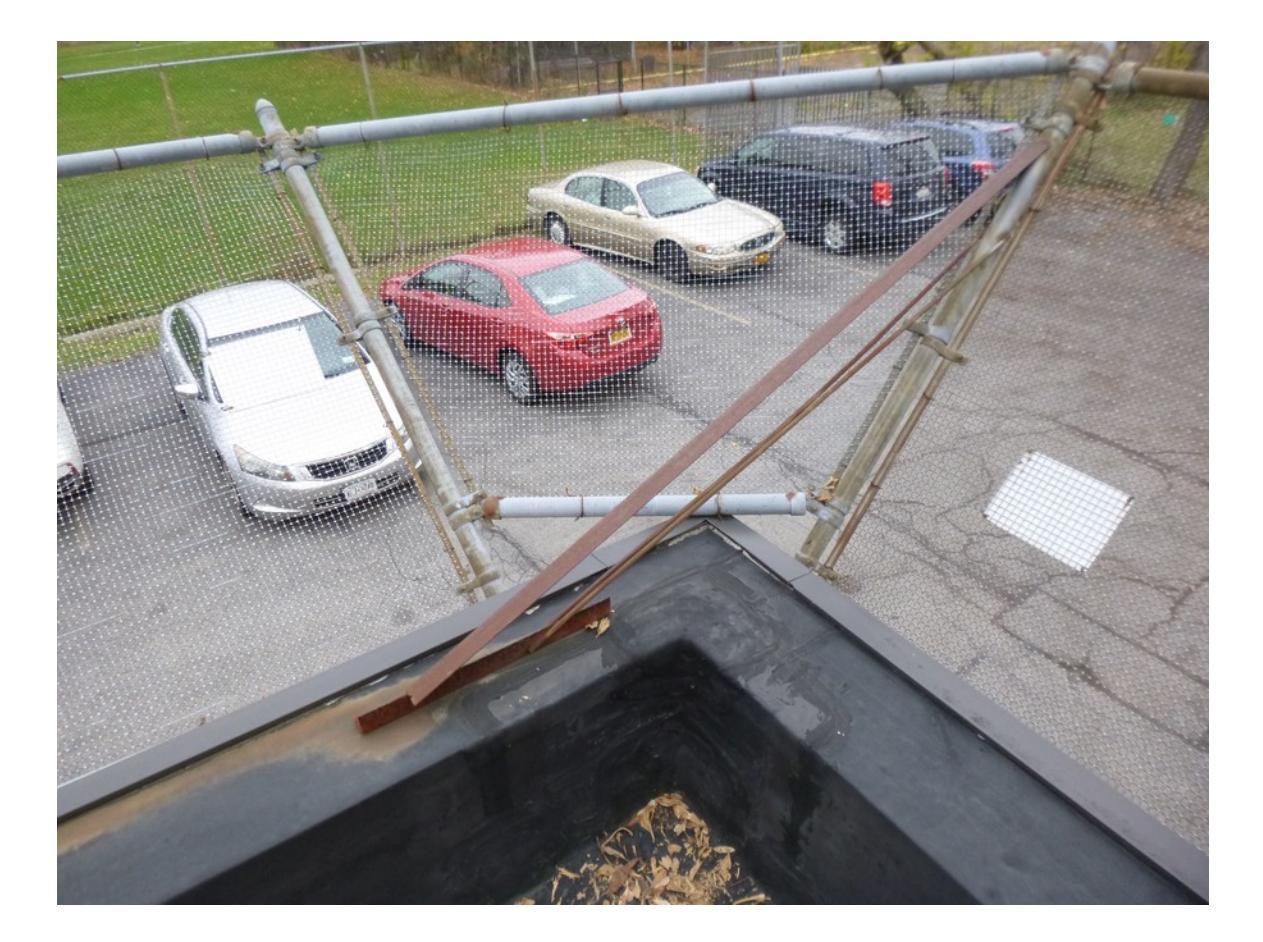
Photo: 432-18 ArchMetal\_Unsecured Loose 2023-1.jpg Material: Architectural Metal Category: Unsecured Loose Condition: Loose TPAS Code: L Autocad Layer: ArchMetal\_Unsecured Severity Units: Not applicable Amount Units: Area in square feet

Metal element or area that can be moved by hand or when sounded with a mallet due to its loss of construction integrity.

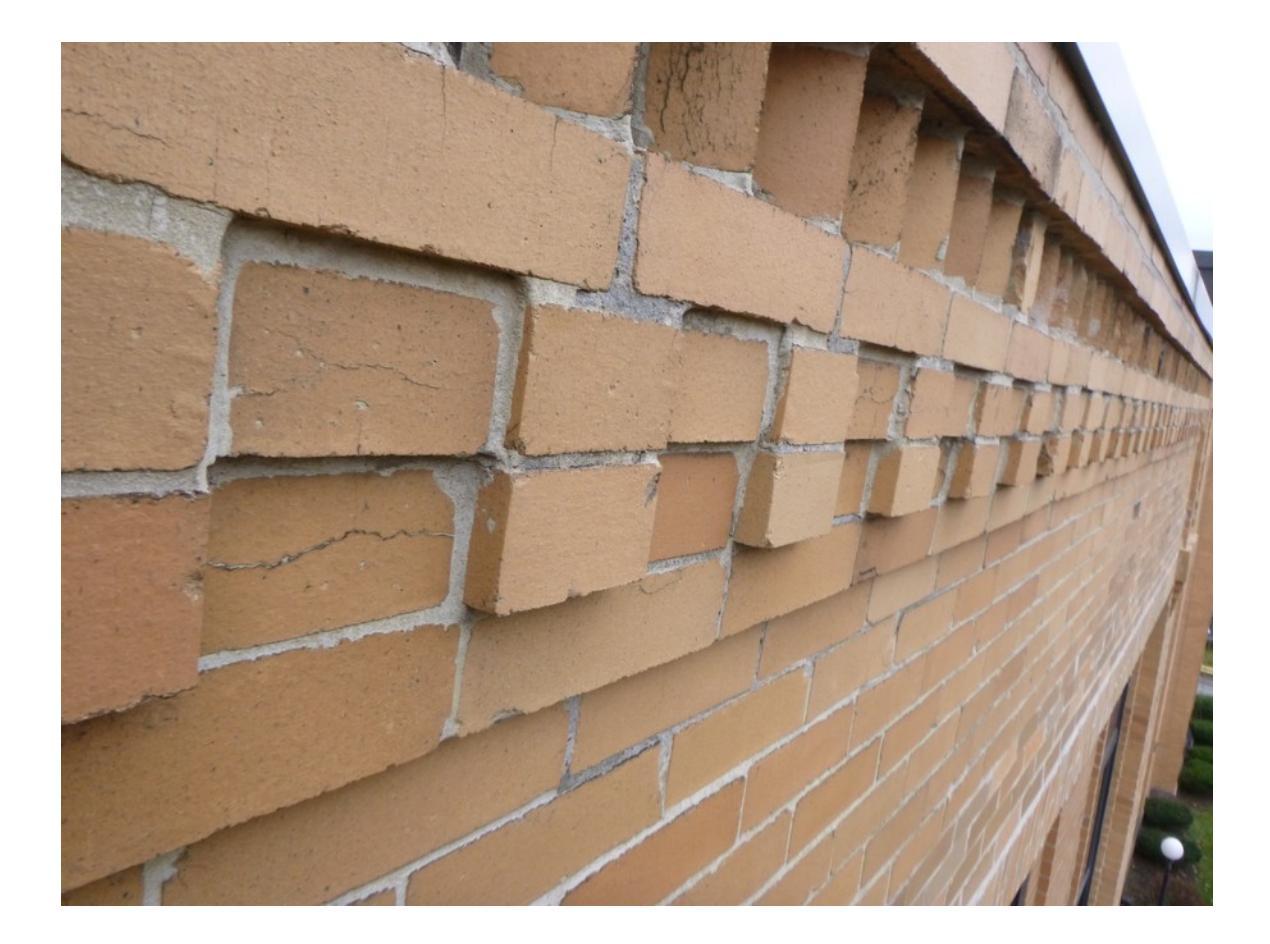
Photo: 16-34 Brick\_Crack Single unit 2023-1.jpg Material: Brick Category: Crack Single Unit Condition: Single Unit TPAS Code: C Autocad Layer: Brick\_Crack Severity Units: Width in 1/16 inch increments Amount Units: Length in lineal feet

A crack through a single unit.

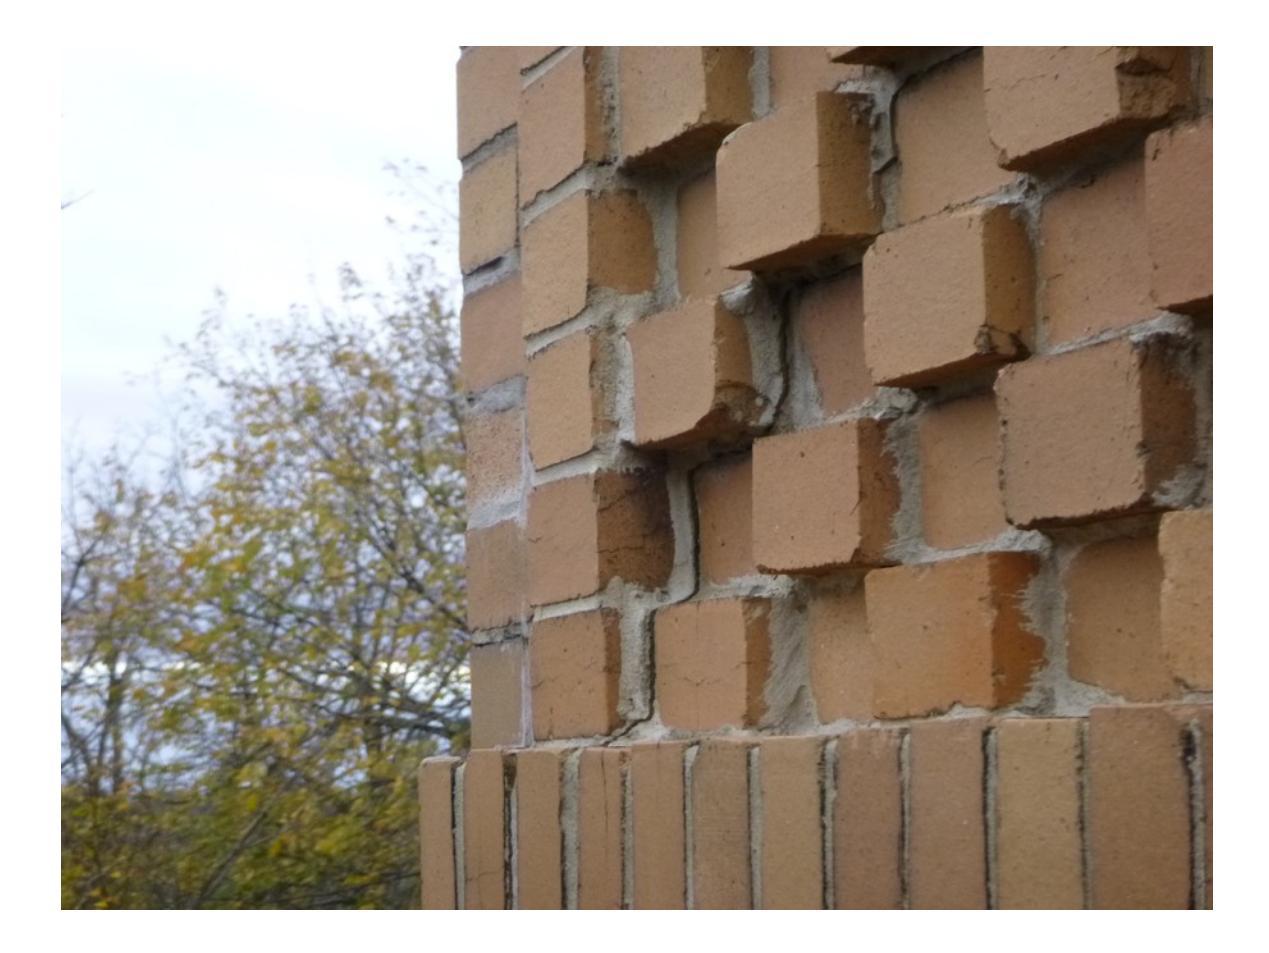
Photo: 13-33 Brick\_Crack System joints 2023-1.jpg Material: Brick Category: Crack System Joint Condition: System Joint TPAS Code: CJ Autocad Layer: Brick\_Crack Severity Units: Width in 1/16 inch increments Amount Units: Length in lineal feet

A crack following the path of two or more connecting joints without any fractured masonry units.

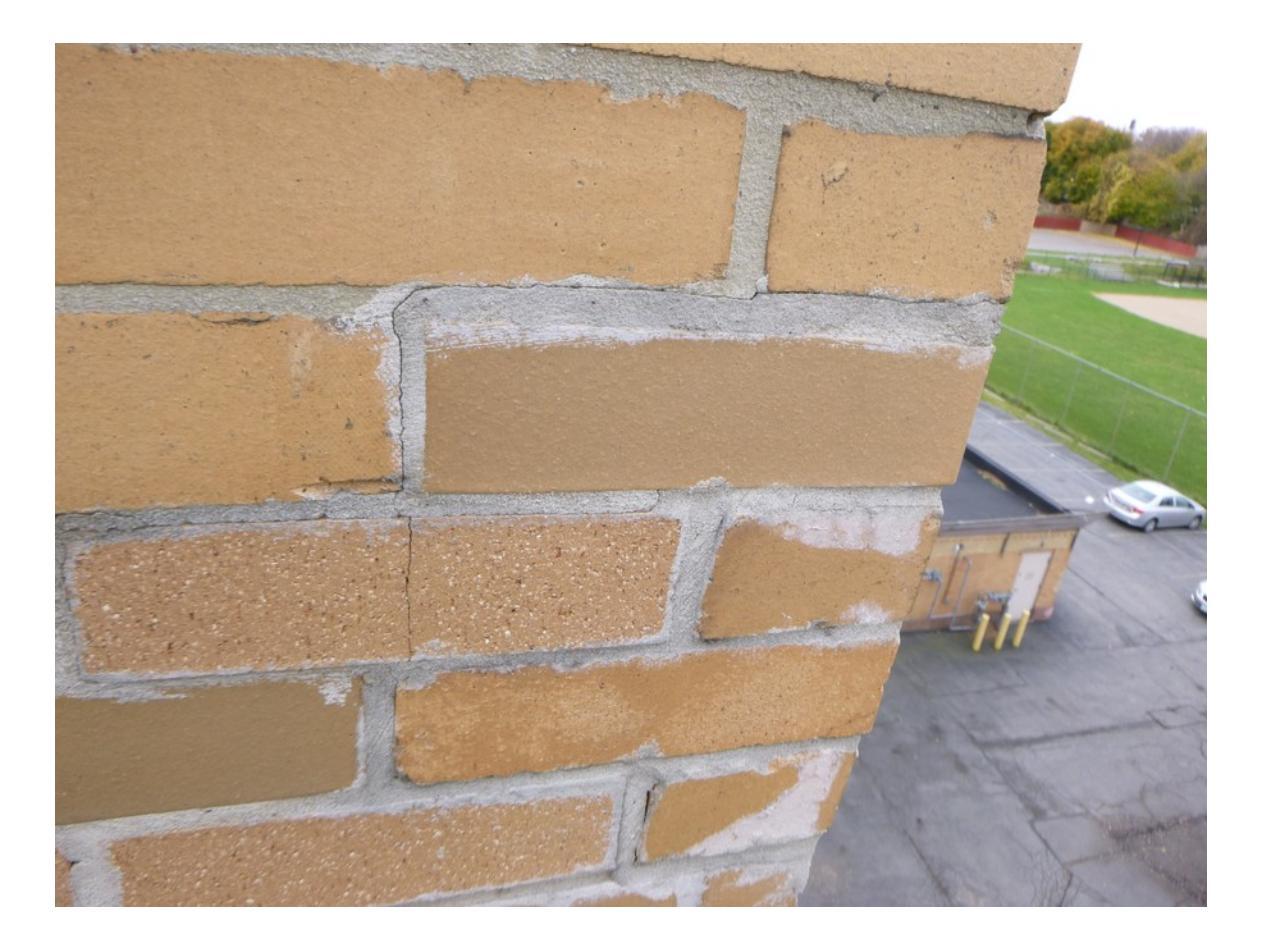
Photo: 244-36 Brick\_Crack System units and joints 2023-1.jpg Material: Brick Category: Crack System Unit Condition: System Unit TPAS Code: CU Autocad Layer: Brick\_Crack Severity Units: Width in 1/16 inch increments Amount Units: Length in lineal feet

A crack through more than one masonry unit, but not following, joints.

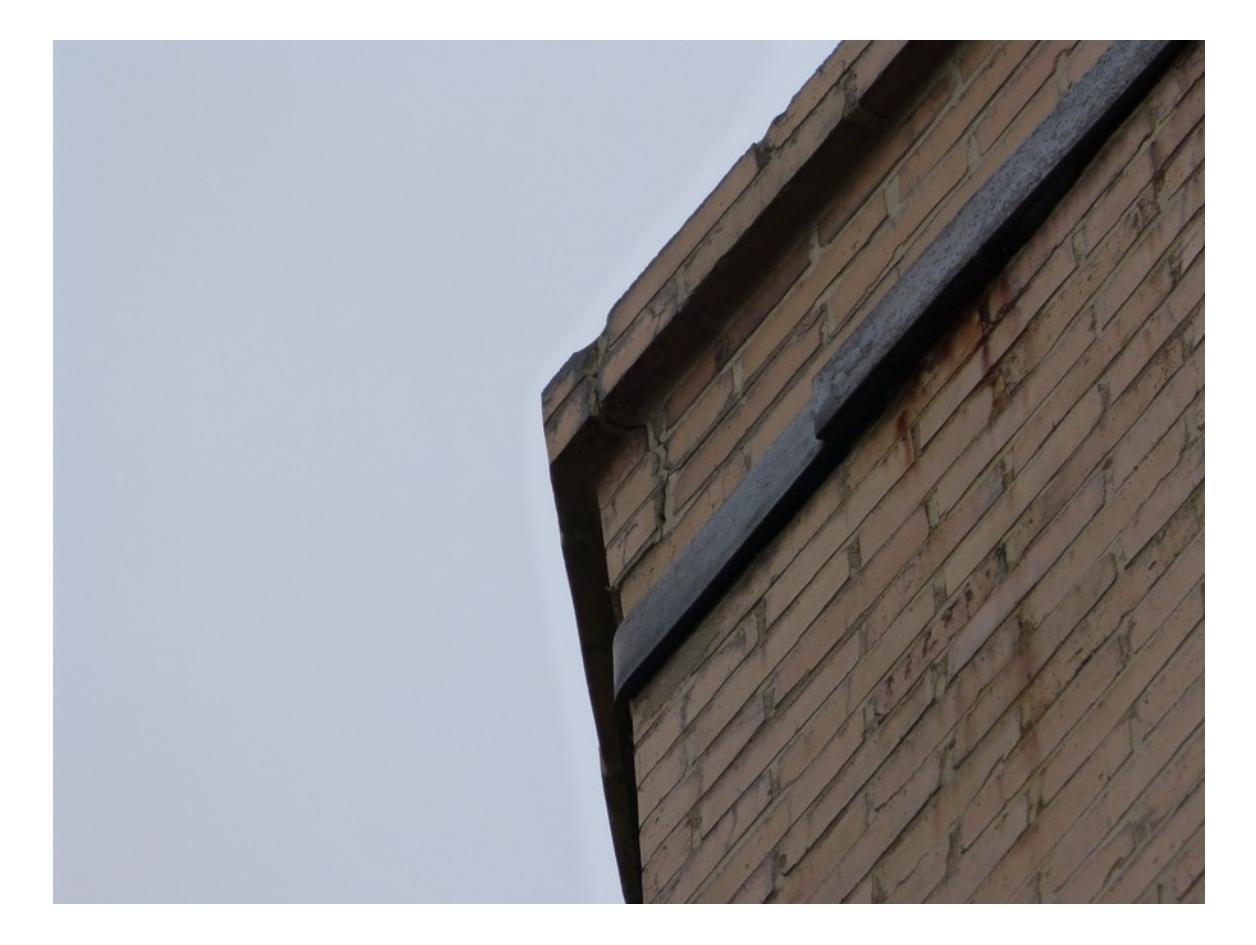
Photo: 255-35 Brick\_Displacement Horizontal 2023-1.jpg Material: Brick Category: Displacement Horizontal Condition: Horizontal TPAS Code: Hor Autocad Layer: Brick\_Displacement Severity Units: Displacement in 1/8 inch increments Amount Units: Area affected in square feet

Units shifted out of their as-built position in a left/right or forward/back direction.

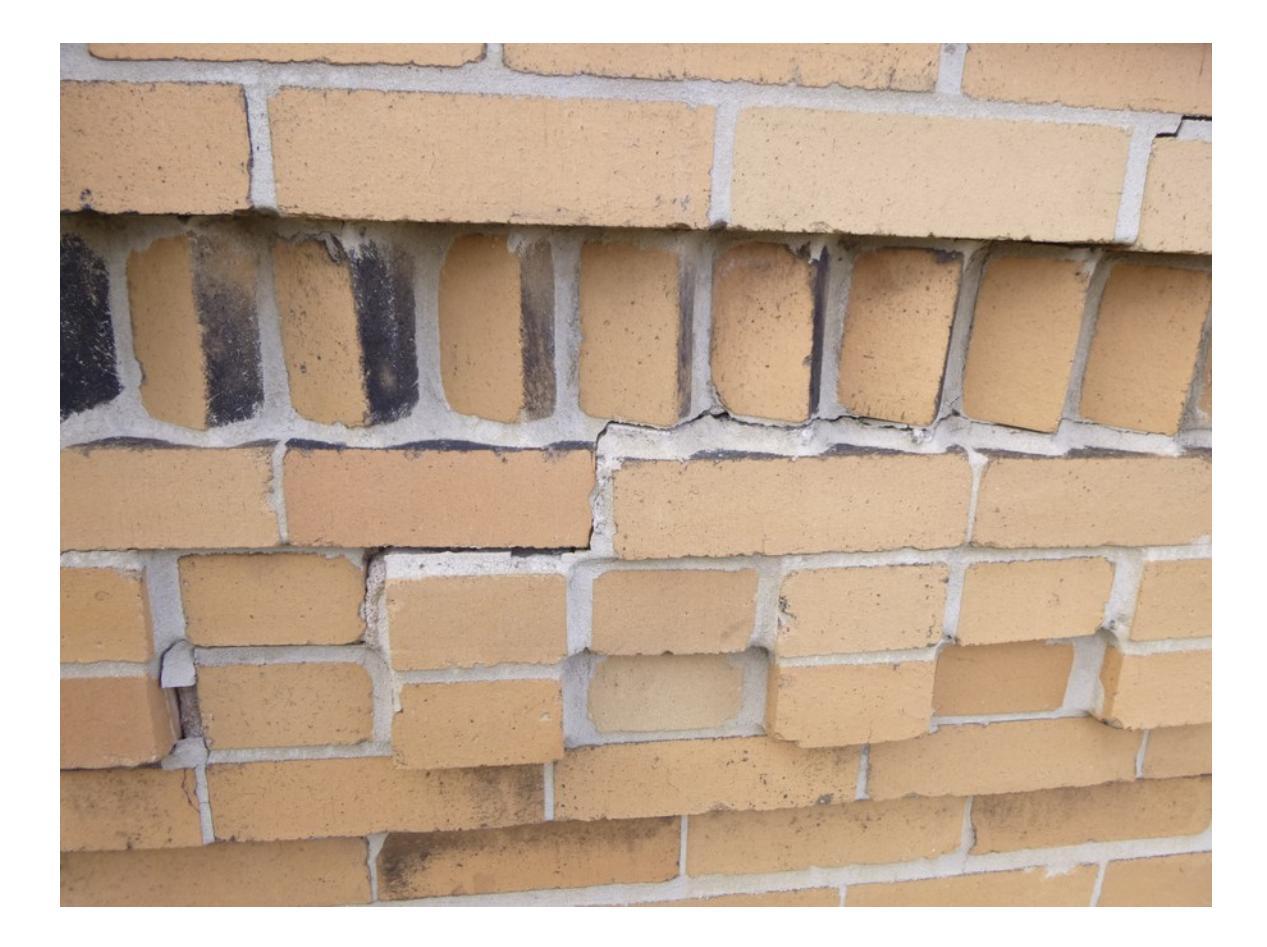
Photo: 54-37 Brick\_Displacement Horizontal and Vertical 2023-1.jpg Material: Brick Category: Displacement Horizontal and Vertical Condition: Horizontal and Vertical TPAS Code: HV Autocad Layer: Brick\_Displacement Severity Units: Displacement in 1/8 inch increments Amount Units: Area affected in square feet

Units shifted out of their as-built position in both a horizontal (left/right or forward/back) and vertical (up/down) directions.

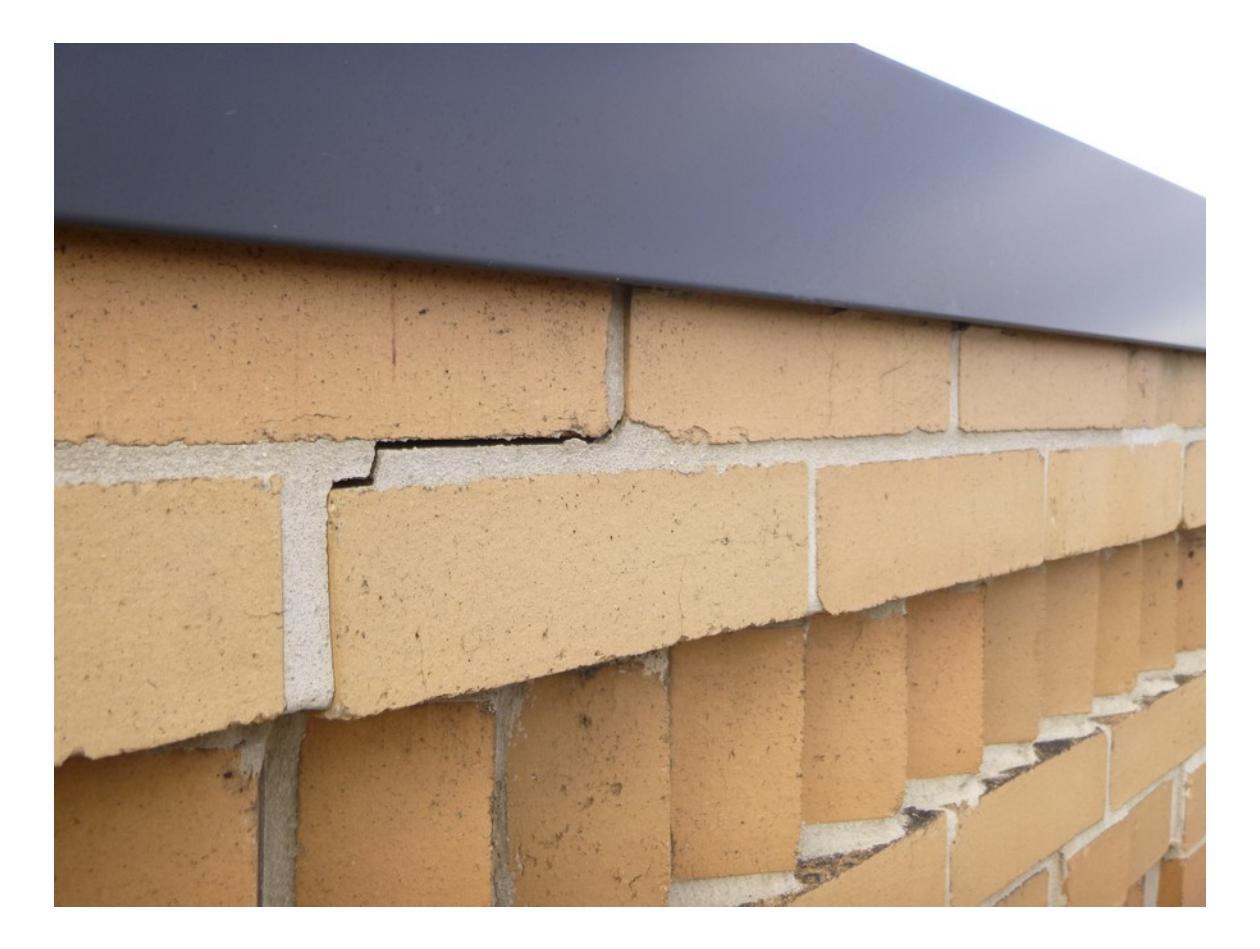
Photo: 55-37 Brick\_Displacement Vertical 2023-1.jpg Material: Brick Category: Displacement Vertical Condition: Vertical TPAS Code: Vrt Autocad Layer: Brick\_Displacement Severity Units: Displacement in 1/8 inch increments Amount Units: Area affected in square feet

Units shifted out of their as-built position in an up/down direction.

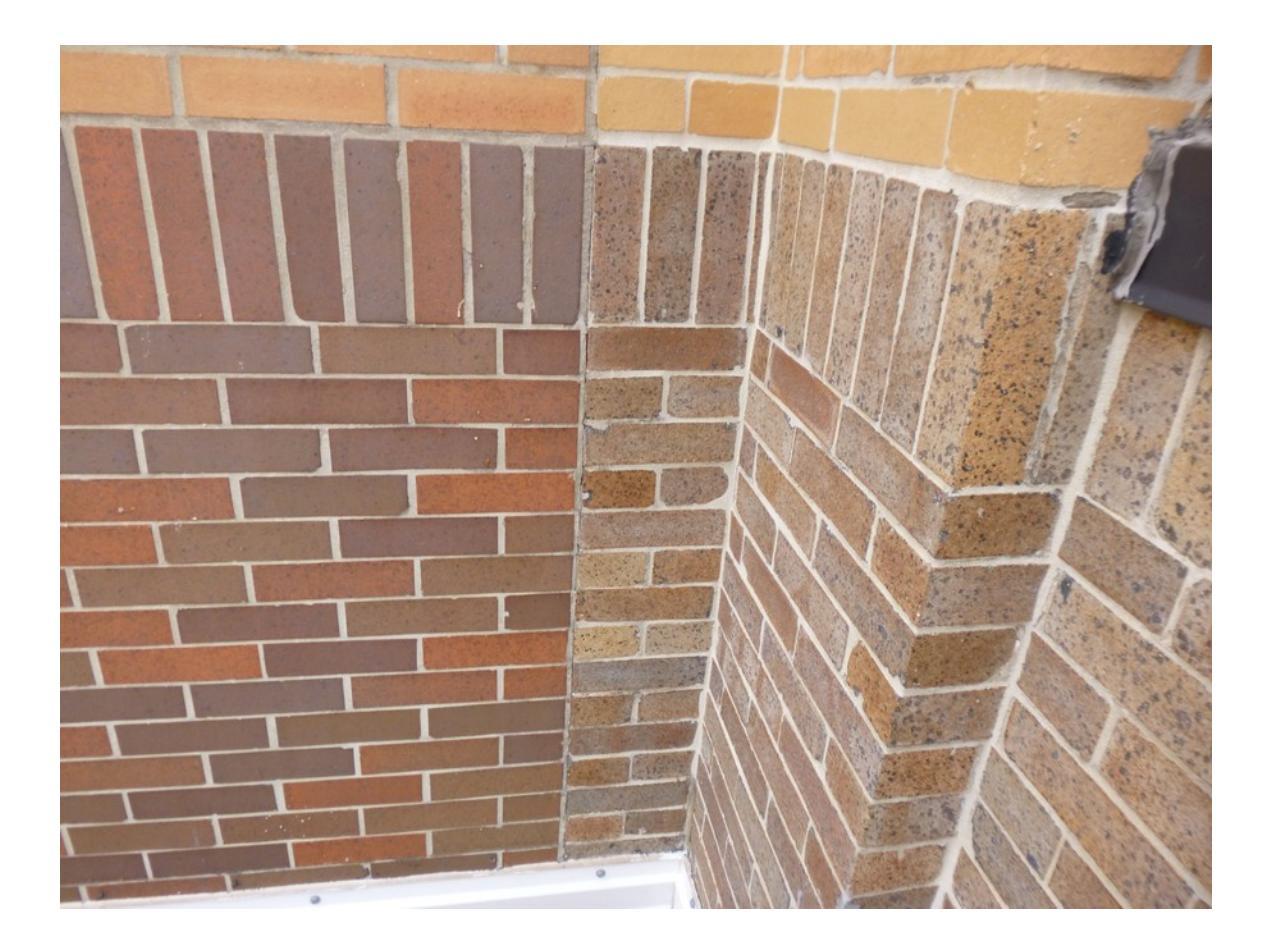
Photo: 1042-18 Brick\_Repair Replacement 2023-2.jpg Material: Brick Category: Repair Replacement Condition: Replacement TPAS Code: Rpl Autocad Layer: Brick\_Repair Severity Units: Not Applicable Amount Units: Size in square inches

A repair made to brick masonry in which new brick unit(s) have been installed to replace an area of deterioration.

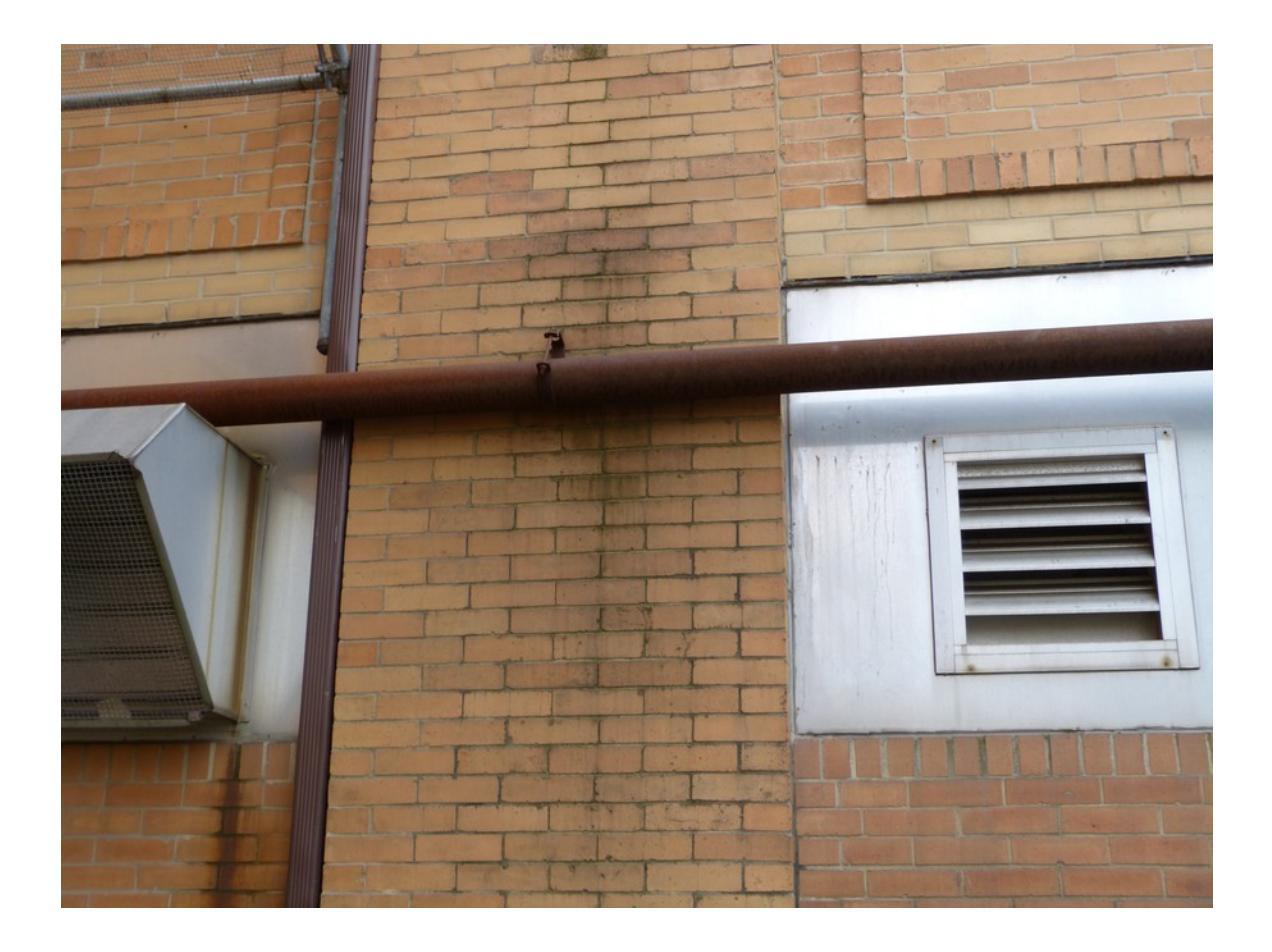
Photo: 244-19 Brick\_SoilStain Atmospheric 2023-1.jpg Material: Brick Category: Soiled Atmospheric Condition: Atmospheric TPAS Code: Atm Autocad Layer: Brick\_SoilStain Severity Units: Not Applicable Amount Units: Area affected in square feet

Soiling from airborne pollutants.

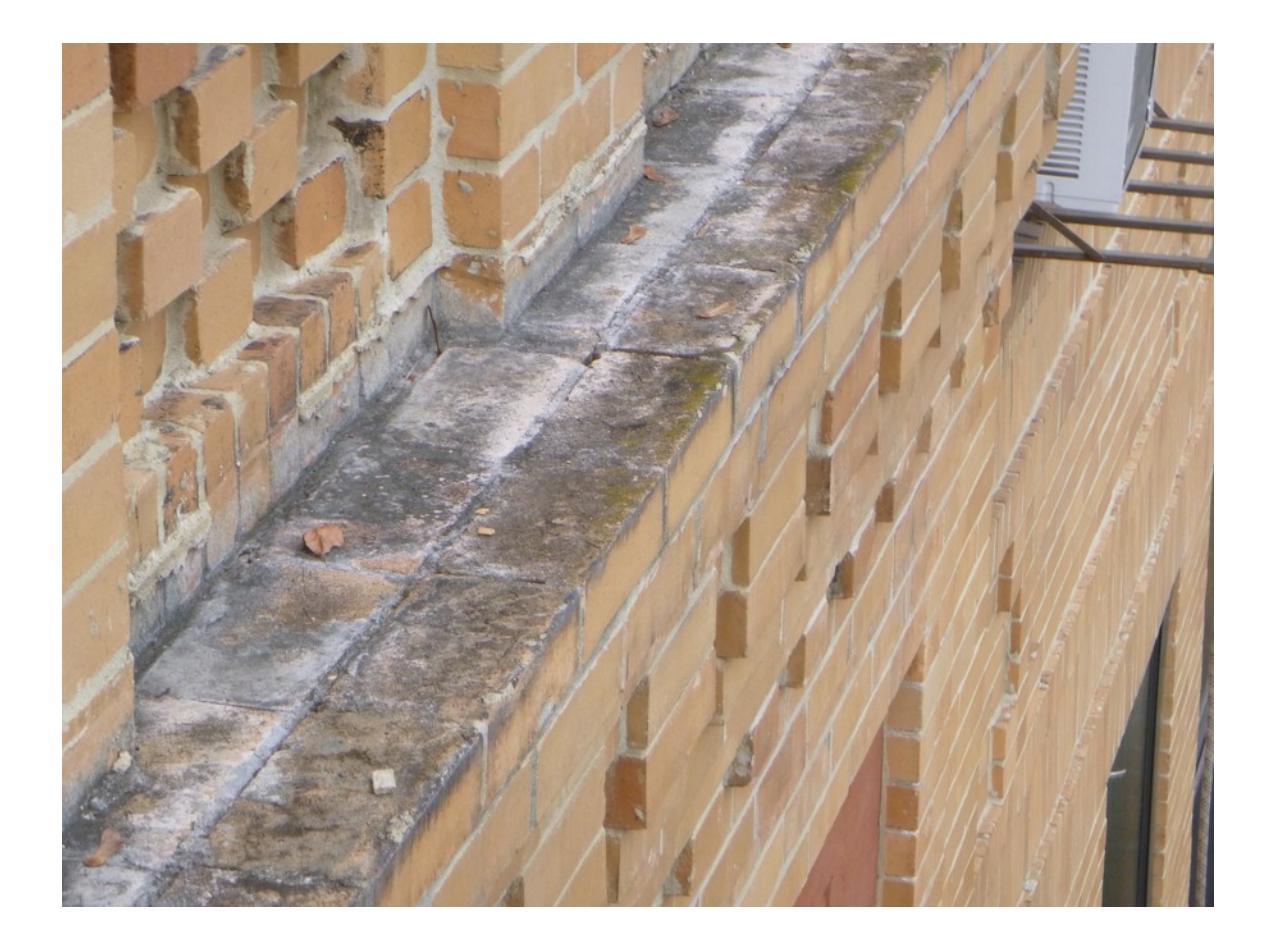
Photo: 51-21 Brick\_SoilStain Biological 2023-1.jpg Material: Brick Category: Soiled Biological Condition: Biological TPAS Code: Bio Autocad Layer: Brick\_SoilStain Severity Units: Not Applicable Amount Units: Area affected in square feet

Microbiological plant growth on the surface of masonry, such as algae, moss or lichen, or vascular plant growth, typically in gutters, cracks or on roofs.

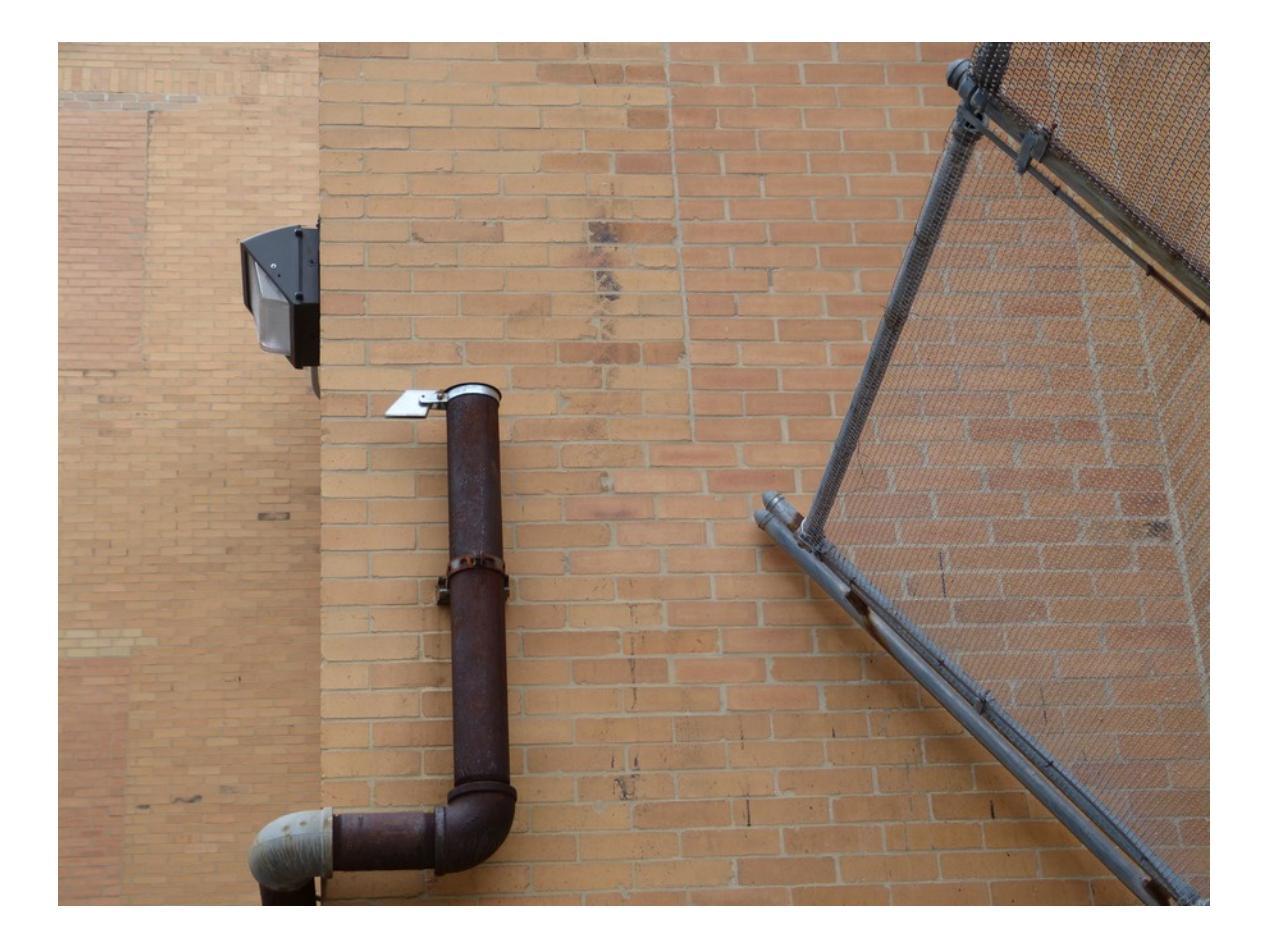
Photo: 431-20 Brick\_SoilStain Bituminous 2023-1.jpg Material: Brick Category: Soiled Bituminous Condition: Bituminous TPAS Code: Bit Autocad Layer: Brick\_SoilStain Severity Units: Not Applicable Amount Units: Area affected in square feet

Surface soiling on masonry from bituminous (hydrocarbon derived from crude oil) roofing or flashing materials.

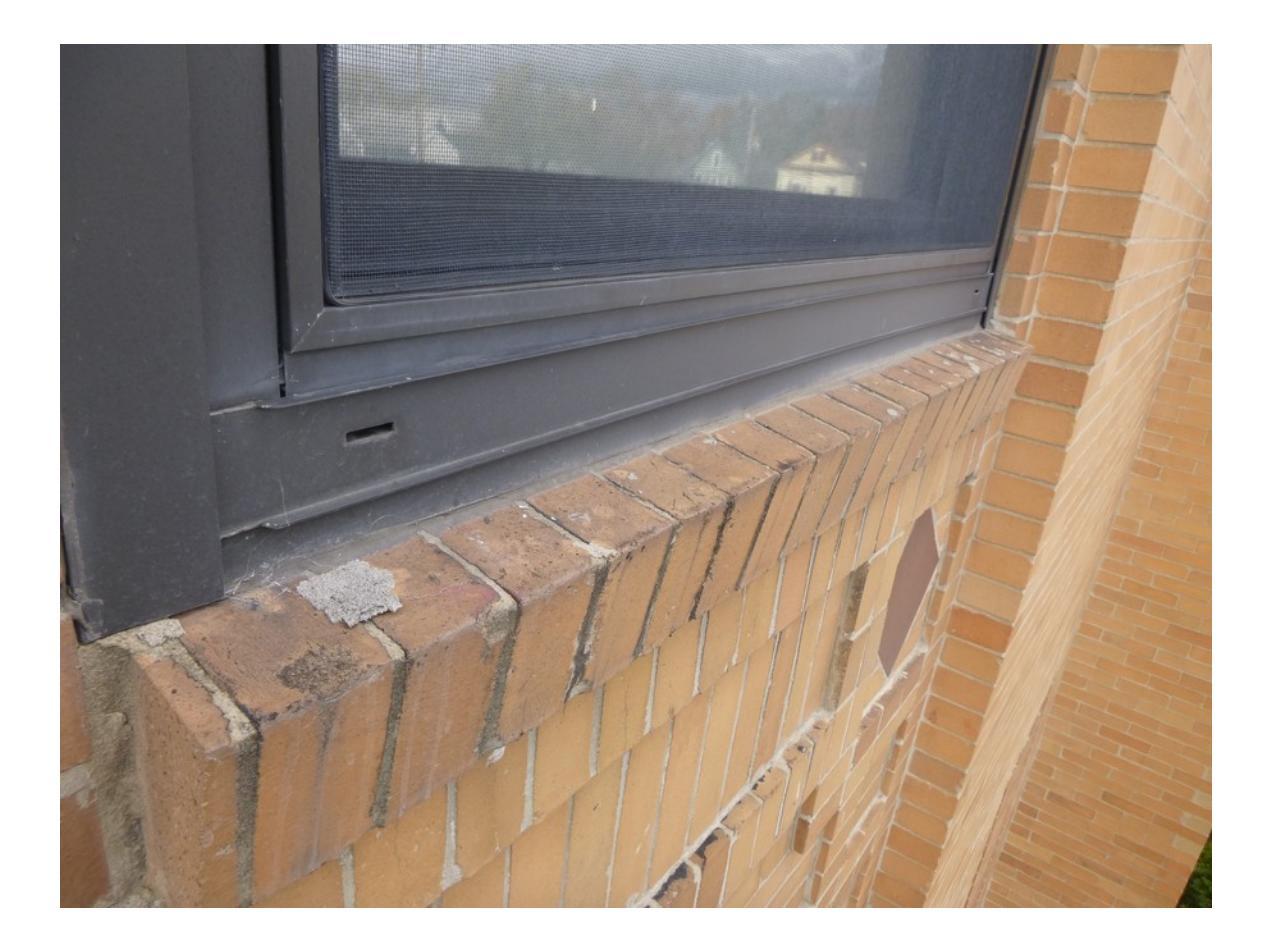
Photo: 60-22 Brick\_SoilStain Cementitious 2023-4.jpg Material: Brick Category: Soiled Cementitious Condition: Cementitious TPAS Code: Cem Autocad Layer: Brick\_SoilStain Severity Units: Not Applicable Amount Units: Area affected in square feet

Cementitious accretions and accumulations on the surface of masonry units resulting from repointing or patch repairs.

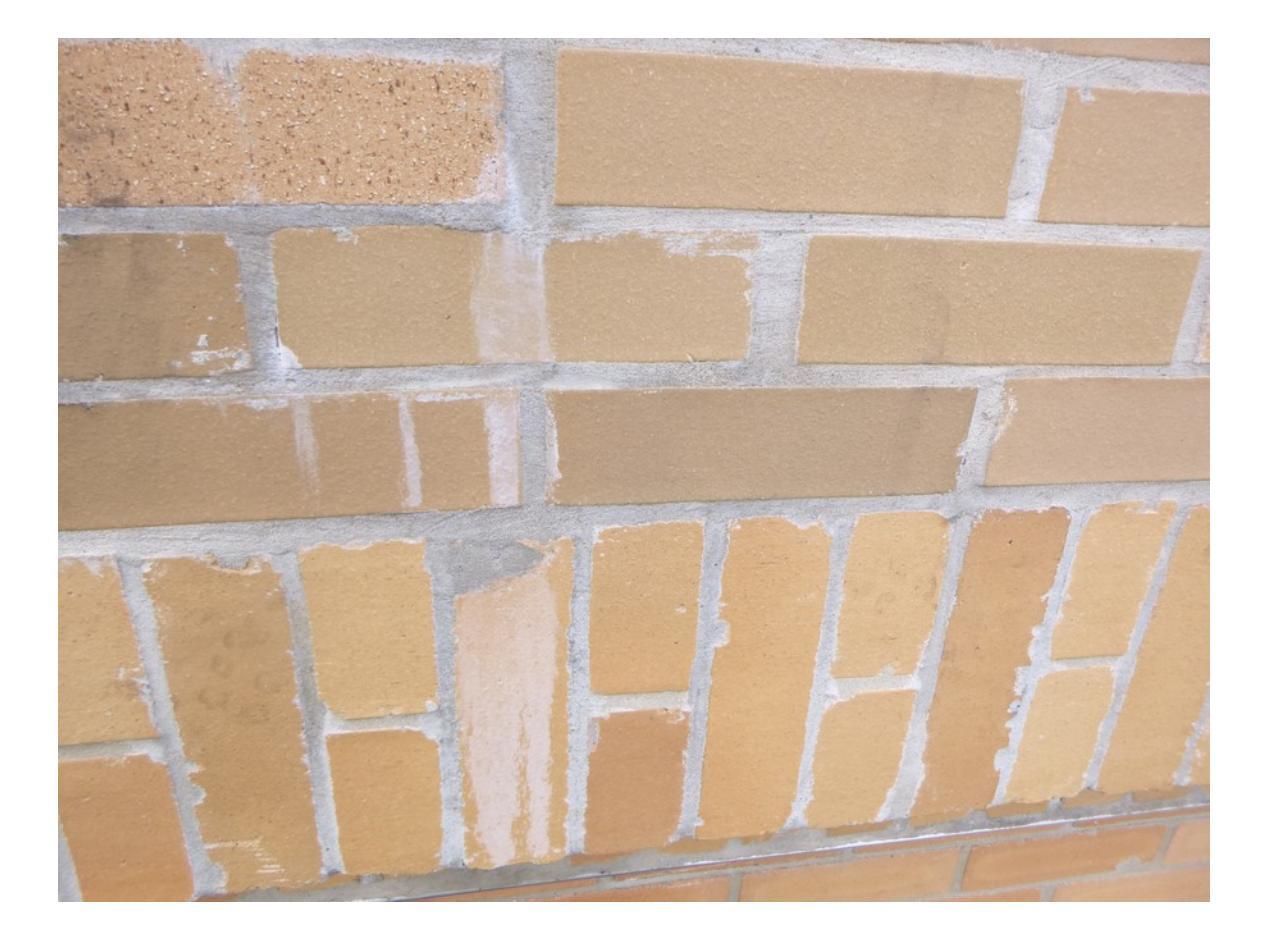
Photo: 36-33 Brick\_SoilStain Efflorescence 2023-1.jpg Material: Brick Category: Soiled Efflorescence Condition: Efflorescence TPAS Code: Eff Autocad Layer: Brick\_SoilStain Severity Units: Not Applicable Amount Units: Area affected in square feet

White, soft deposition on the surface of masonry due to evaporative precipitation of salts. When this process occurs below the surface of the masonry unit (subflorescence), it is revealed at areas of exfoliation or spalling.

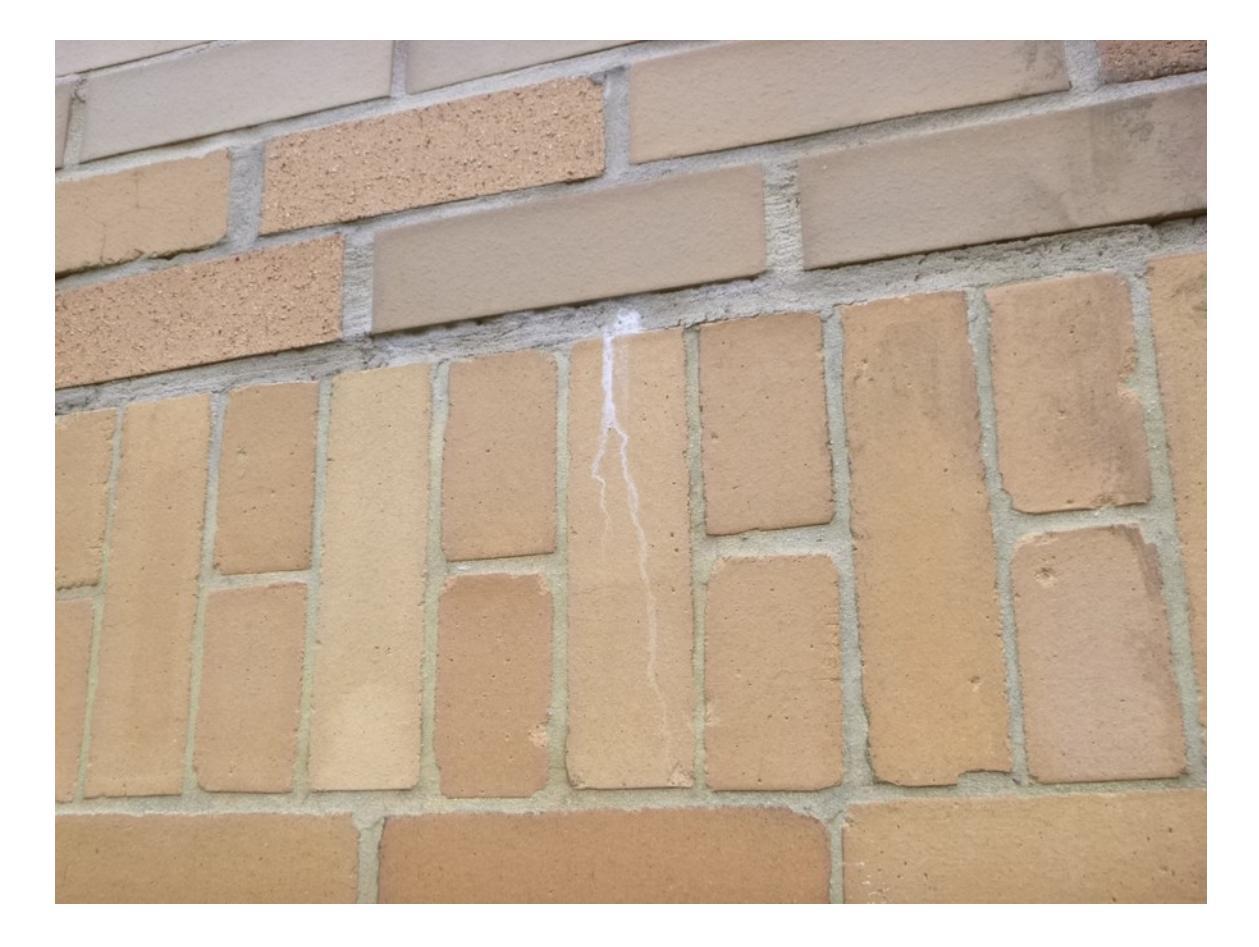
Photo: 674-32 Brick\_SoilStain Leached Salts 2023-1.jpg Material: Brick Category: Soiled Leached Salts Condition: Leached Salts TPAS Code: Lch Autocad Layer: Brick\_SoilStain Severity Units: Not Applicable Amount Units: Area affected in square feet

Hard encrustations or deposits of salts on the surface of masonry, typically caused by salts being leached out of the mortar or back-up masonry through the effects of moisture.

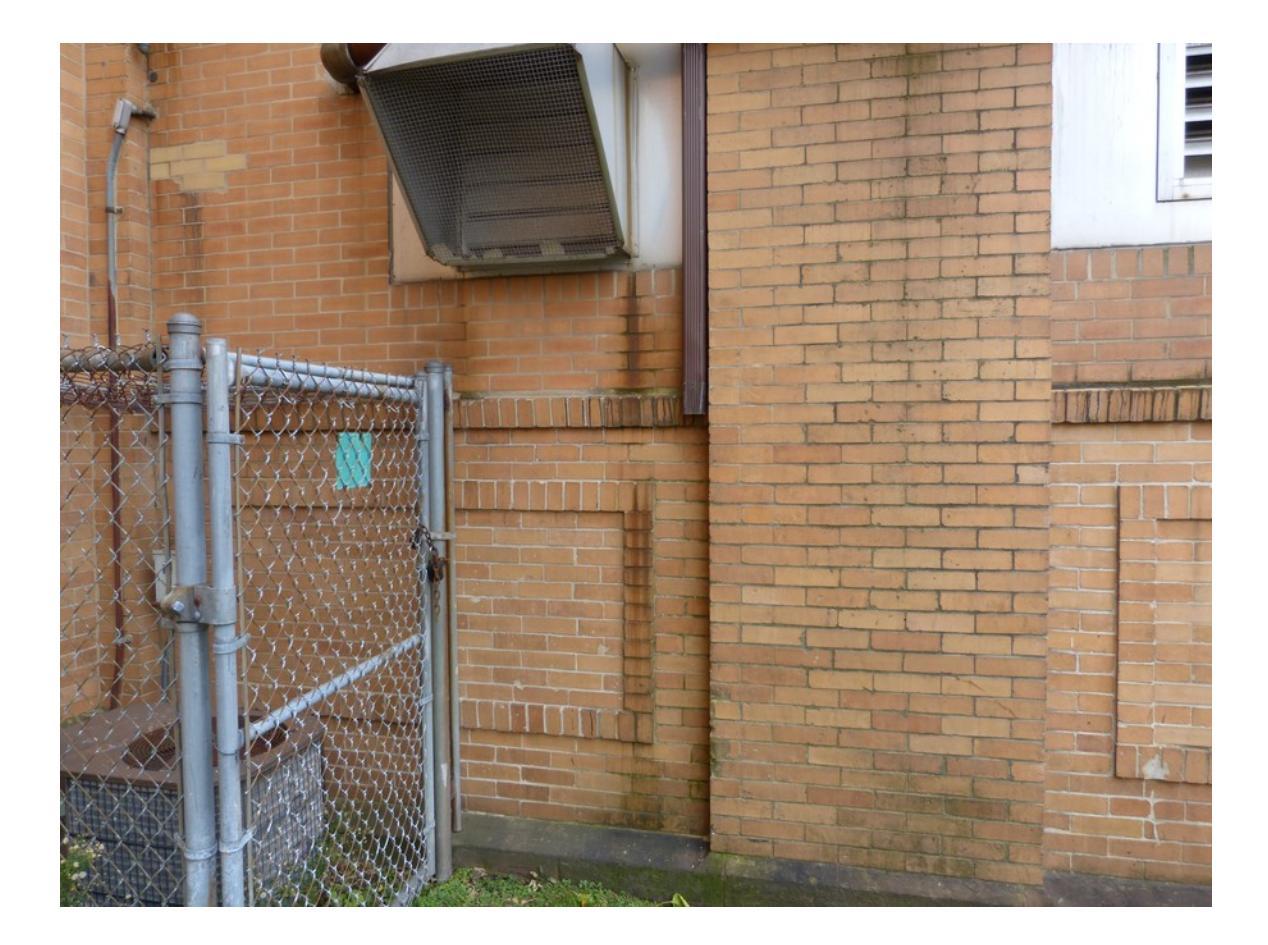
Photo: 241-14 Brick\_SoilStain Rust 2023-1.jpg Material: Brick Category: Soiled Rust Condition: Rust TPAS Code: Rst Autocad Layer: Brick\_SoilStain Severity Units: Not Applicable Amount Units: Area Affected in square feet

Orange brown iron-based stains, typically appearing as streaks below steel or cast iron fasteners or elements.

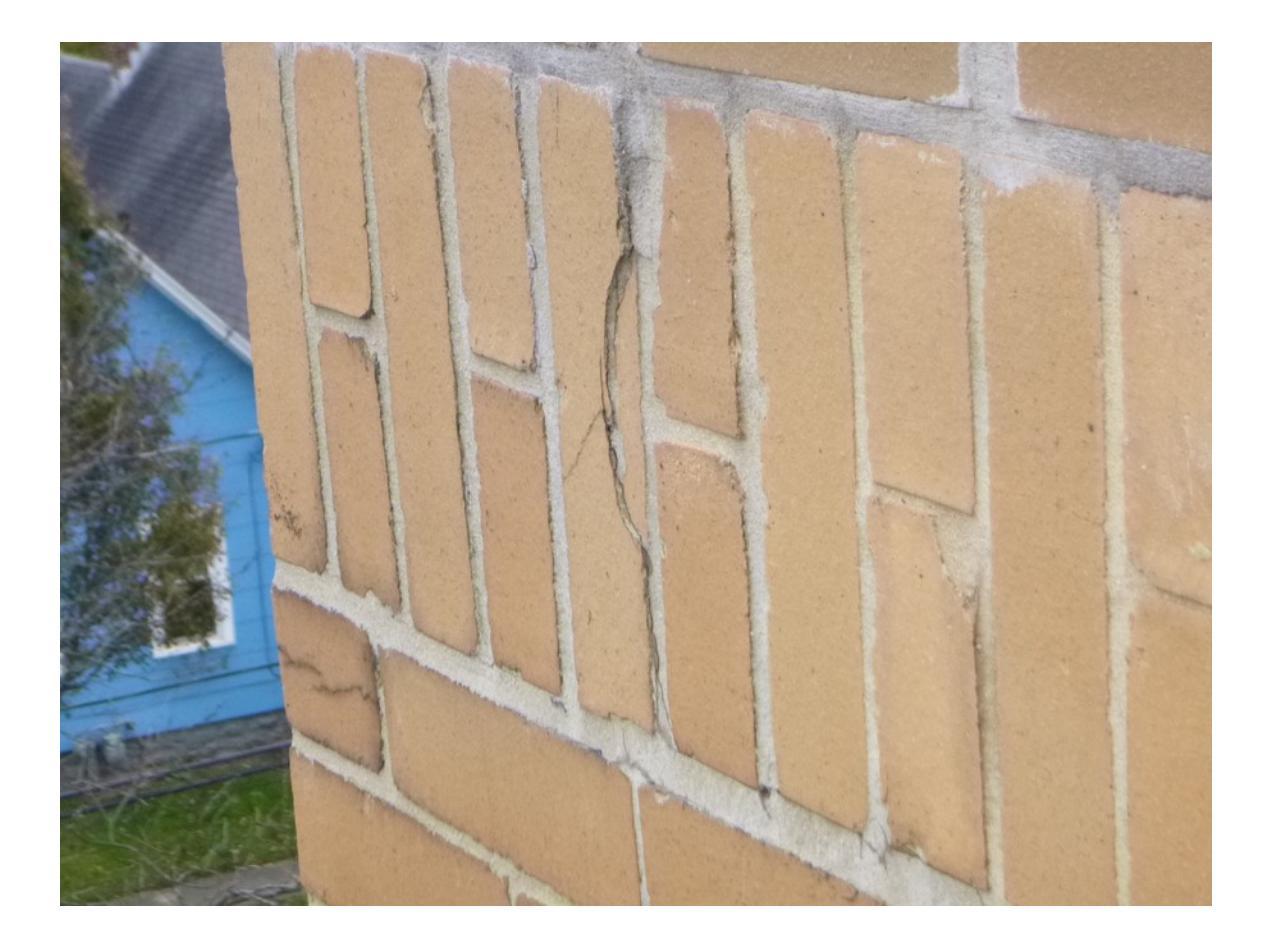
Photo: 206-34 Brick\_Spall Bonded 2023-2.jpg Material: Brick Category: Spall Bonded Condition: Bonded TPAS Code: B Autocad Layer: Brick\_Spall Severity Units: Not Applicable Amount Units: Size in square inches

Piece of material dislodged from a masonry unit by excessive stress that appears, based on visual inspection and sounding with a mallet where possible, to be solidly attached to the substrate, typically by means of mortar or adhesive.
