## ADDENDUM #1

RE: Rochester Housing Authority

## Jonathan Child Apartments Façade Repairs

## TRAUTMAN ASSOCIATES ROCHESTER HOUSING AUTHORITY JONATHAN CHILD APARTMENTS MASONRY RECONSTRUCTION TA PROJECT No. 24042

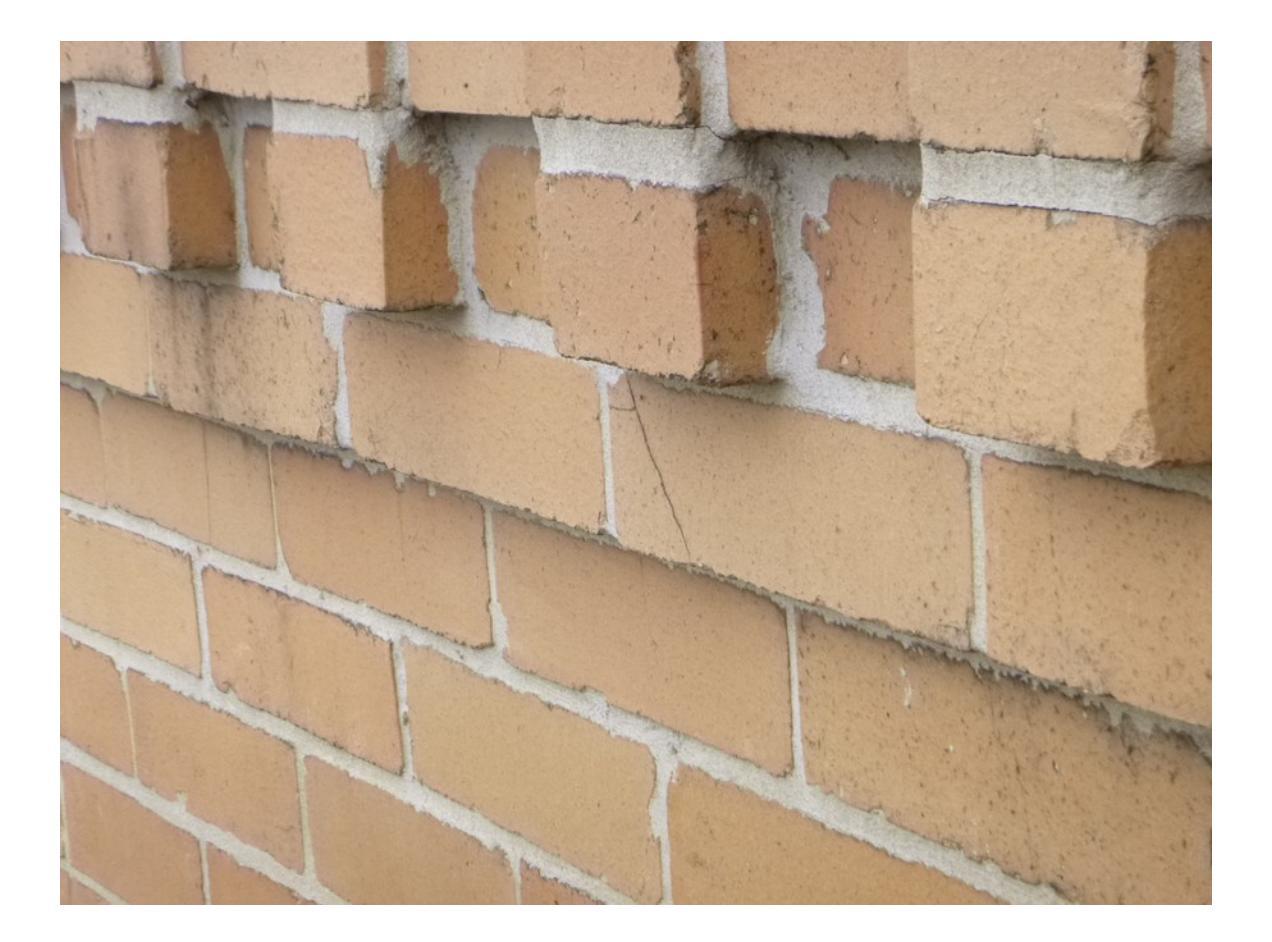
Photo: 216-34 Brick\_Spall Incipient 2023-1.jpg Material: Brick Category: Spall Incipient Condition: Incipient TPAS Code: I Autocad Layer: Brick\_Spall Severity Units: Not Applicable Amount Units: Size in square inches

Partially formed spall that appears to be well attached.

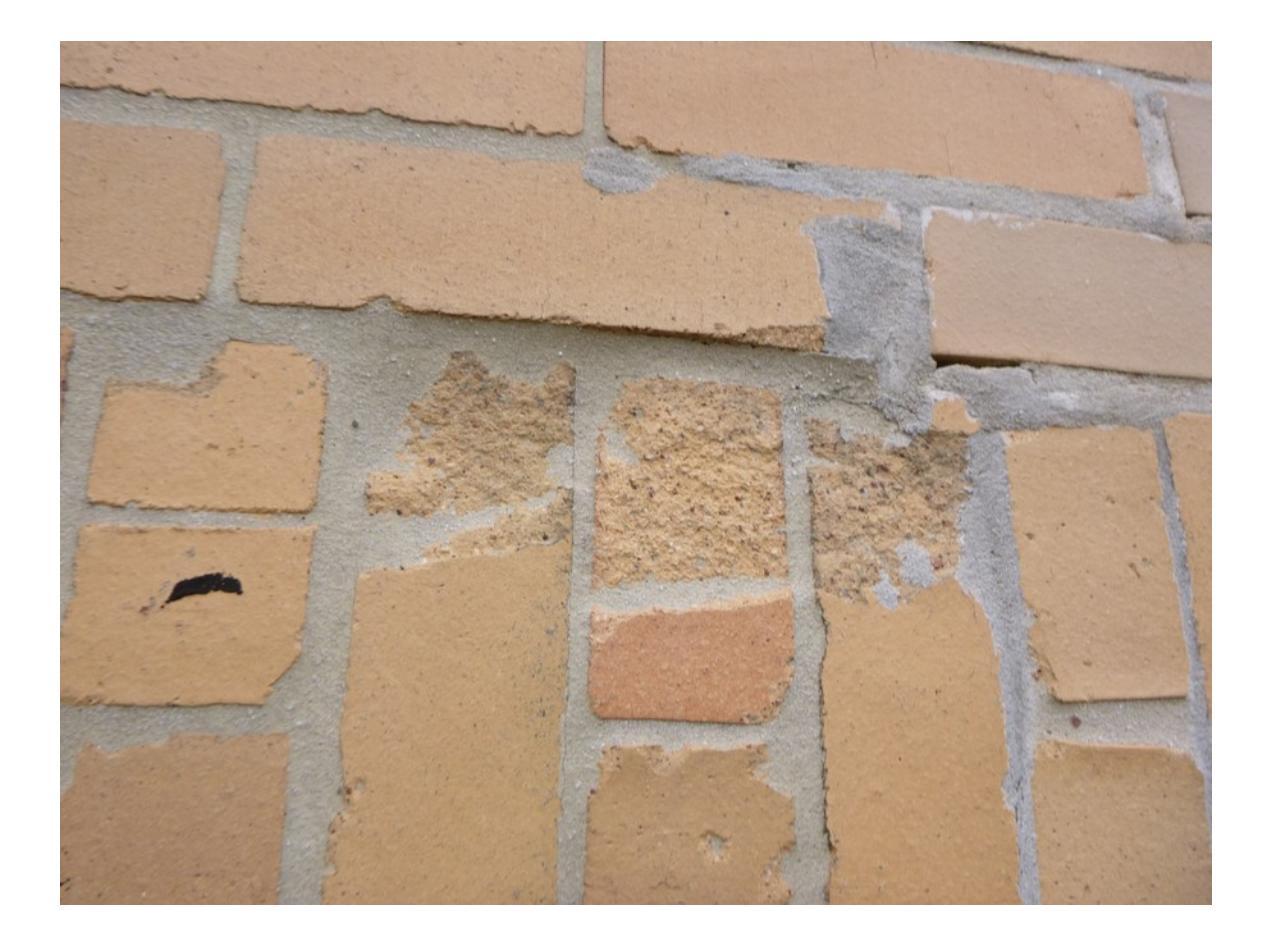
Photo: 230-33 Brick\_Spall Missing 2023-1.jpg Material: Brick Category: Spall Missing Condition: Missing TPAS Code: M Autocad Layer: Brick\_Spall Severity Units: Not Applicable Amount Units: Size in square inches

The location of a spall that is no longer in situ at the time of the investigation, with no steel evident.

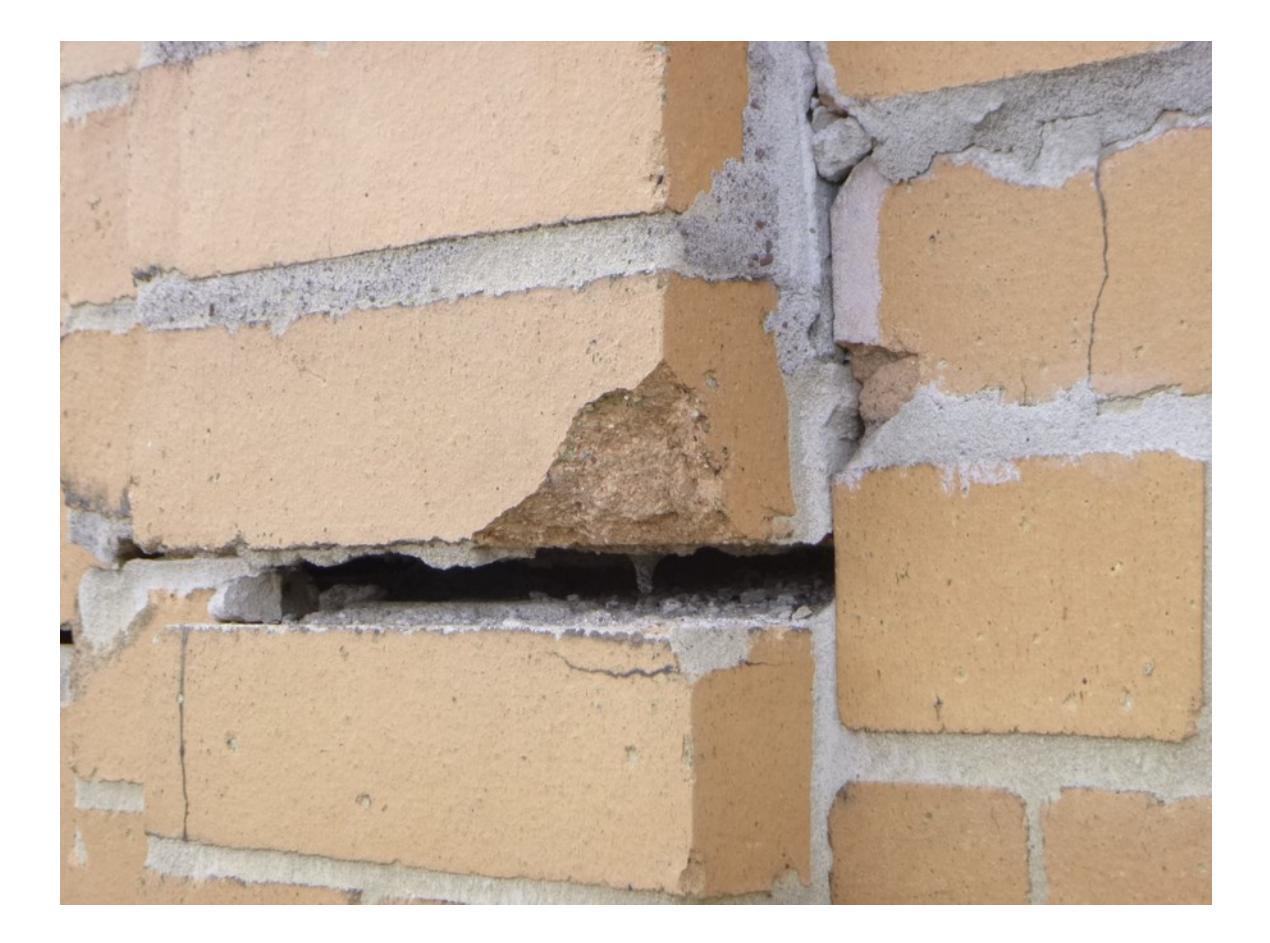
Photo: 52-33 Brick\_Spall Removed 2023-2.jpg Material: Brick Category: Spall Removed Condition: Removed TPAS Code: R Autocad Layer: Brick\_Spall Severity Units: Not Applicable Amount Units: Size in square inches

The location of a spall that was taken from the building at the time of the investigation, with no steel evident.

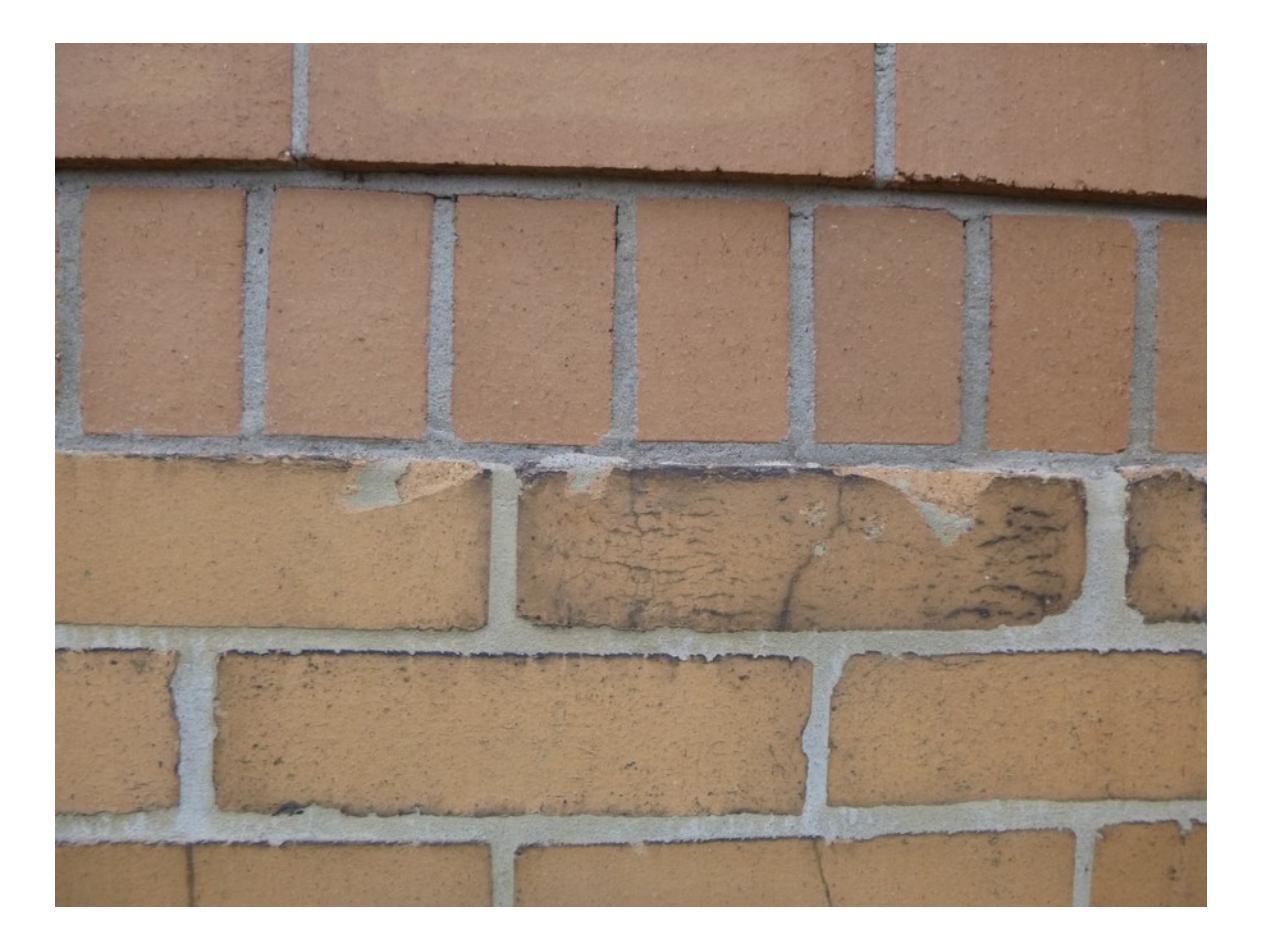
Photo: 67-30 Brick\_SurfLoss Chipped 2023-2.jpg Material: Brick Category: Surface Chipped Condition: Chipped TPAS Code: Chp Autocad Layer: Brick\_SurfLoss Severity Units: Depth of loss in 1/8 inch increments Amount Units: Area affecrted in square feet

Shallow loss of material, typically at the edges of the masonry unit.

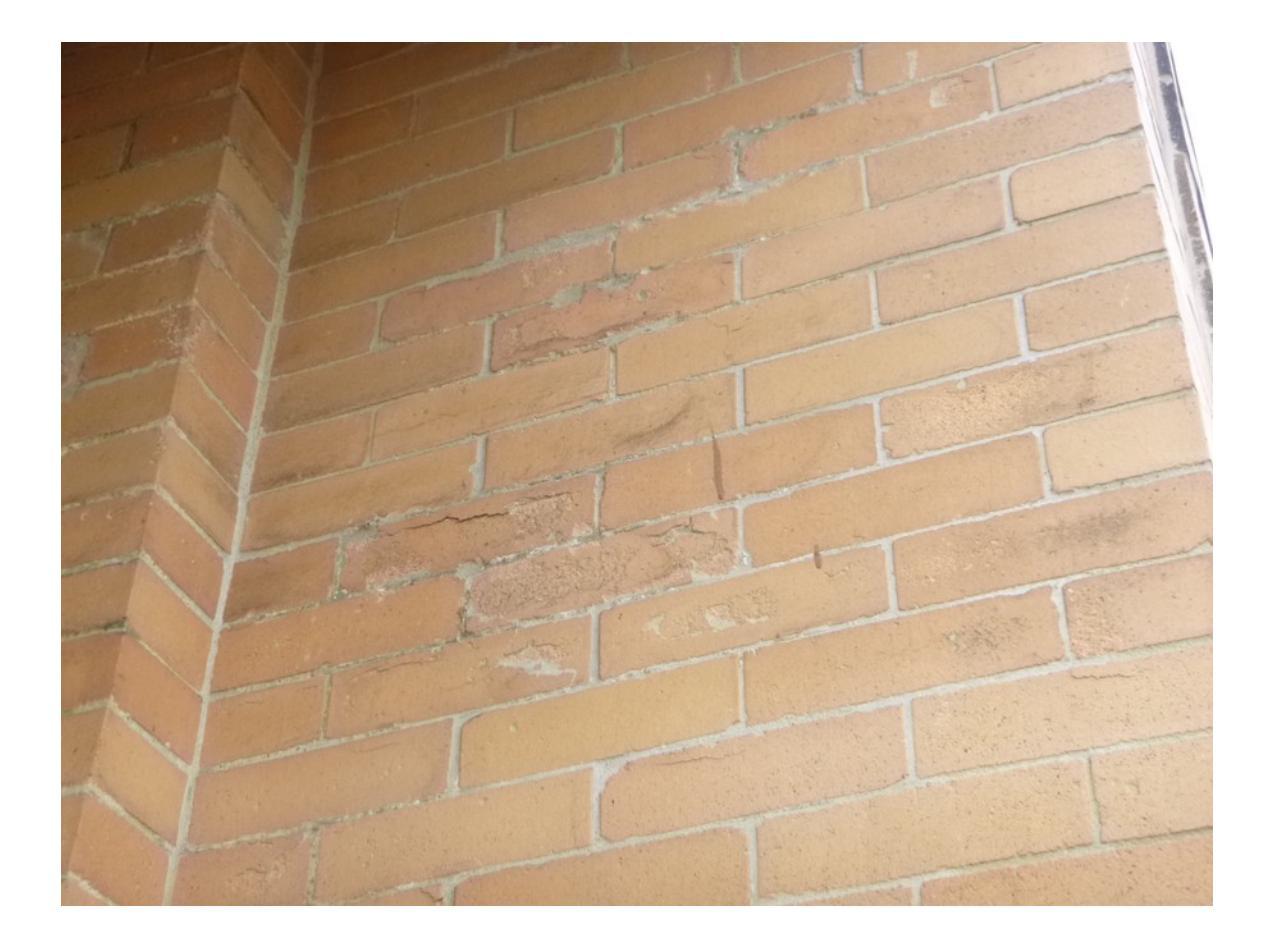
Photo: 223-17 Brick\_SurfLoss Eroded 2023-1.jpg Material: Brick Category: Surface Eroded Condition: Eroded TPAS Code: Erd Autocad Layer: Brick\_SurfLoss Severity Units: Depth of loss in 1/8 inch increments Amount Units: Area affected in square feet

Loss of material at the surface of the masonry unit, typically due to scouring by wind or rain.

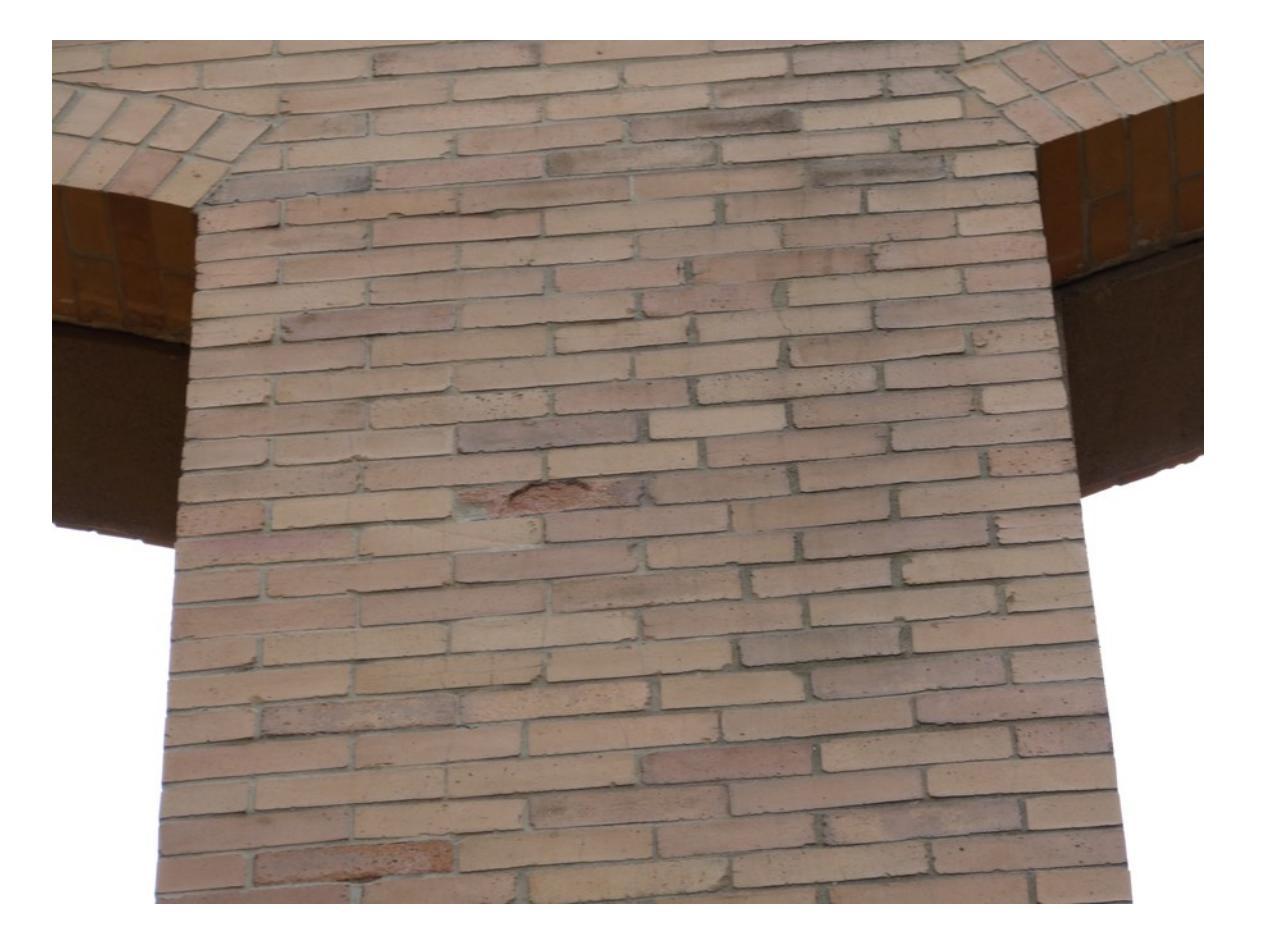
Photo: 249-29 Brick\_SurfLoss Face spalled 2023-1.jpg Material: Brick Category: Surface Face Spall Condition: Face Spall TPAS Code: Fce Autocad Layer: Brick\_SurfLoss Severity Units: Depth of loss in 1/8 inch increments Amount Units: Area affected in square feet

Loss of outer surface of masonry unit in layers.

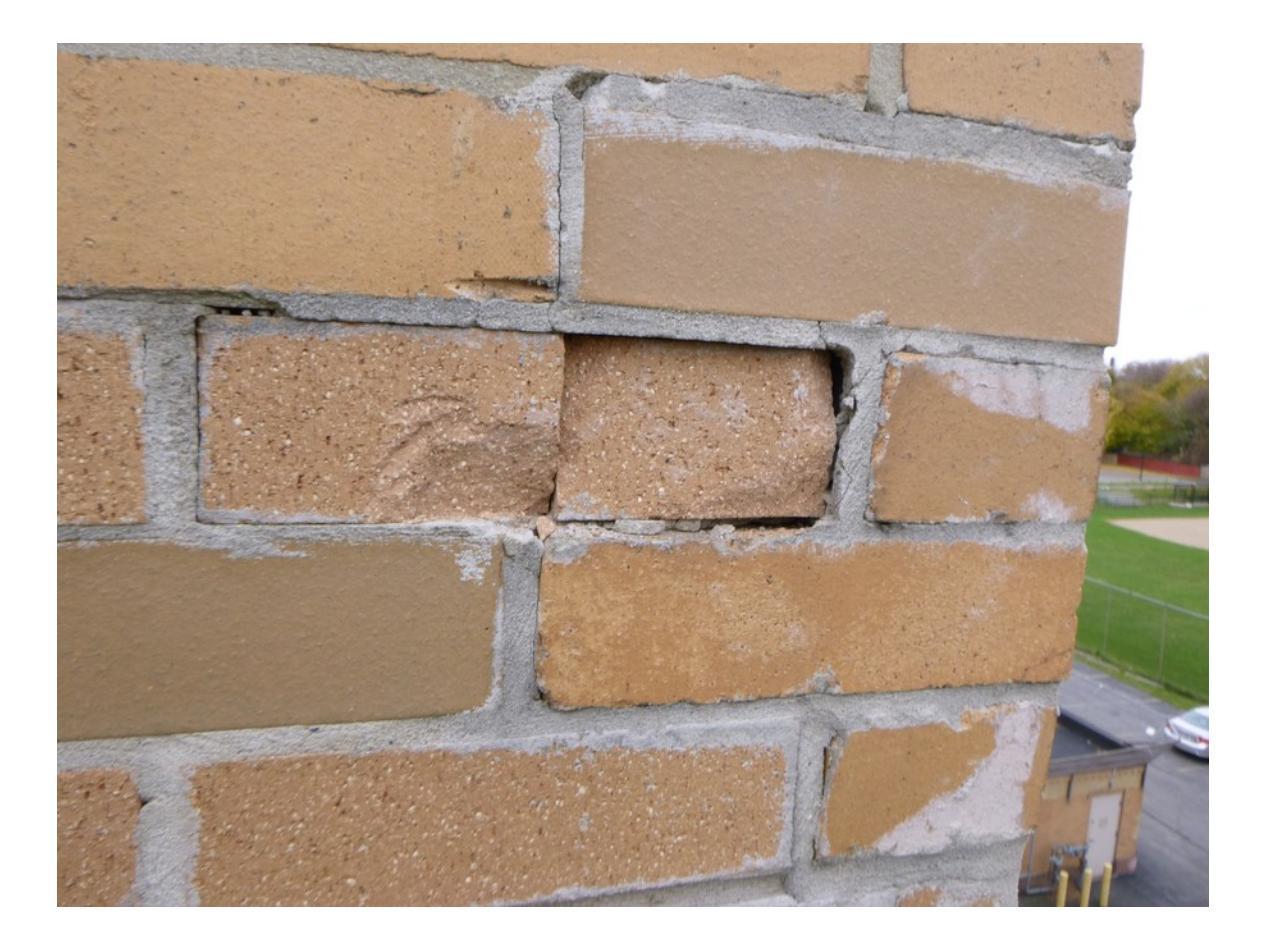
Photo: 244-36 Brick\_Unsecured Hollow 2023-1.jpg Material: Brick Category: Unsecured Hollow Condition: Hollow TPAS Code: H Autocad Layer: Brick\_Unsecured Severity Units: Not Applicable Amount Units: Area in square feet

Area of masonry that appears to have a void behind the intact surface or face brick, based on sounding with a mallet.

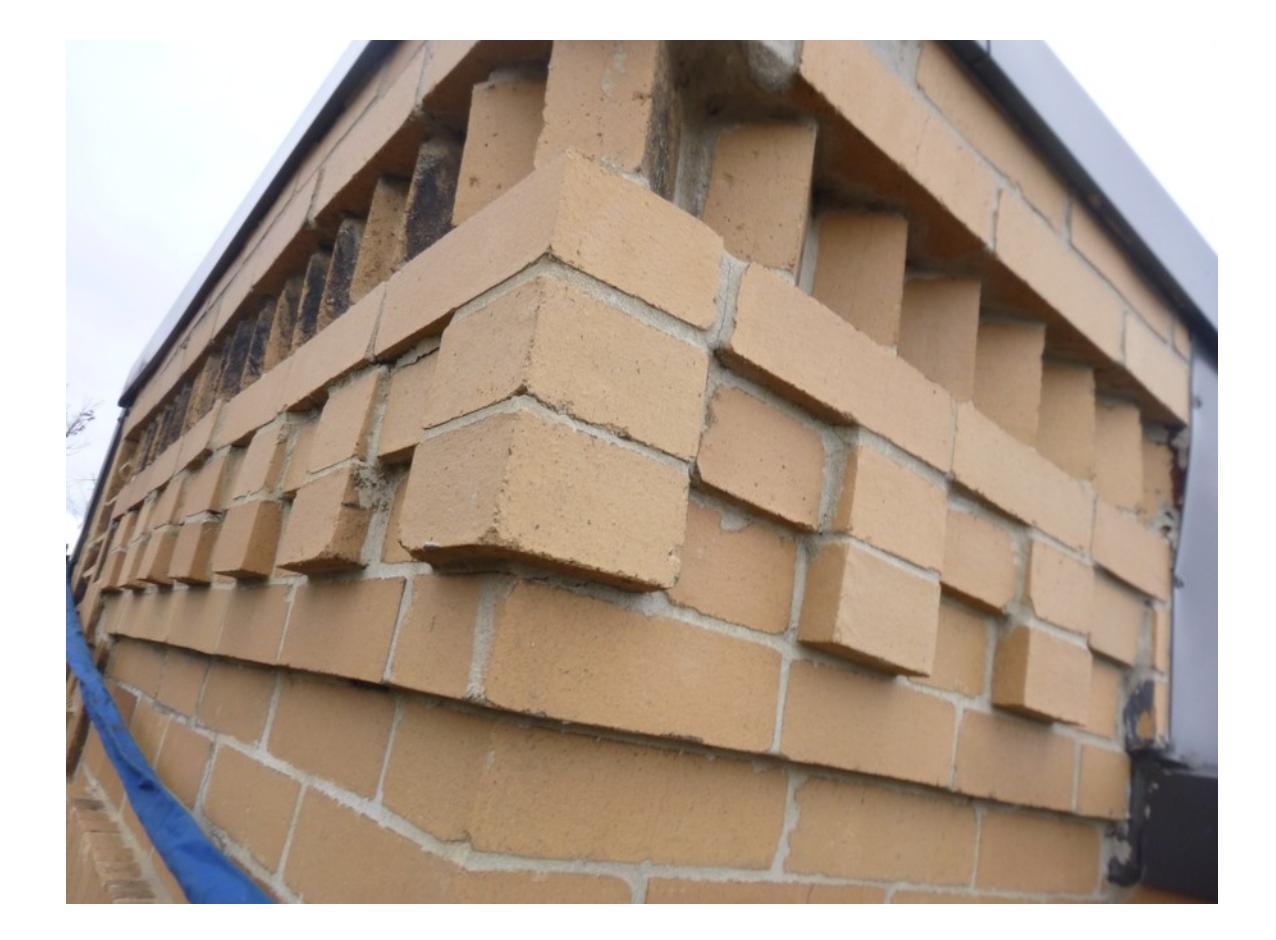
Photo: 28-36 Brick\_Unsecured Loose 2023-1.jpg Material: Brick Category: Unsecured Loose Condition: Loose TPAS Code: L Autocad Layer: Brick\_Unsecured Severity Units: Not Applicable Amount Units: Area in square feet

Area of masonry that can be moved by hand or when sounded with a mallet due to a loss of its construction integrity, but which is not removed during the investigation.

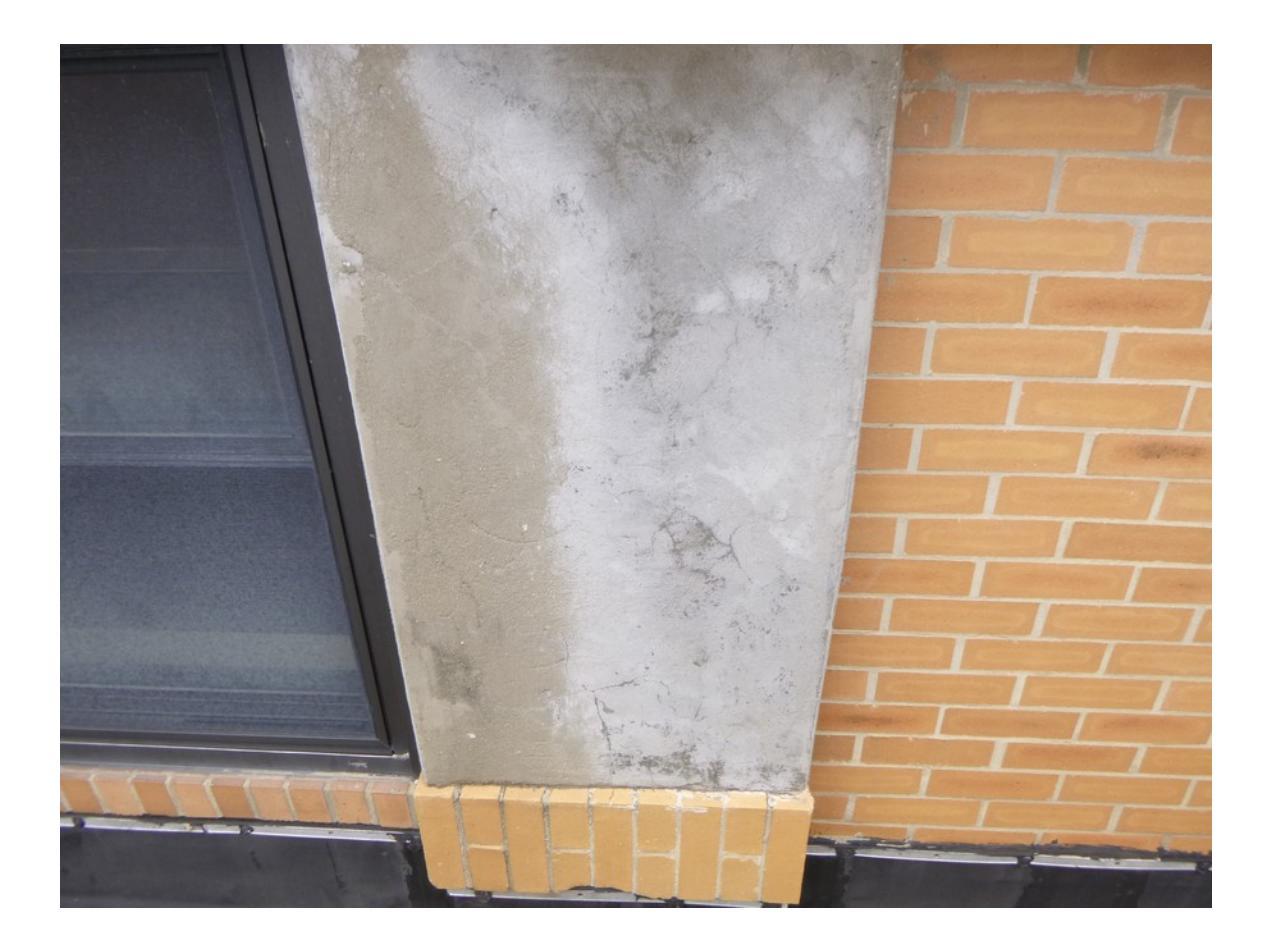
Photo: 447-28 Concrete\_Crack Crazing 2023-2.jpg Material: Concrete Category: Crazing Condition: Crazing TPAS Code: Crz Autocad Layer: Concrete\_Crack Severity Units: Width in 1/16 inch increments Amount Units: Area affected in square feet

Small cracks, typically hairline in width and random in pattern, at the concrete surface.

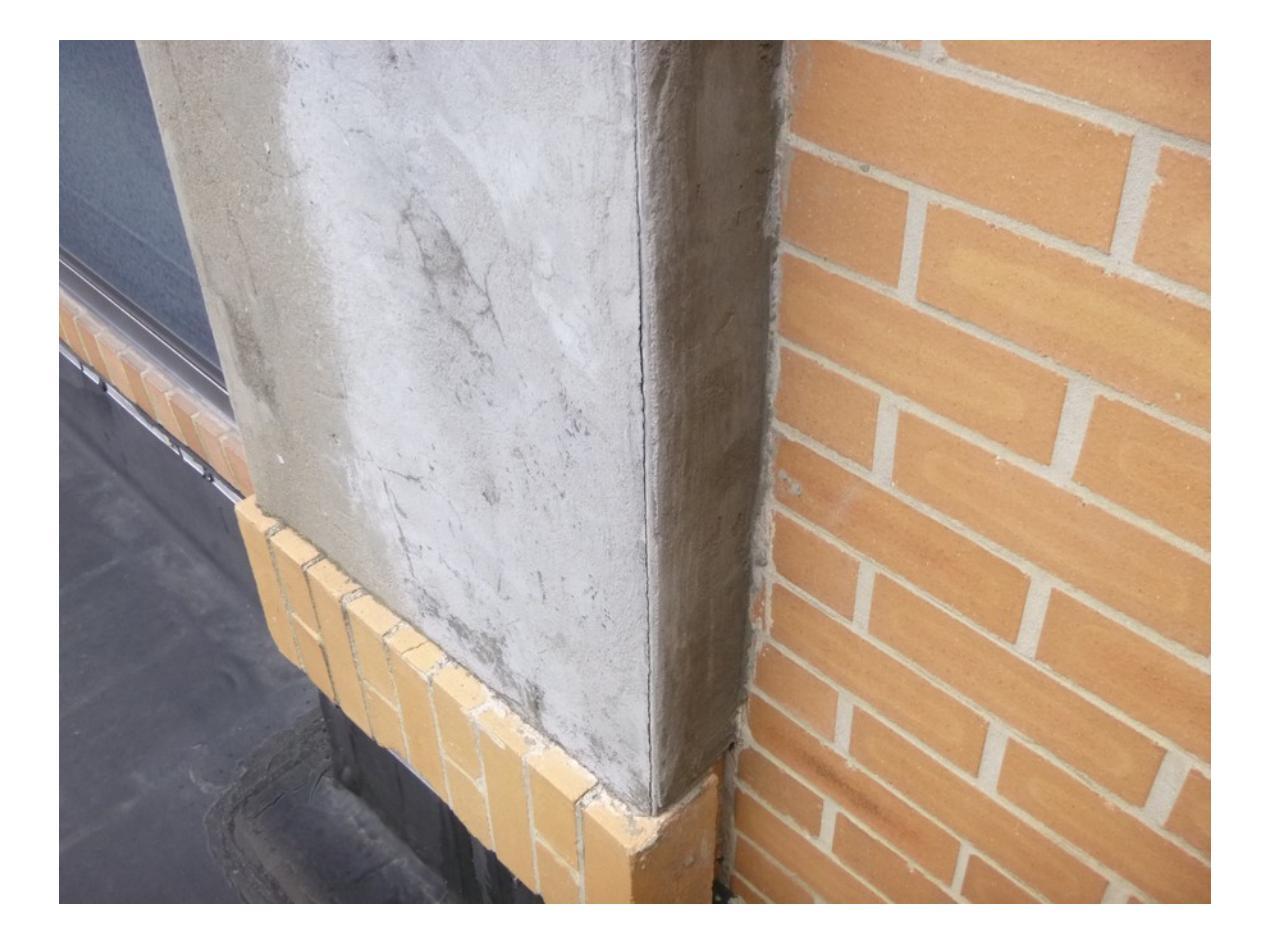
Photo: 445-29 Concrete\_Crack Single unit 2023-1.jpg Material: Concrete Category: Crack Single Unit Condition: Single Unit TPAS Code: C Autocad Layer: Concrete\_Crack Severity Units: Crack Width in 1/16 inch increments Amount Units: Length in lineal feet

A crack visible at the surface of the concrete or through a single cast unit.

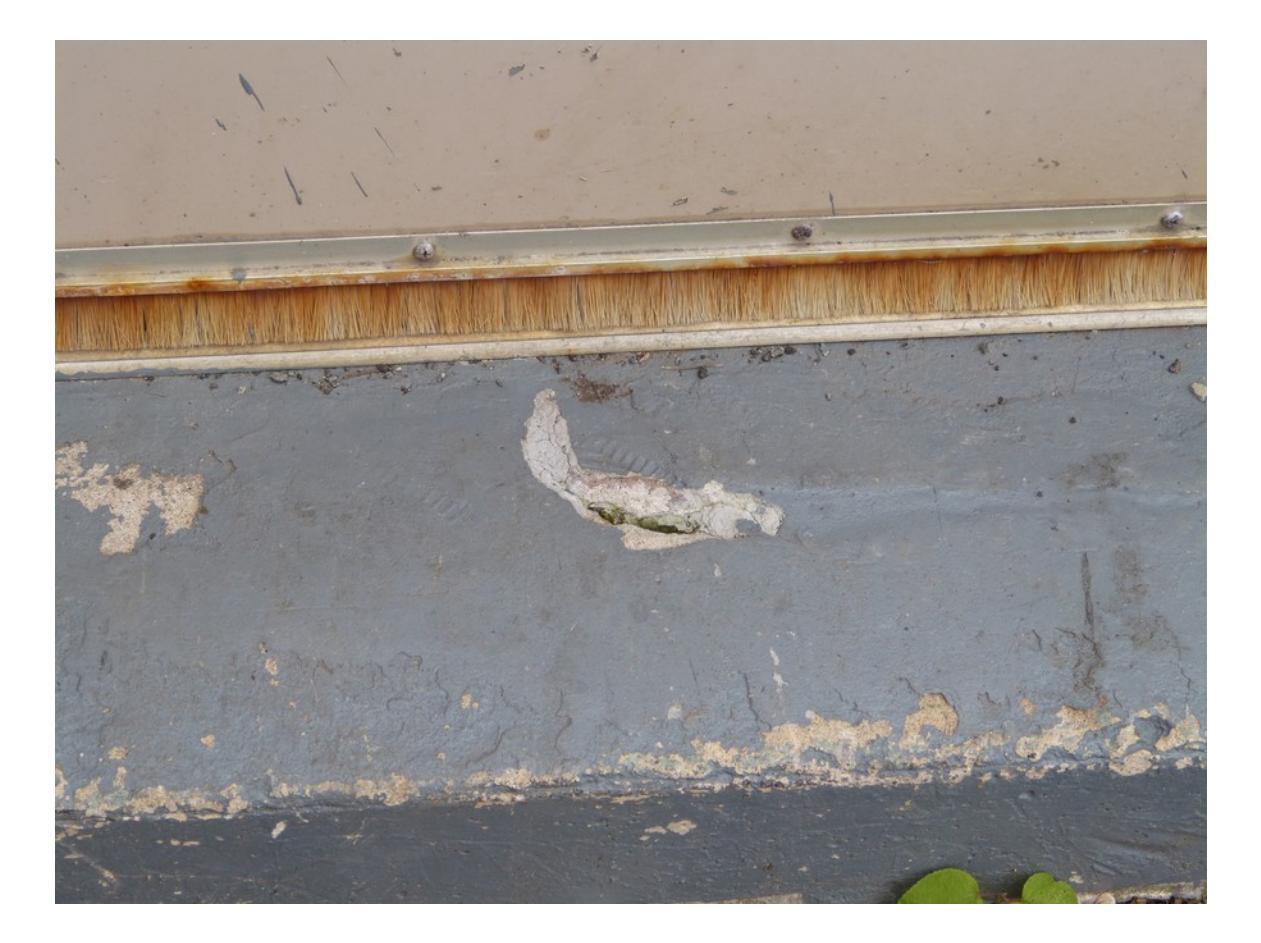
Photo: 254-13 Concrete\_Spall Missing 2023-1.jpg Material: Concrete Category: Spall Missing Condition: Missing TPAS Code: M Autocad Layer: Concrete\_Spall Severity Units: Not applicable Amount Units: Size in square inches

The location of a spall that is no longer in situ at the time of the investigation, with no steel evident.

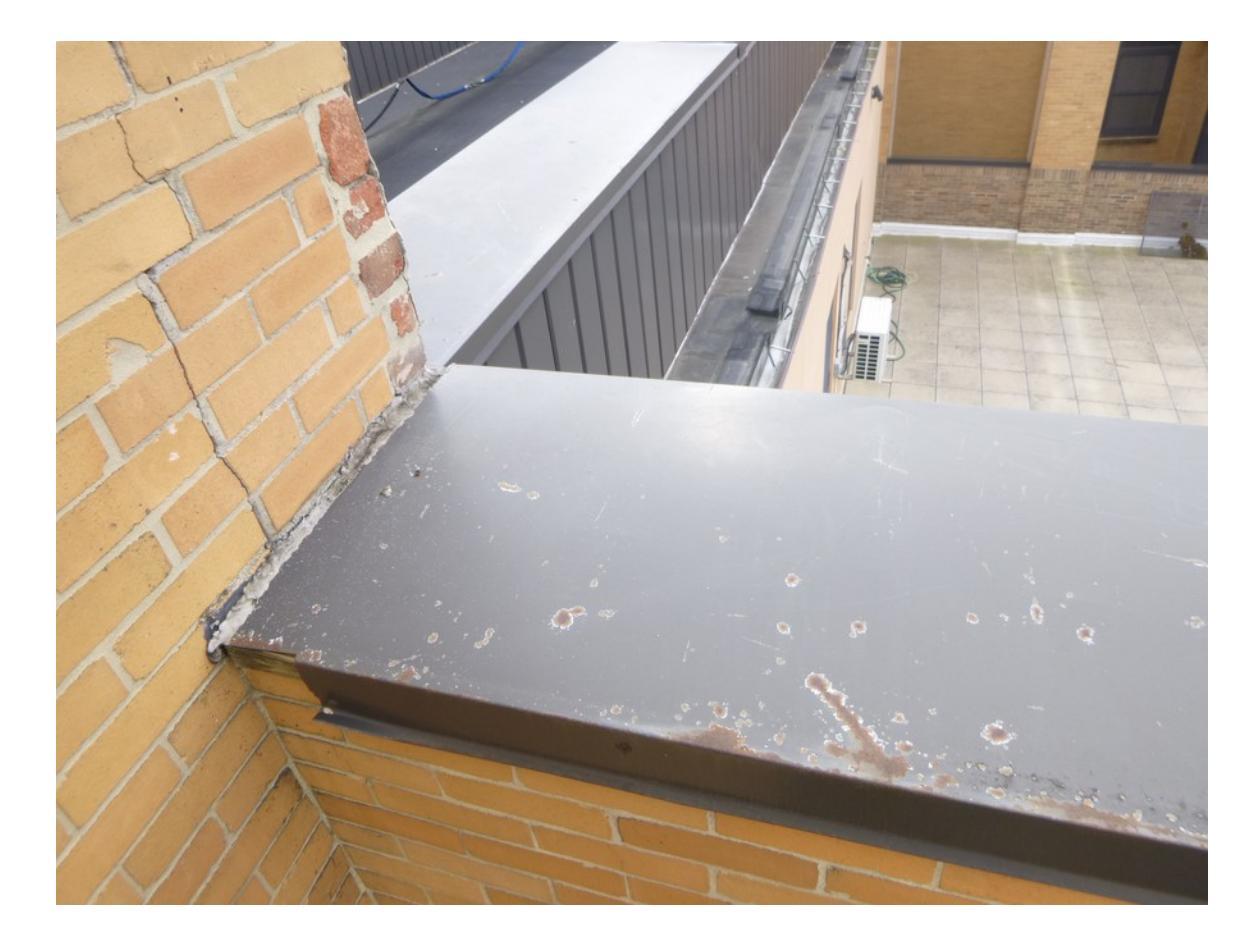
Photo: 430-27 SheetMetal\_Corrosion Surface 2023-1.jpg Material: Sheet Metal Category: Corrosion Surface Condition: Surface TPAS Code: Srf Autocad Layer: SheetMetal\_Corrosion Severity Units: Not applicable Amount Units: Area affected in square feet

Rust on the surface of a metal element, which has not yet resulted in delamination or expansion of the element.

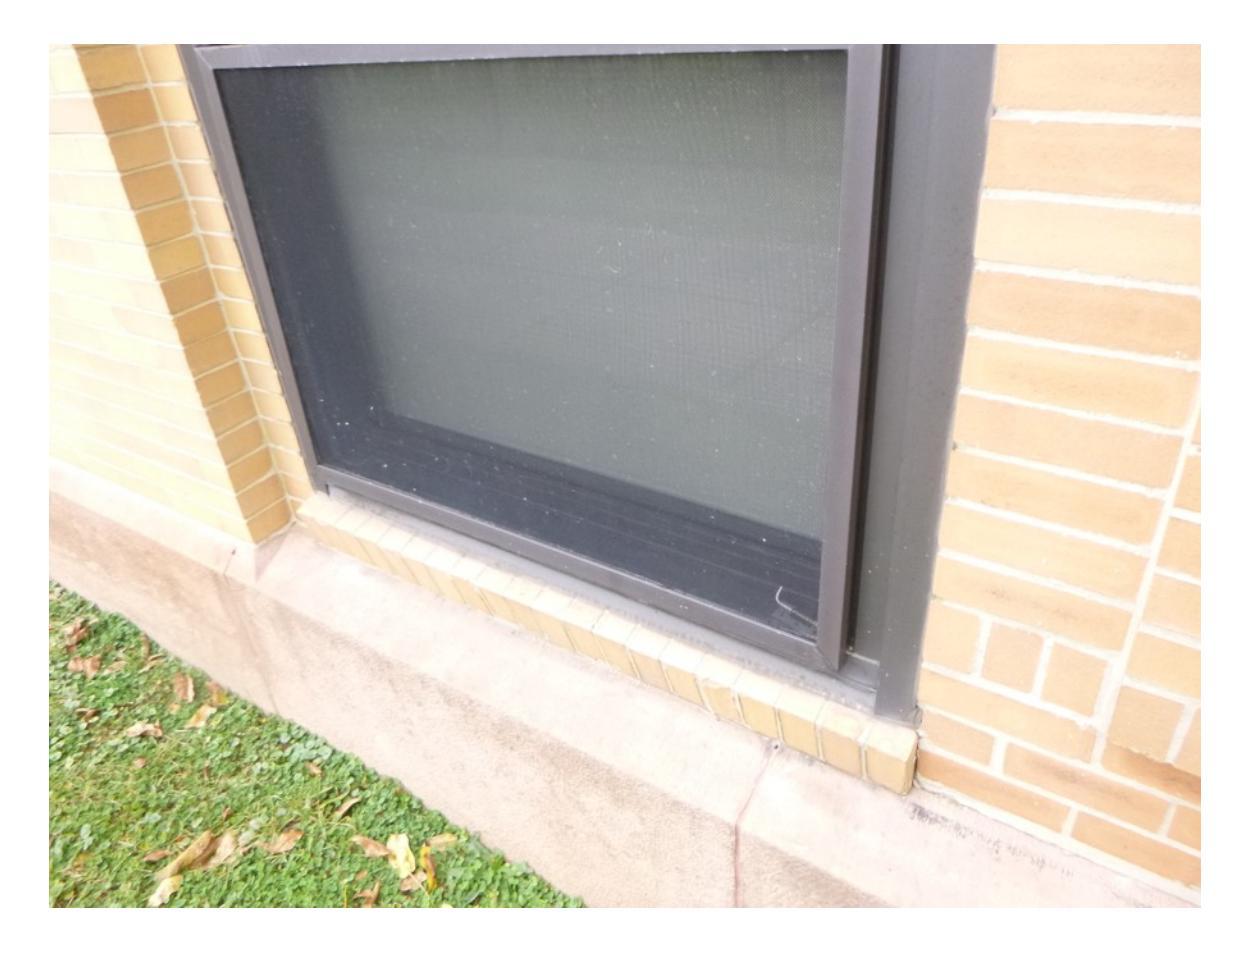
Photo: 628-13 SheetMetal\_Unsecured Loose 2023-1.jpg Material: Sheet Metal Category: Unsecured Loose Condition: Loose TPAS Code: L Autocad Layer: SheetMetal\_Unsecured Severity Units: Not applicable Amount Units: Area in square feet

Metal element or area that can be moved by hand or when sounded with a mallet due to its loss of construction integrity.

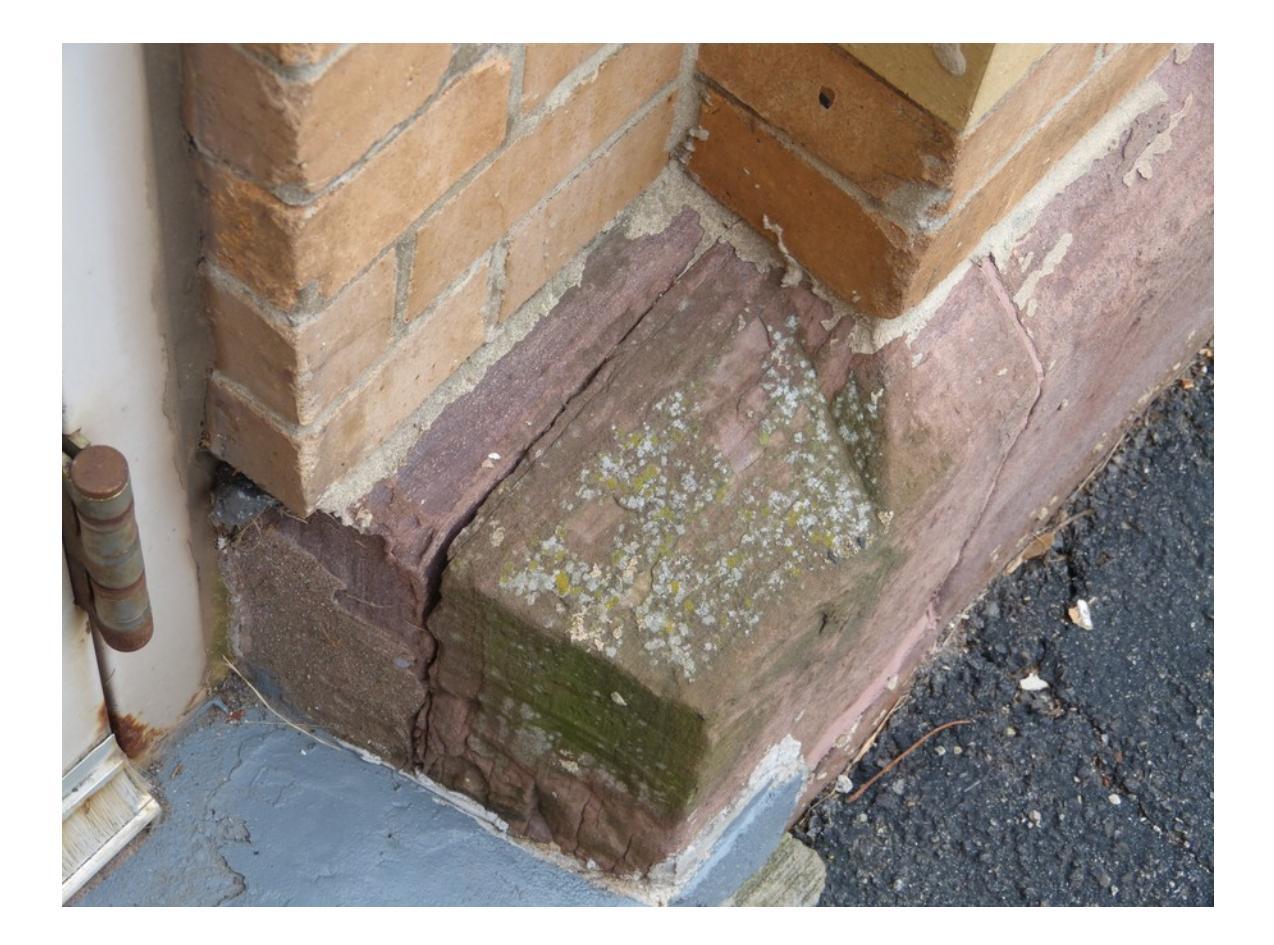
Photo: 255-15 Stone\_Crack Single unit 2023-1.jpg Material: Stone Category: Crack Single Unit Condition: Single Unit TPAS Code: C Autocad Layer: Stone\_Crack Severity Units: Width in 1/16 inch increments Amount Units: Length in lineal feet

A crack through a single unit.

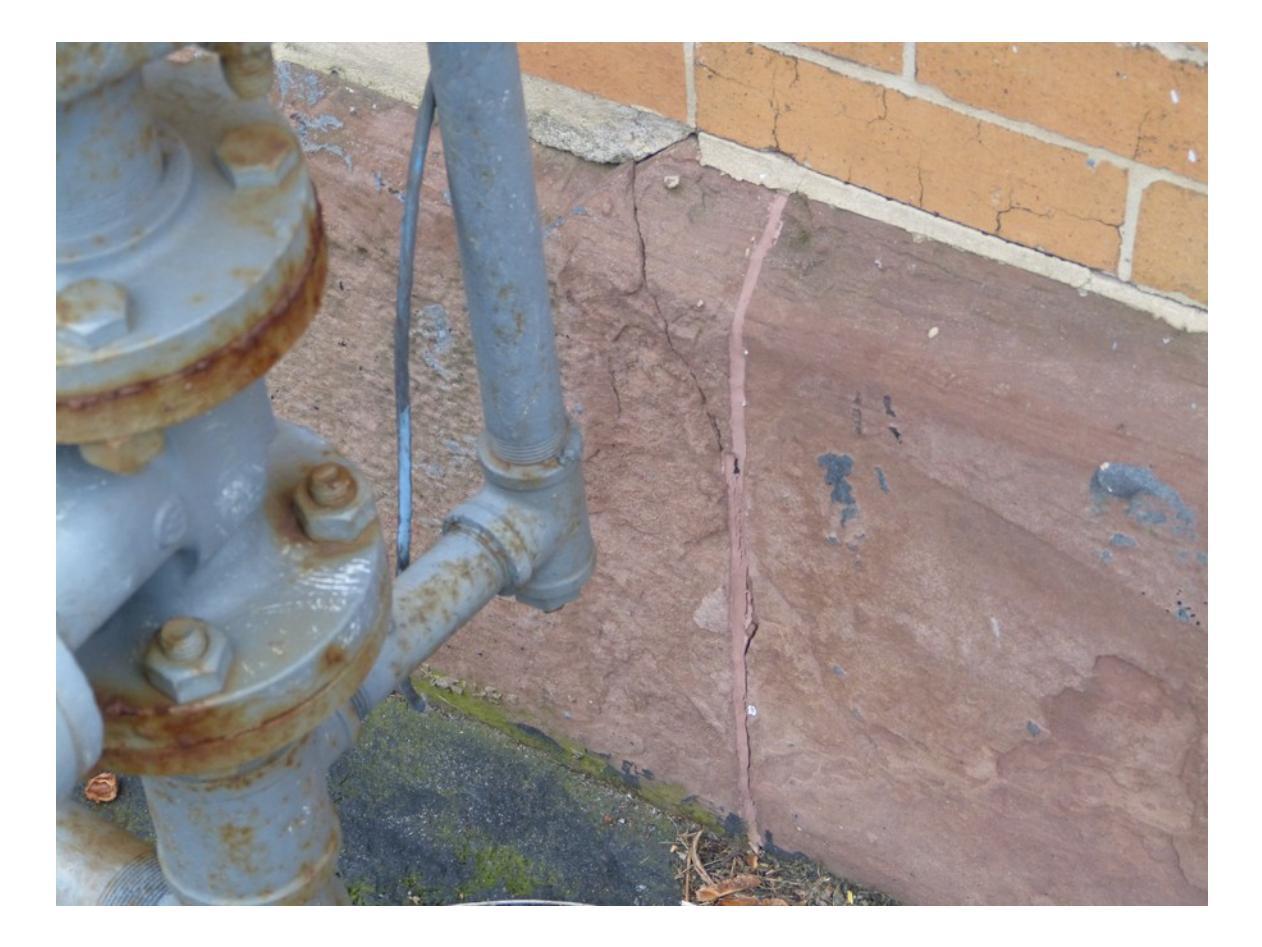
Photo: 270-14 Stone\_Crack System units and joints 2023-1.jpg Material: Stone Category: Crack System Unit Condition: System Unit TPAS Code: CU Autocad Layer: Stone\_Crack Severity Units: Width in 1/16 inch increments Amount Units: Length in lineal feet

A crack through more than one masonry unit, crossing, but not following, joints.

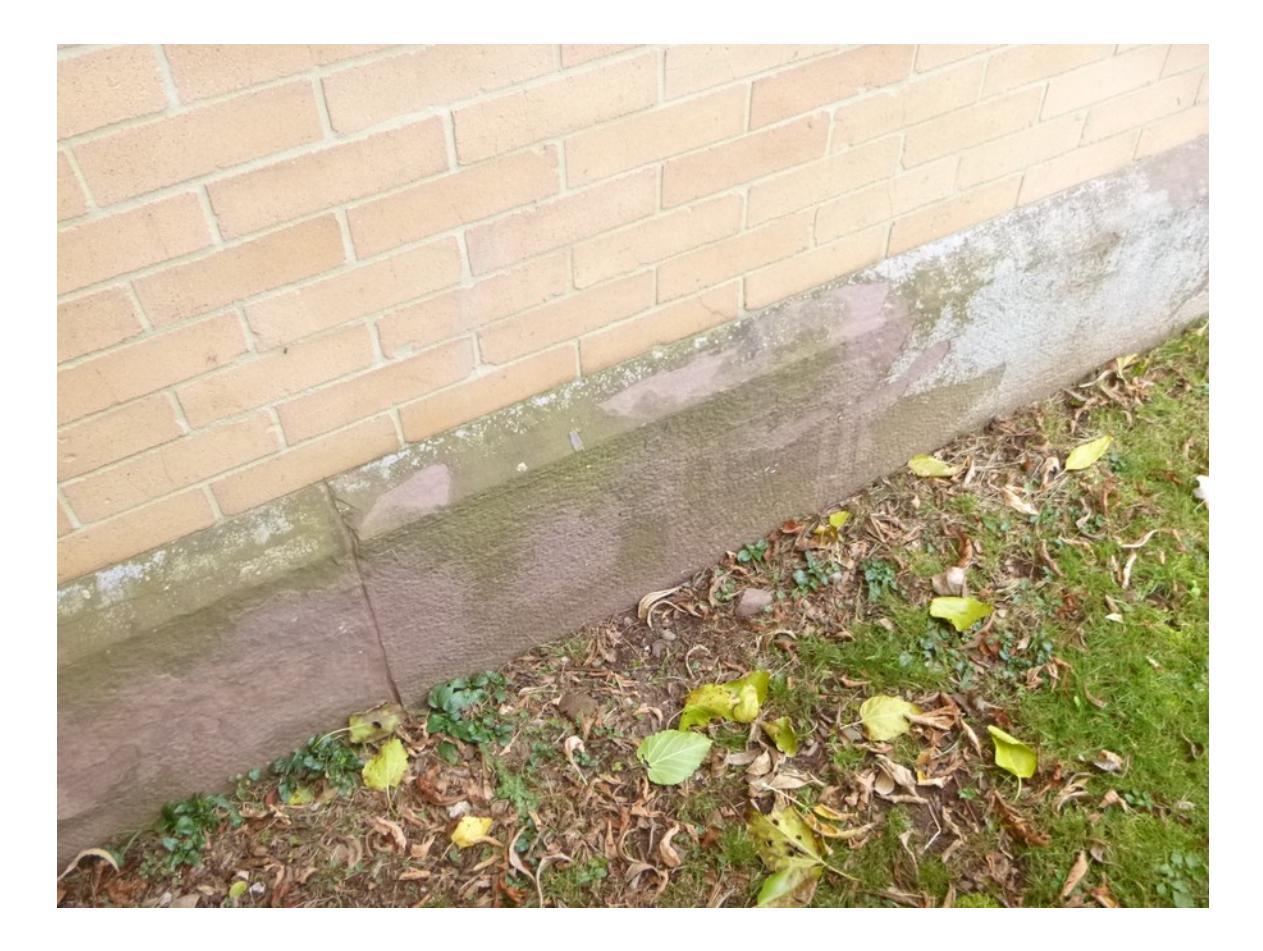
Photo: 88-13 Stone\_SoilStain Biological 2023-1.jpg Material: Stone Category: Soiled Biological Condition: Biological TPAS Code: Bio Autocad Layer: Stone\_SoilStain Severity Units: Not applicable Amount Units: Area affected in square feet

Microbiological plant growth on the surface of masonry, such as algae, moss or lichen, or vascular plant growth, typically in gutters, cracks or on roofs.

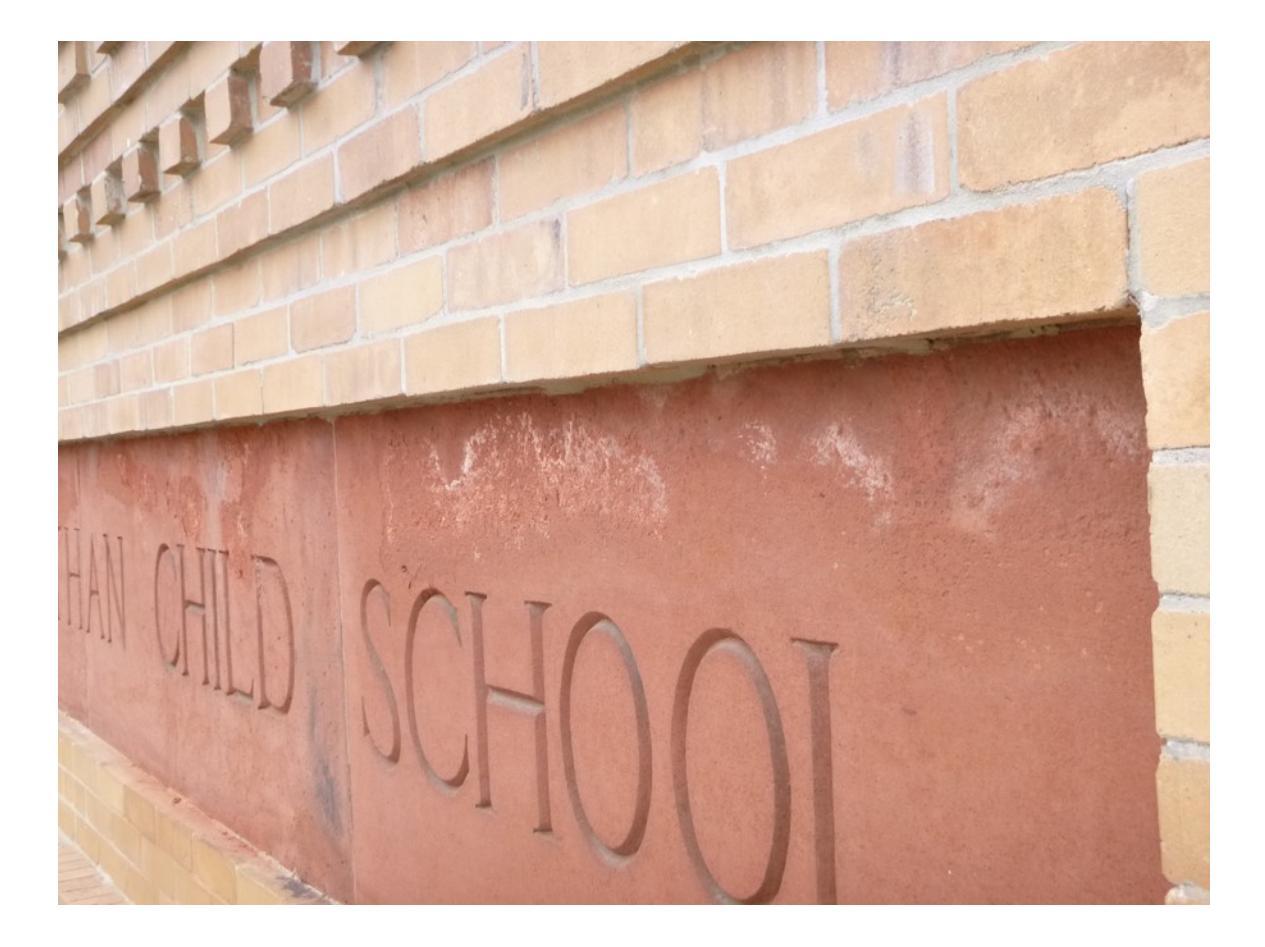
Photo: 51-20 Stone\_SoilStain Efflorescence 2023-1.jpg Material: Stone Category: Soiled Efflorescence Condition: Efflorescence TPAS Code: Eff Autocad Layer: Stone\_SoilStain Severity Units: Not applicable Amount Units: Area affected in square feet

White, soft deposition on the surface of masonry due to evaporative precipitation of salts. When this process occurs below the surface of the stone (subflorescence), it is revealed at areas of exfoliation or spalling.
