## ADDENDUM #1

RE: Rochester Housing Authority

## Jonathan Child Apartments Façade Repairs

## TRAUTMAN ASSOCIATES ROCHESTER HOUSING AUTHORITY JONATHAN CHILD APARTMENTS MASONRY RECONSTRUCTION TA PROJECT No. 24042

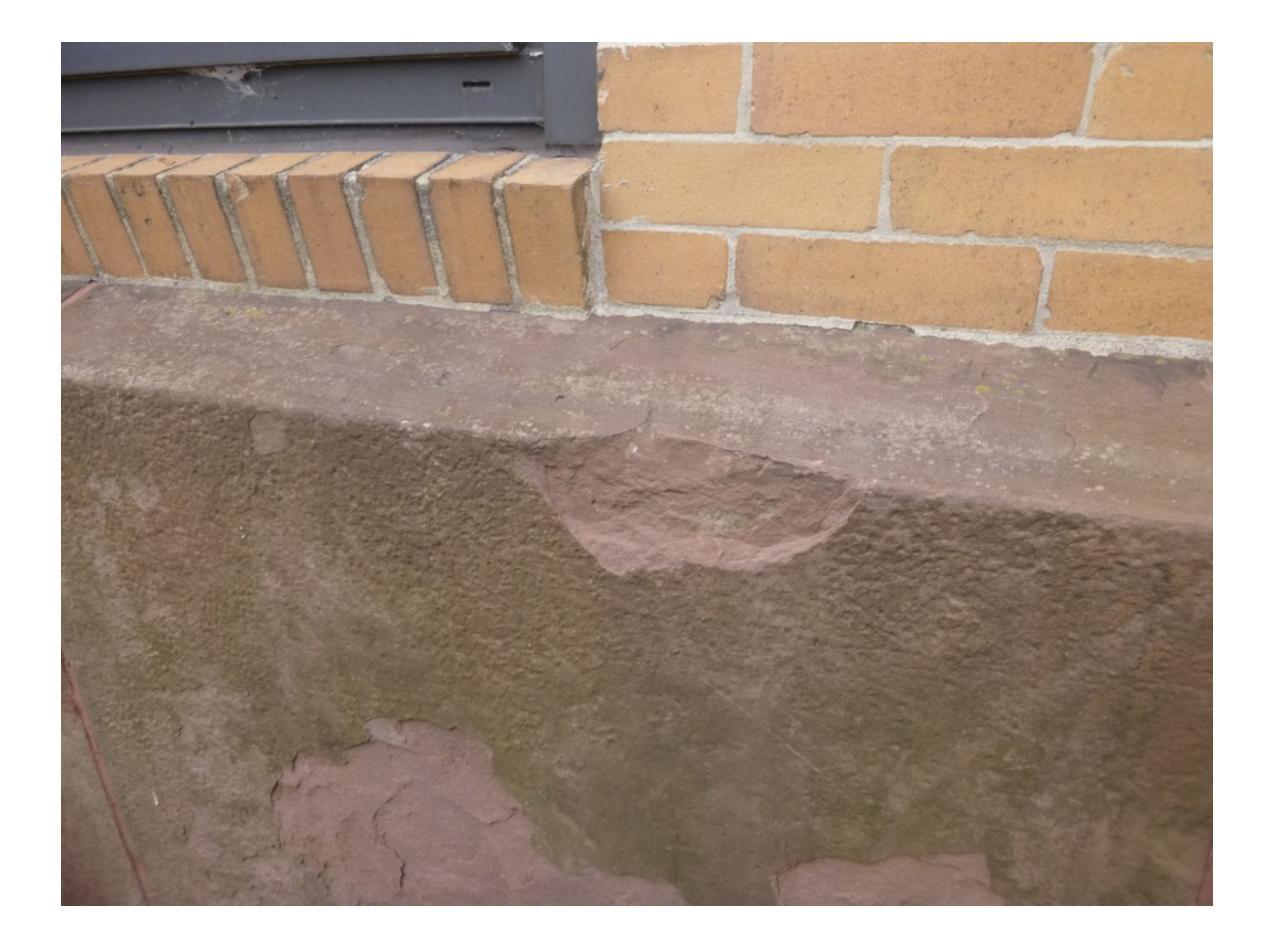
Photo: 56-14 Stone\_Spall Missing 2023-1.jpg Material: Stone Category: Spall Missing Condition: Missing TPAS Code: M Autocad Layer: Stone\_Spall Severity Units: Not applicable Amount Units: Size in square inches

The location of a spall that is no longer in situ at the time of the investigation, with no steel evident.

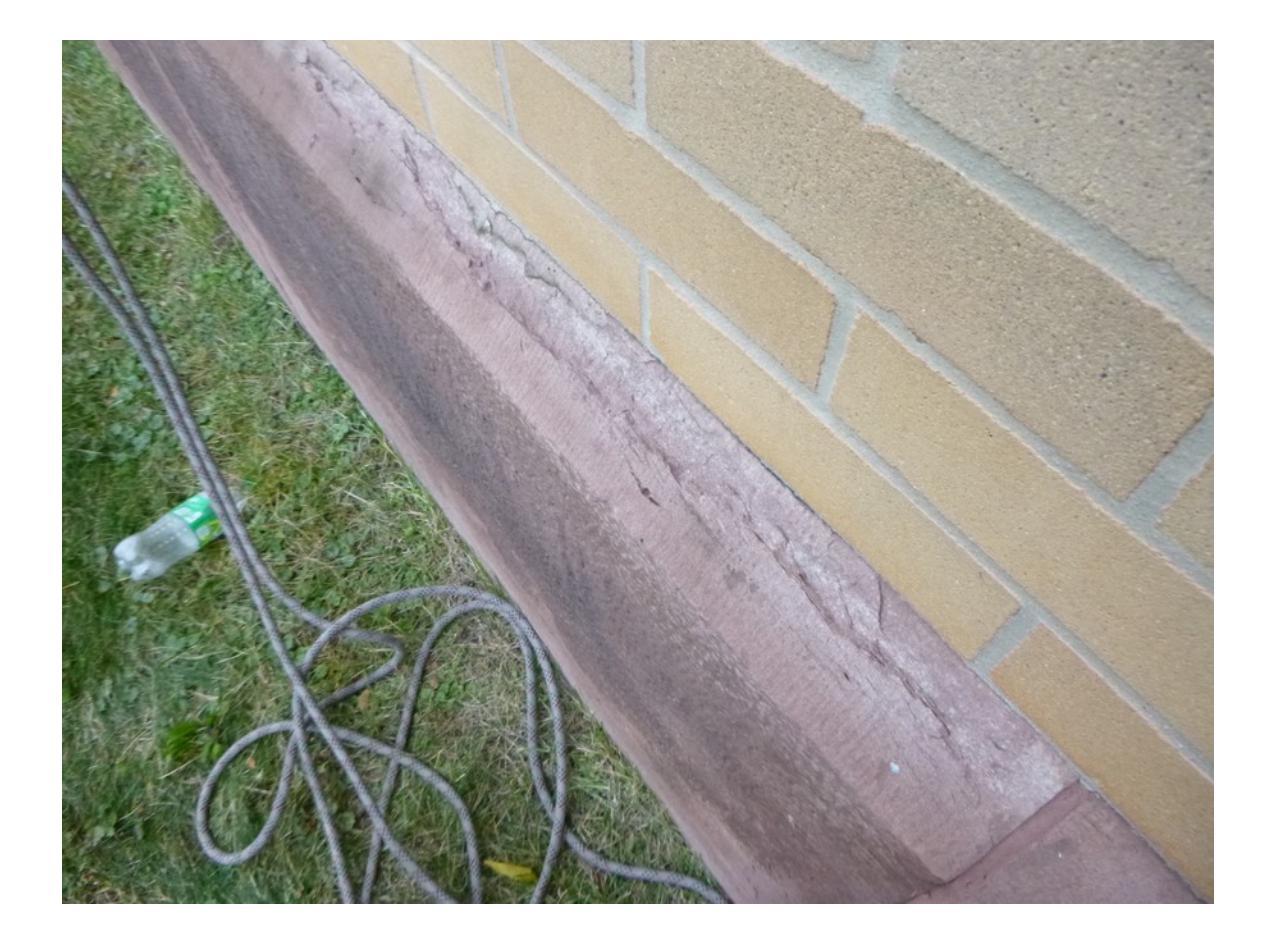
Photo: 474-16 Stone\_SurfLoss Delaminated 2023-1.jpg Material: Stone Category: Surface Delaminated Condition: Delaminated TPAS Code: Dlm Autocad Layer: Stone\_SurfLoss Severity Units: Depth of loss in 1/8 inch increments Amount Units: Area affected in square feet

Separation of layers along natural bedding planes, resulting in loss of material at the outer surface of the unit or voids within the unit.

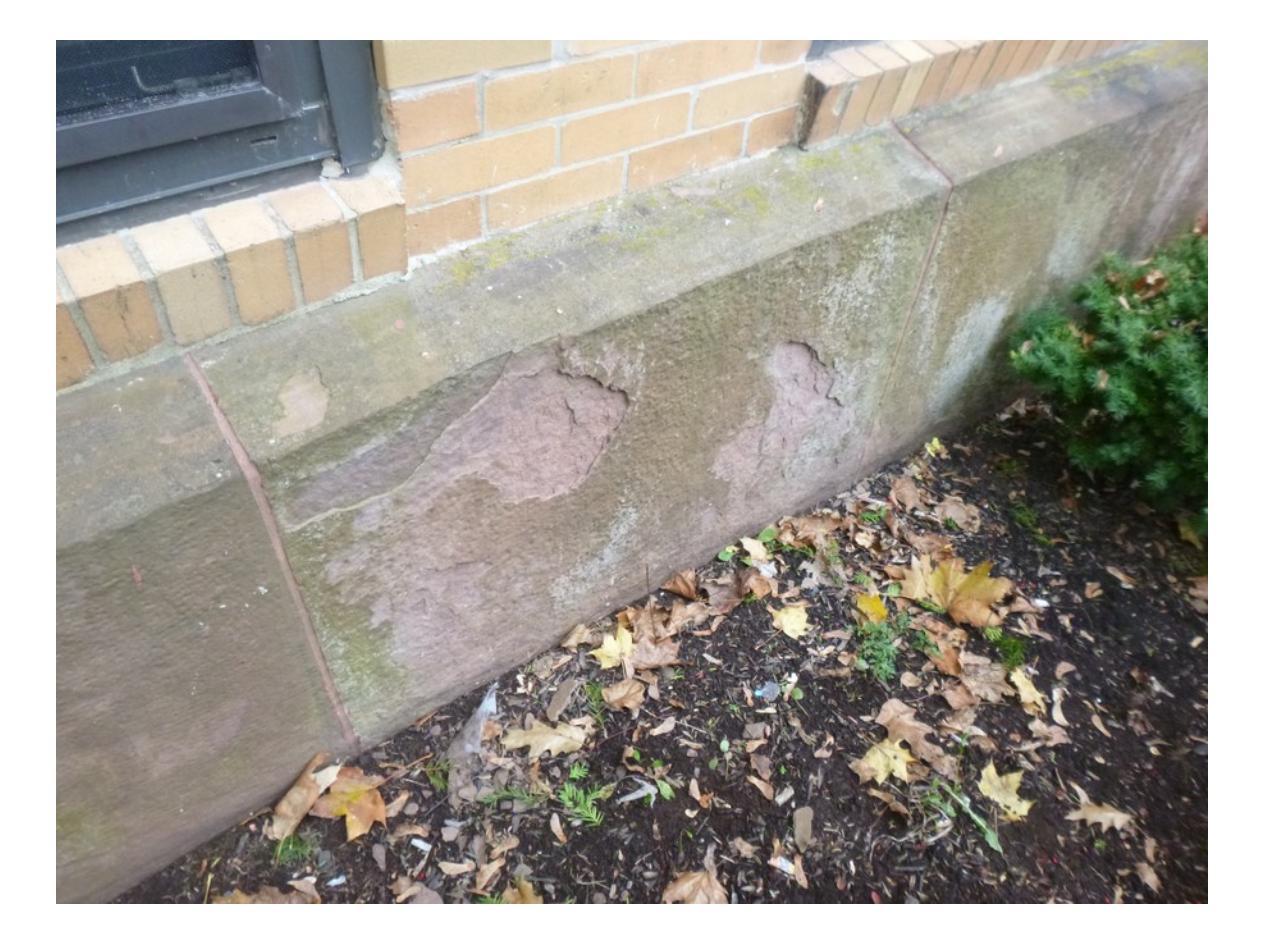
Photo: 35-13 Stone\_SurfLoss Exfoliated 2023-1.jpg Material: Stone Category: Surface Exfoliated Condition: Exfoliated TPAS Code: Exf Autocad Layer: Stone\_SurfLoss Severity Units: Depth of loss in 1/8 inch increments Amount Units: Area affected in square feet

Loss of outer surface of a masonry unit in layers.

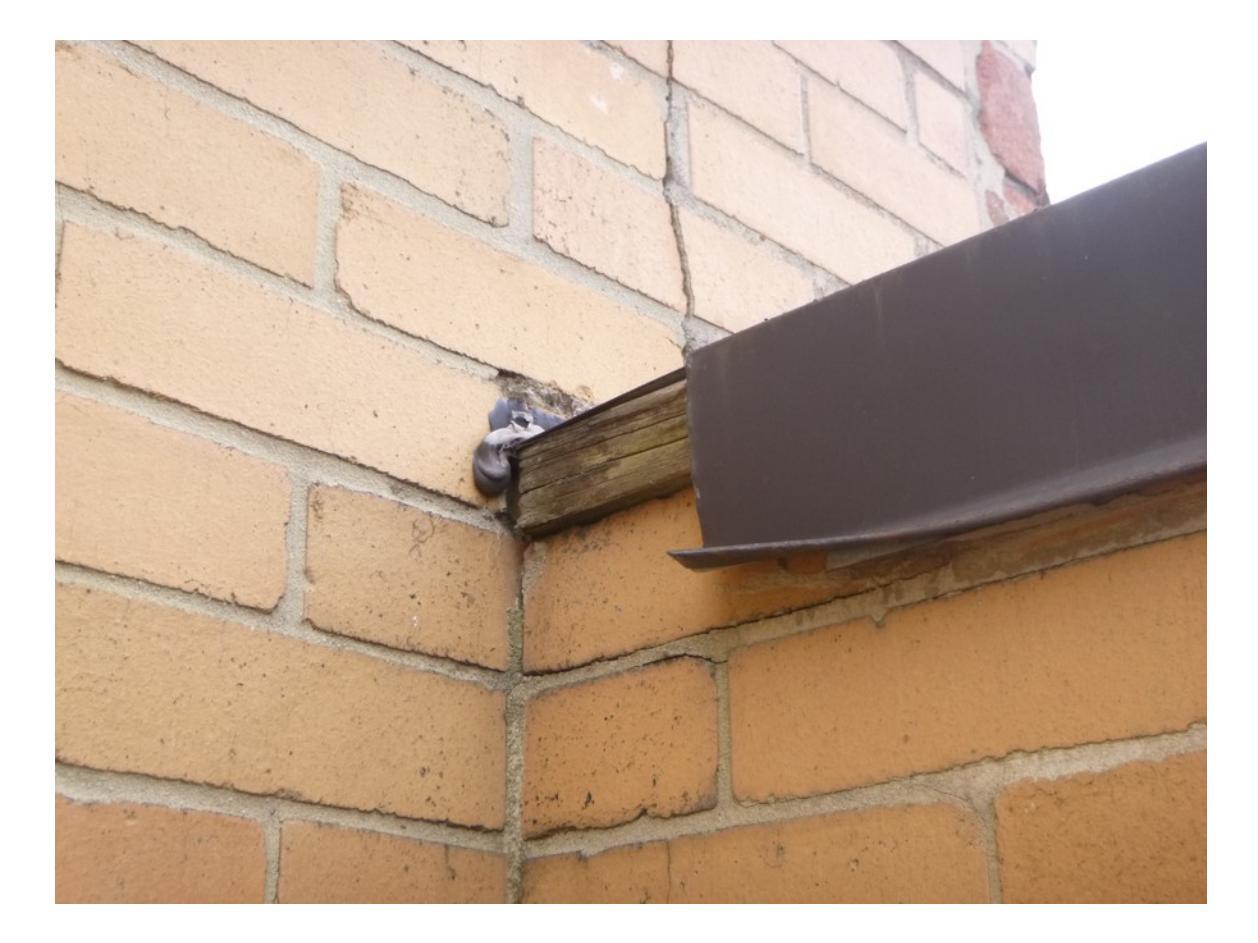
Photo: 428-27 Wood\_Deteriorated Weathered 2023-1.jpg Material: Wood Category: Weathered Condition: Weathered TPAS Code: Wthr Autocad Layer: Wood\_Deteriorated Severity Units: Not applicable Amount Units: Area affected in square feet

Loss of softwood due to abrasion or erosion and resulting in uneven surface texture of wood.

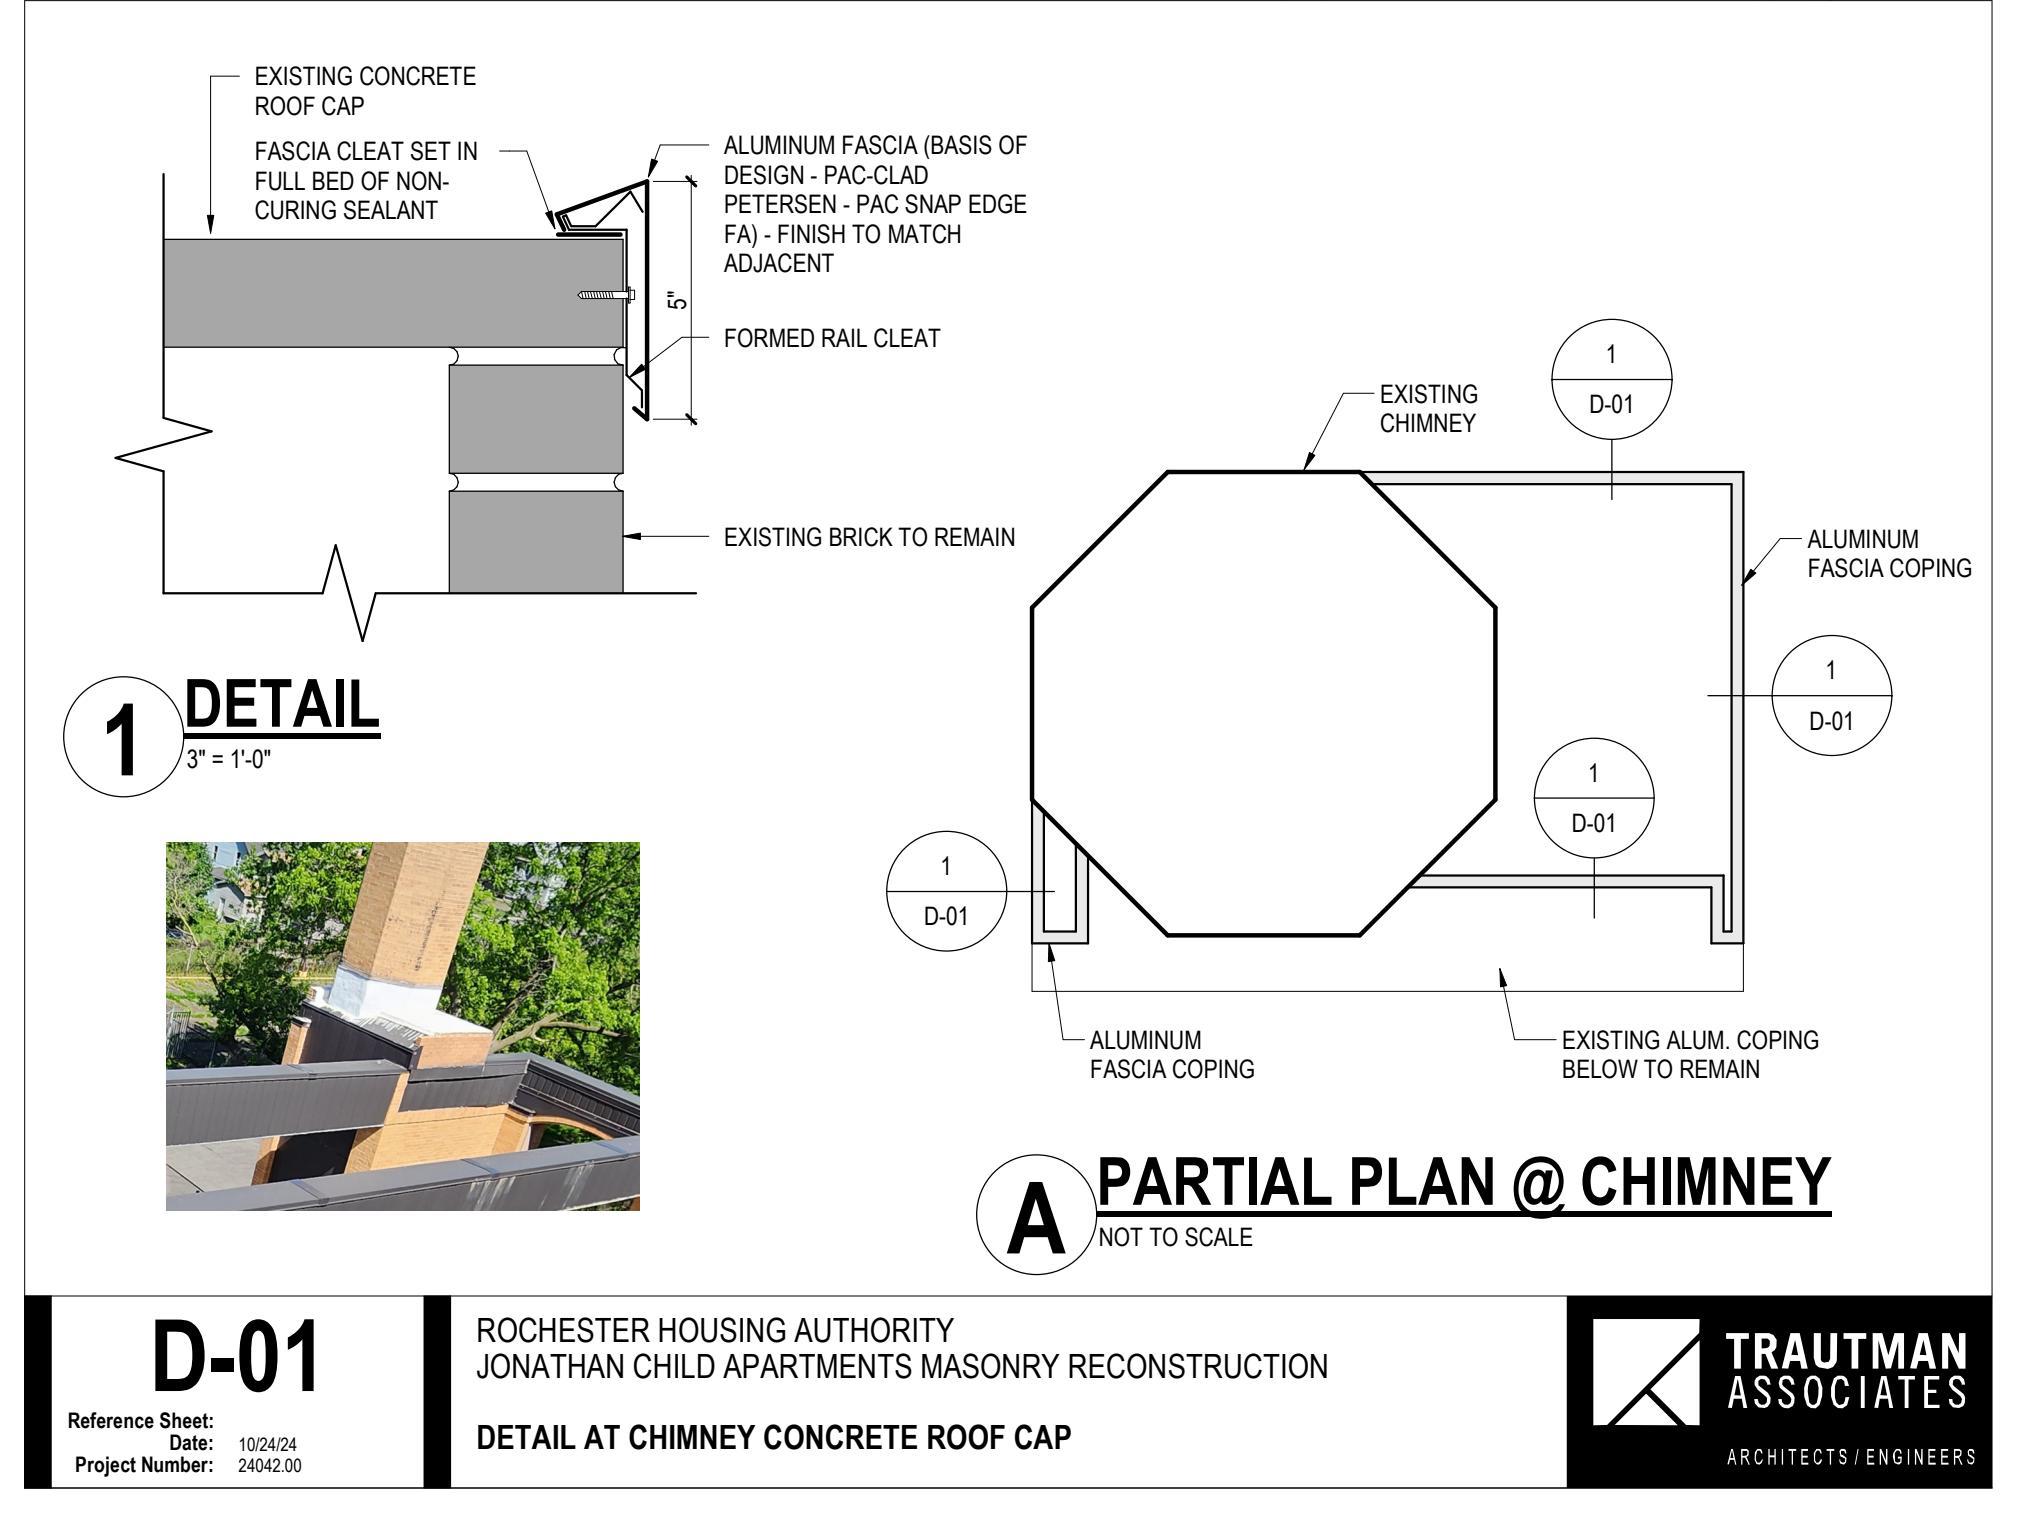
Page 45 is an additional detail provided by the architects for more detail of the chimney.

REPLACE Note 15 with the following: Provide aluminum coping cap flashing along all (3) edges of the concrete roof cap – finish to match existing. Refer to sketch D-01 "Detail at Chimney Concrete Roof Cap".

ADD the attached addendum sketch D-01 "Detail at Chimney Concrete Roof Cap".
